September 26, 2017

**Subject: Letter Report for Fisherman's Wharf Structural Inspection and Evaluation,  
Kewalo Basin, Honolulu, Hawaii**

Attachments: Photographs, Inspection Plans, Vehicle and Pedestrian Operational Restriction Plan

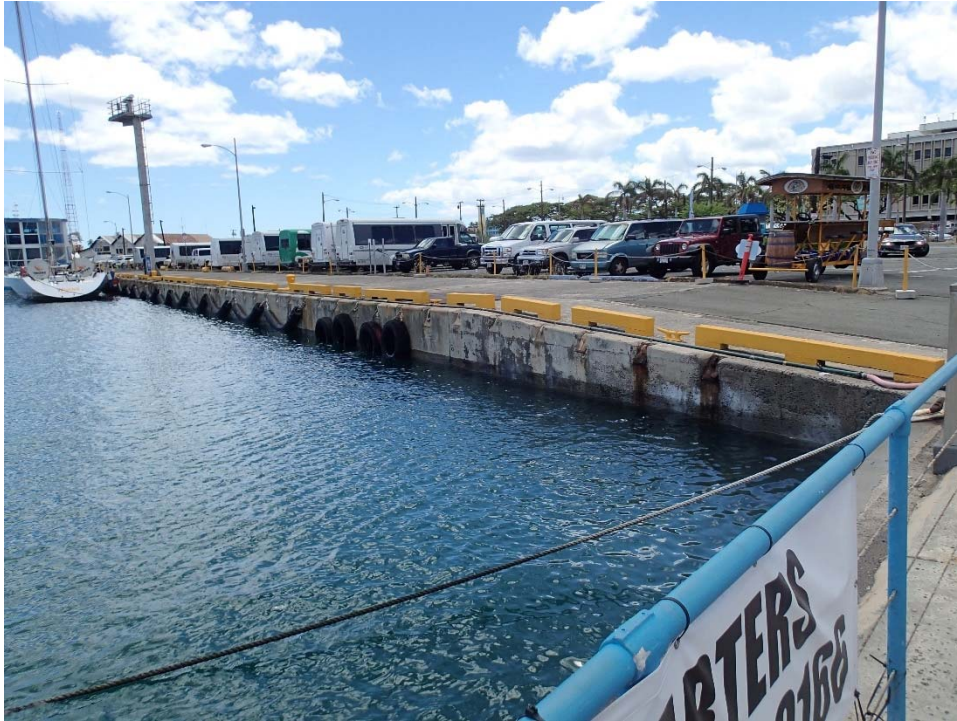
1 - General view of Fisherman's Wharf. Photo taken from north end of 1924 section of wharf looking South-West.

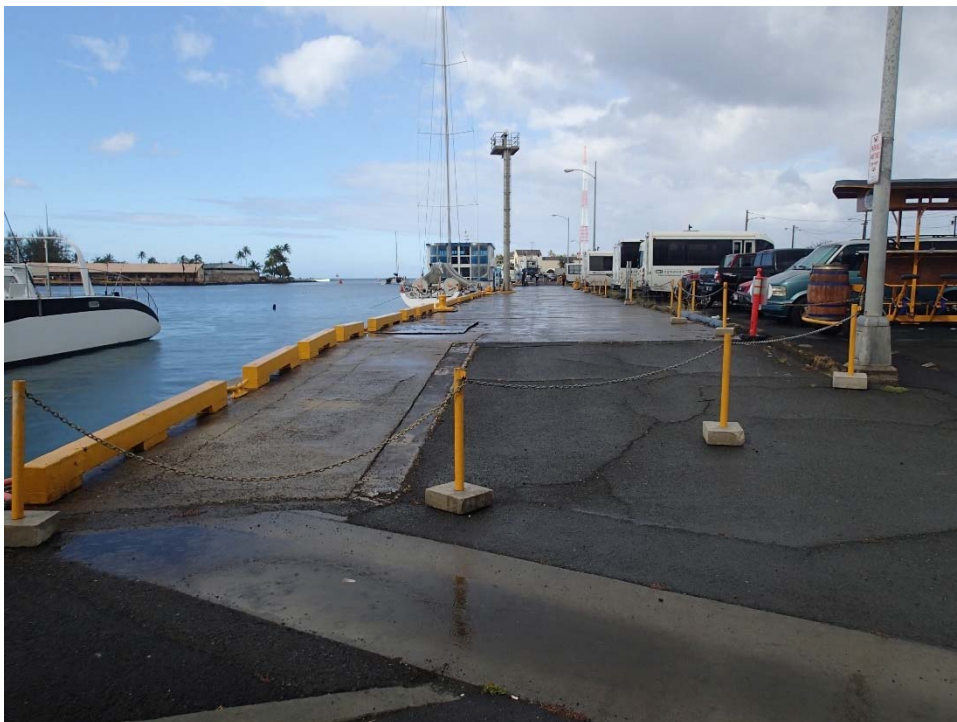
The 1924 section of Fisherman's Wharf currently has posts and chains at the north and south ends prohibiting vehicles access (see Photos 2 thru 4). There are no signs posted restricting pedestrian access. During the site inspection, ship operators were observed walking across the 1924 section of deck. Additional deck restrictions are discussed in the SUMMARY section of this report.

2 - Fisherman's Wharf, looking south from Ala Moana Blvd end of 1924 section of wharf. Chain and posts prohibit vehicles onto the 1924 section of wharf deck.

Damages have significantly progressed since the 2012 wharf inspection and evaluation. The existing chain link fencing (Shown in Photos 2 thru 4) at each end of the 1924 section of wharf should be maintained to prohibit vehicle access. Based on the existing level of structural damage, maximum live loading should be limited to pedestrians (i.e., 50 pounds per square foot [psf]) only within the limited areas indicated below:

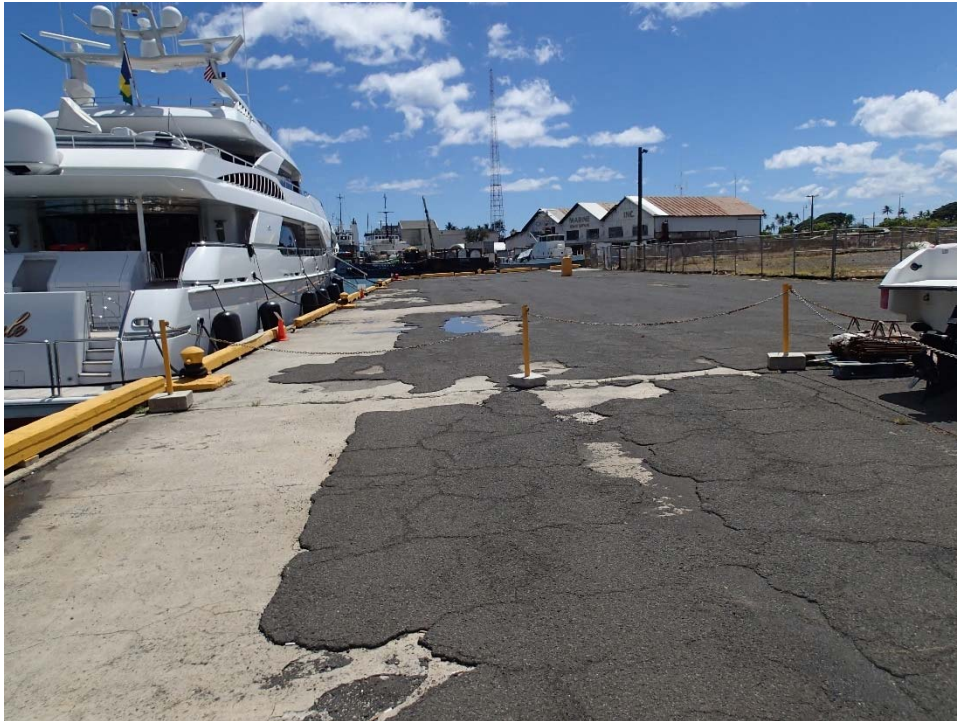
3 – Fisherman’s Wharf, looking south at the 1968 wharf construction (1924 wharf construction in foreground). Chain and posts prohibit vehicles onto the 1924 section of wharf deck.

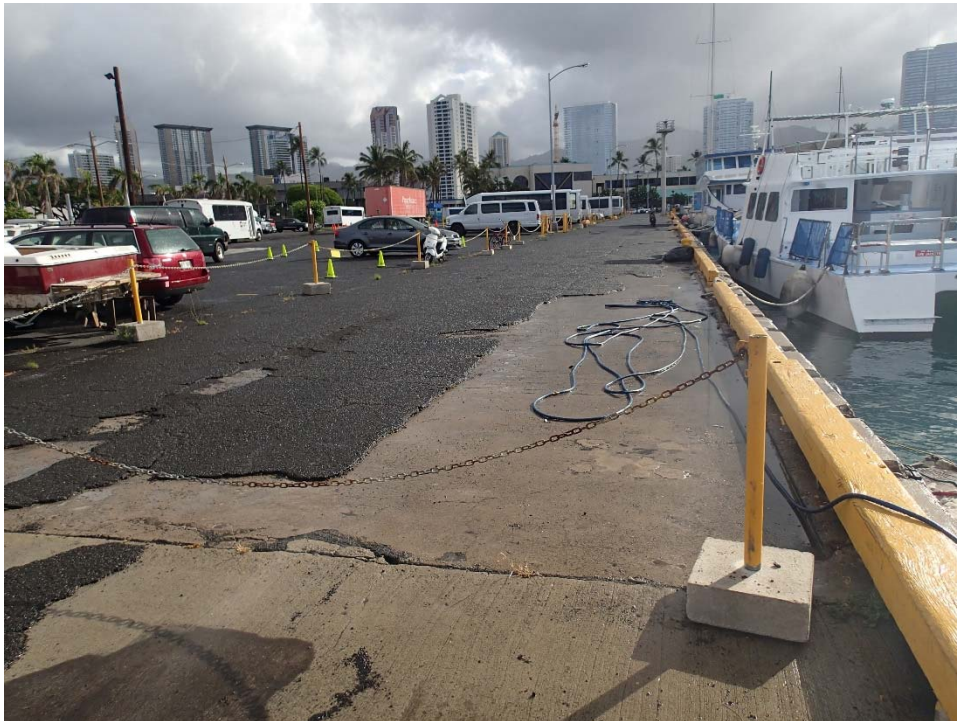
4 - Fisherman’s Wharf, looking north at the 1924 wharf construction (1968 wharf construction in foreground). Chain and posts prohibit vehicles onto the 1924 section of wharf deck.

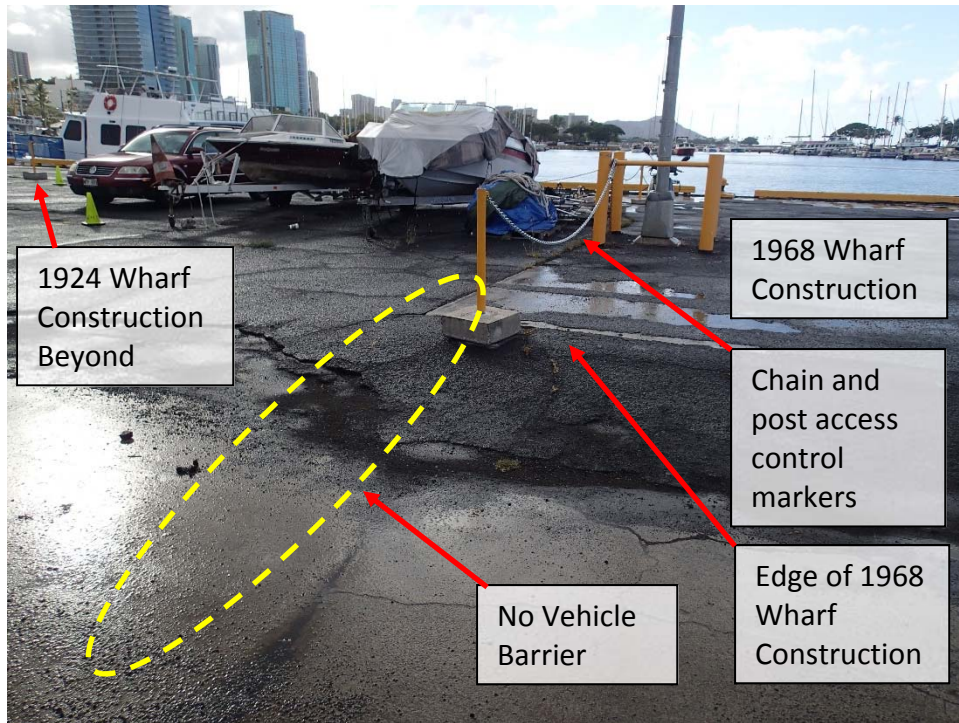
There are posts and chains along the north end of the 1968 section of Fisherman's Wharf; however, there is a section without posts and chains that allow vehicles to access the 1968 wharf construction (see Photo 5). During the site inspection, ship operators were observed to temporarily park on the 1924 section of deck to load supplies onto the vessel. Additional deck restrictions are discussed in the SUMMARY section of this report.

5 –North end of 1968 wharf construction looking east. Note chain and posts separating 1968 and 1924 wharf construction does not restrict vehicles from accessing 1968 portion of wharf

It is recommended that immediate measures be taken to prohibit vehicles from accessing the 1968 wharf deck from the north end of the deck by extending the access barriers (see Photo 5) to prevent vehicles from entering prohibited areas mentioned above. Vehicle access to the 1968 wharf, if necessary, could be provided via an existing access lane that is currently closed on the southwest corner of the wharf.

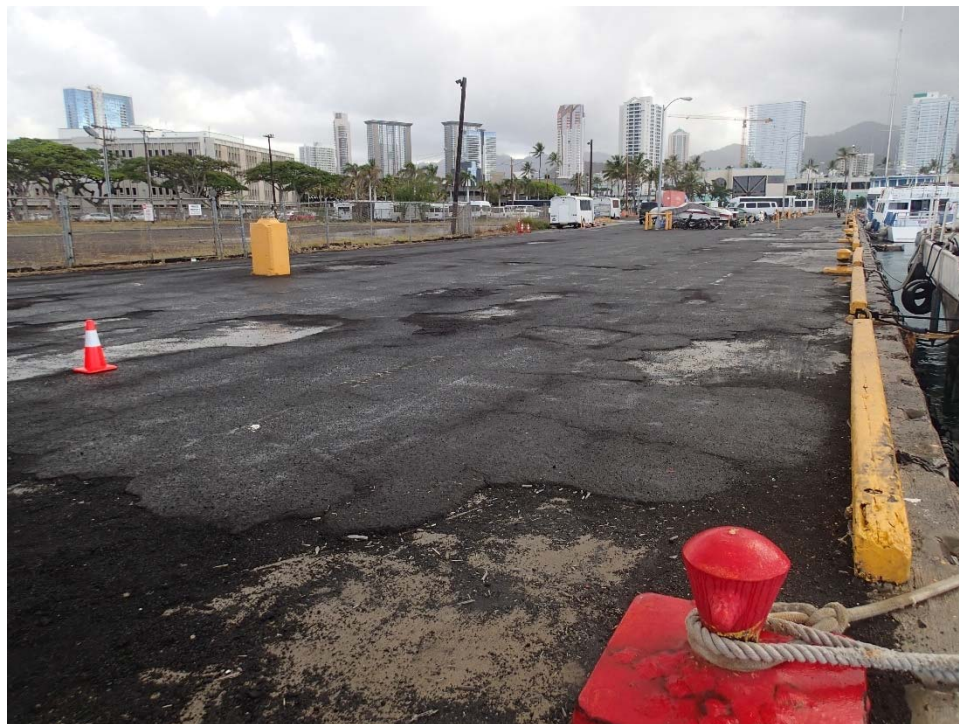
6 – Fisherman's Wharf, looking north from end of 1968 wharf. Note poor condition of asphalt topping

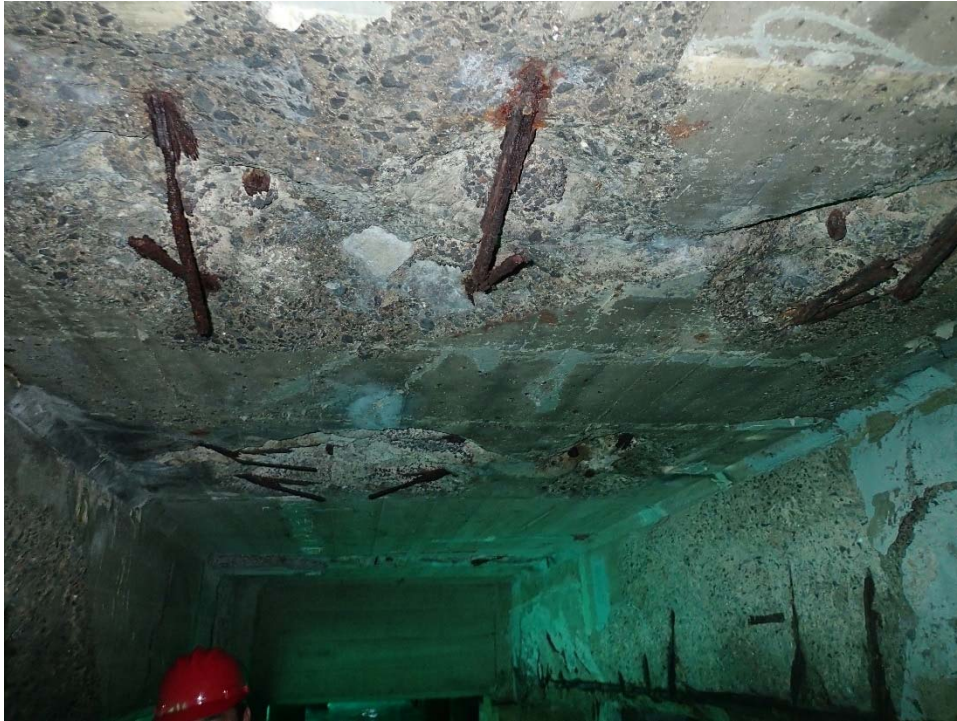
Approximately 25% of the 1924 deck soffits is spalled with large areas of exposed and corroding reinforcing steel. This is approximately a 170% increase of damaged area from the previous wharf evaluation conducted in 2012. An example of a spalled soffit area with fractured slab reinforcing steel is shown in Photo 7.

7 – Typical deck soffit and longitudinal beam damage under 1924 wharf. Note exposed and fractured slab reinforcing steel

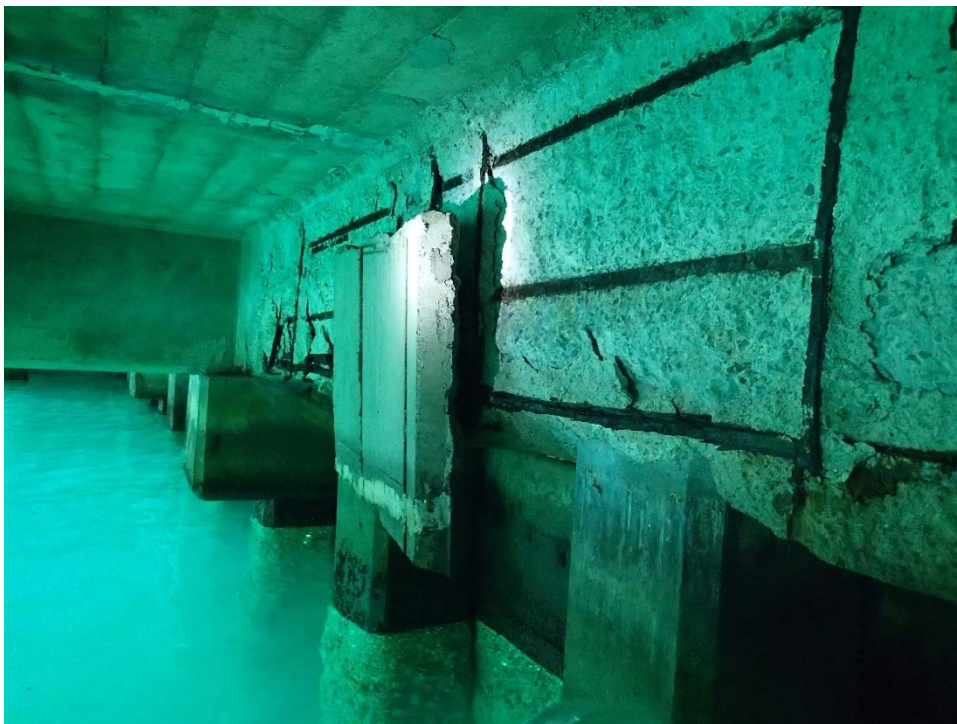
The longitudinal beams in the 1924 structure are in poor condition with extensive spalling and exposed corroding reinforcing steel. In numerous areas, the shear stirrups are completely exposed and are broken along the bottom and sides of the beam. The extent of the damage covers nearly 97% of the length of the rear marginal beam above the bulkhead soldier piles, and approximately 85% of the intermediate beams (see Photos No. 8 and 10).

8 – Typical condition of the rear marginal beam with exposed and corroding reinforcing steel. The remaining portion of a previous beam repair area is shown hanging.

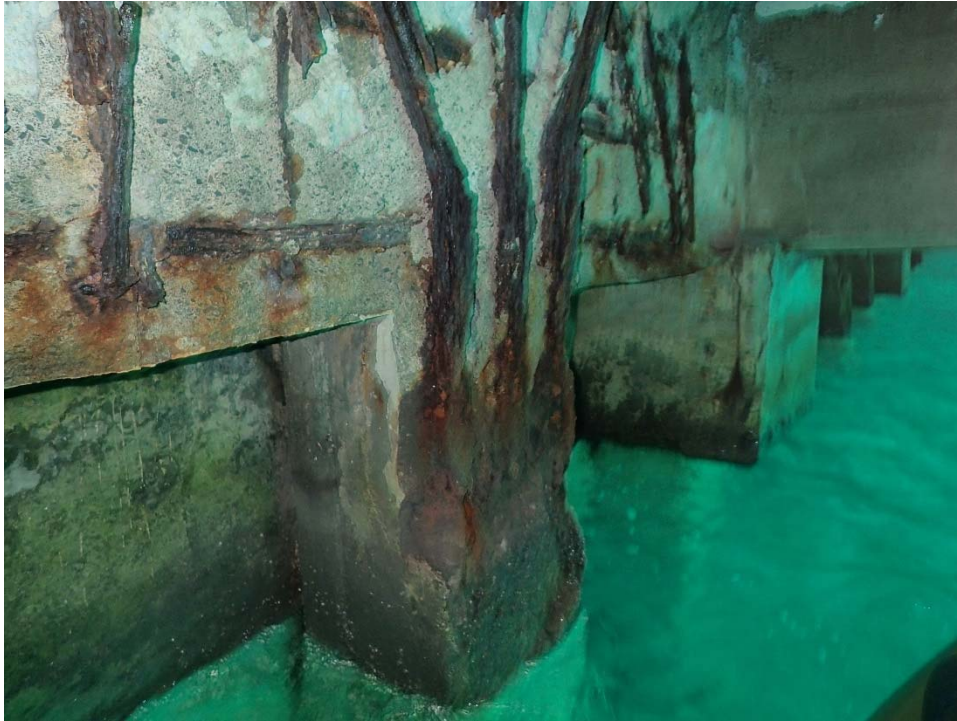
The above-water portion of the piles in Gridline A (along the bulkhead) are typically in a moderate to poor condition. Moderate defects included surface spalls, horizontal and vertical cracks up to 1/4 in. width. Poor conditions included areas of failed repairs with exposed reinforcing steel extending from the pile cap down 2 to 3 feet below the tidal zone (see Photo No. 9).

9 – Example of damage at the top of some piles along Gridline A (bulkhead) on the 1924 wharf.

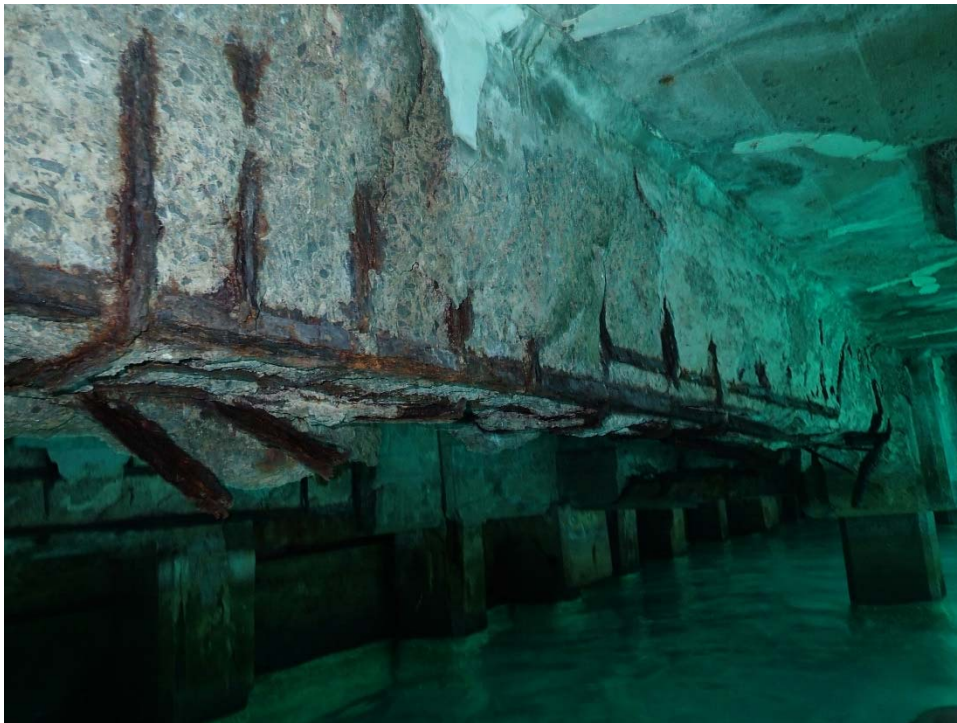
10 – Example of location with extensive beam spalling and fractured beam bottom reinforcing steel and shear stirrups on the 1924 wharf.

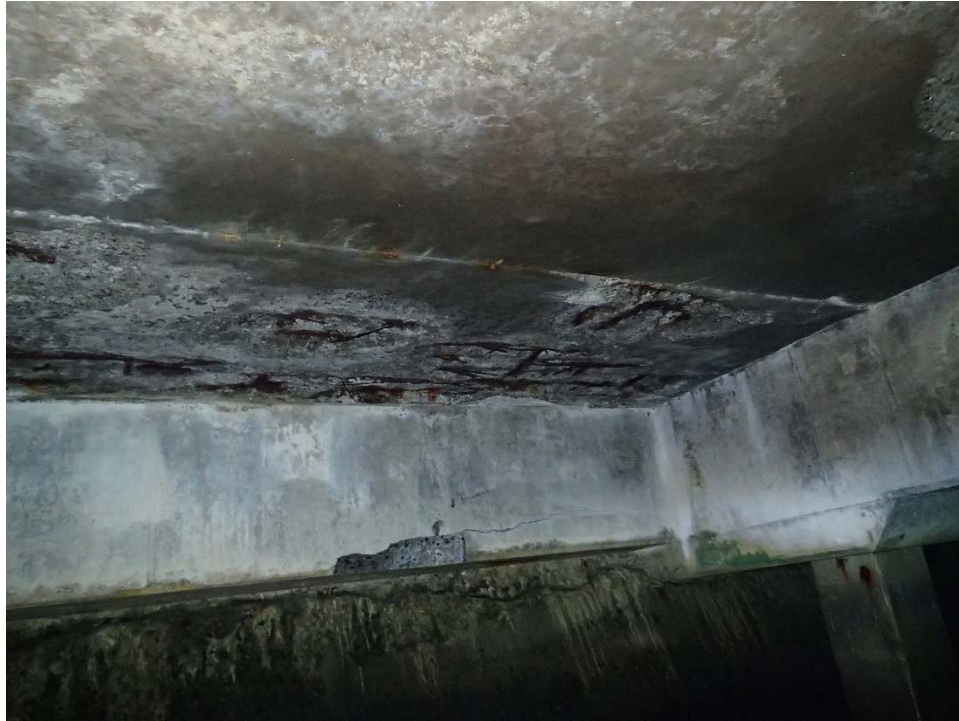
Several prestressed panels adjacent to the bulkhead have exposed reinforcing steel and prestressing steel strands which have already corroded causing the concrete to spall and further accelerate atmospheric corrosion of the reinforcement. On twelve panels, the steel strands were noted to be completely severed due to corrosion loss (example of this condition is shown on Photo No. 11). The proximity of the damaged planks to the bulkhead suggests that the combination of relatively low deck height and splash from waves breaking against the bulkhead is accelerating the deterioration in these areas.

This type of corrosion is especially critical since once prestressing steel begins to corrode, the strength and ductility of the prestressed concrete plank is significantly reduced. Prestressed planks with exposed and damaged prestressing steel strands should be repaired or removed and reconstructed.

11 – Soffit of precast-prestressed plank with broken prestressing strands on the 1968 wharf

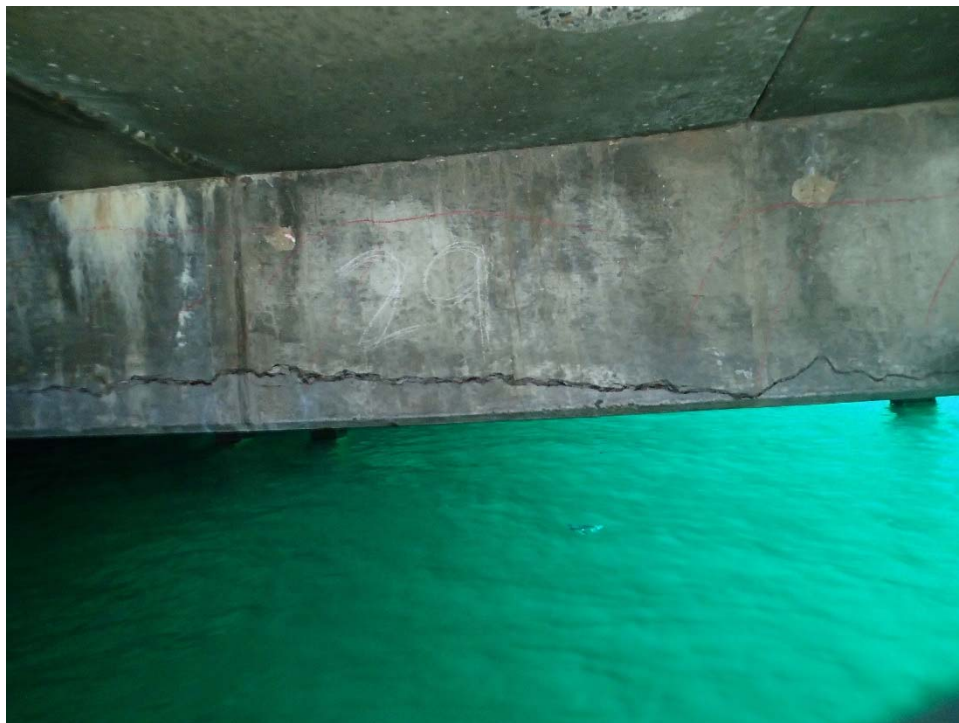
The 1968 pile caps are in fair condition, with spalling and/or exposed corroding reinforcing steel on 60% of the 1968 structure. This is approximately a 240% increase in damage from the previous wharf evaluation conducted in 2012.

12 – Spalling along soffit of 1968 wharf pile cap

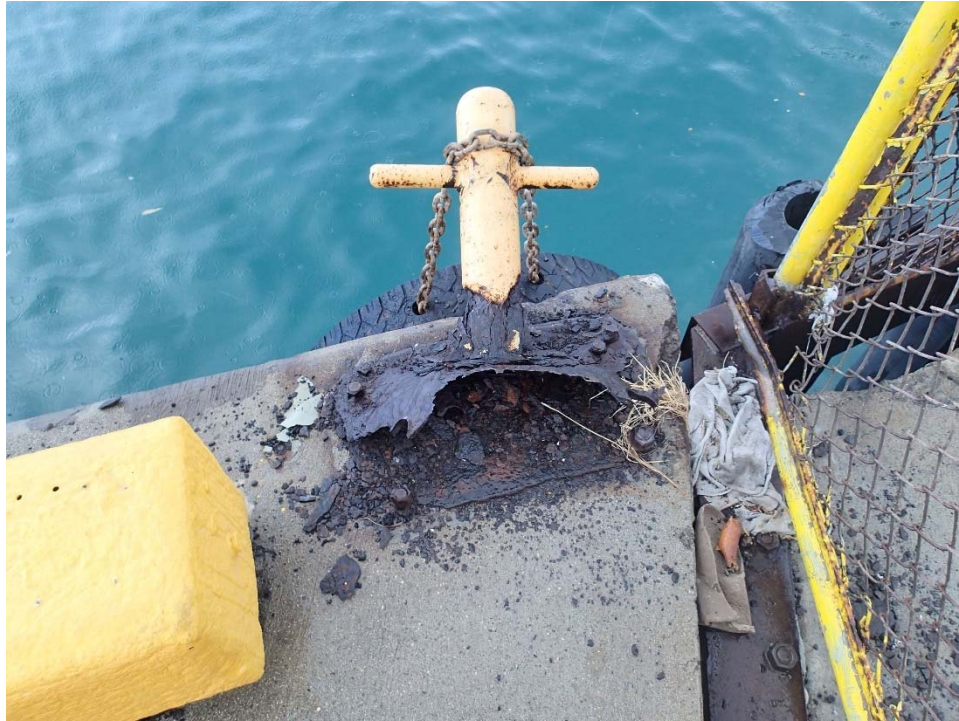
With the exception of a heavily corroded bollard at the south end of the 1968 section of wharf (see Photo 13), the topside appurtenances appear to be in good to fair condition. The heavily damaged bollard should be immediately removed from service.

13 – Mooring cleat with significant corrosion (near collapse) at south end of 1968 wharf

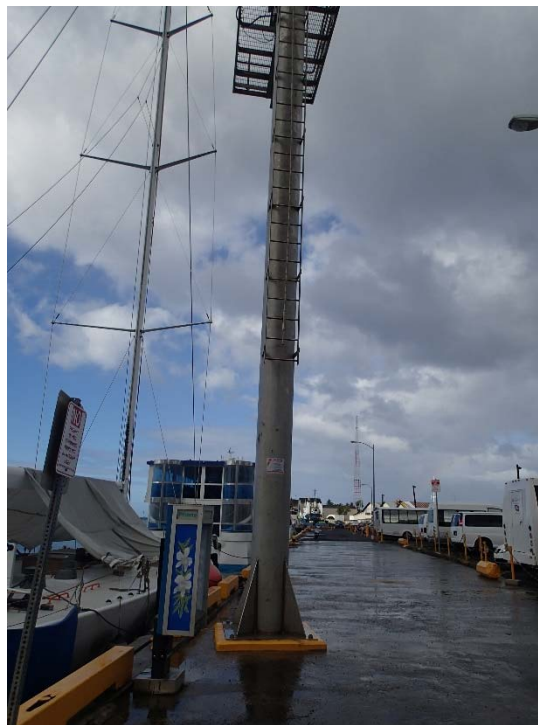
14 – 1924 section of wharf near gridline 7 with range light, telephone booth and bull rails along wharf edge

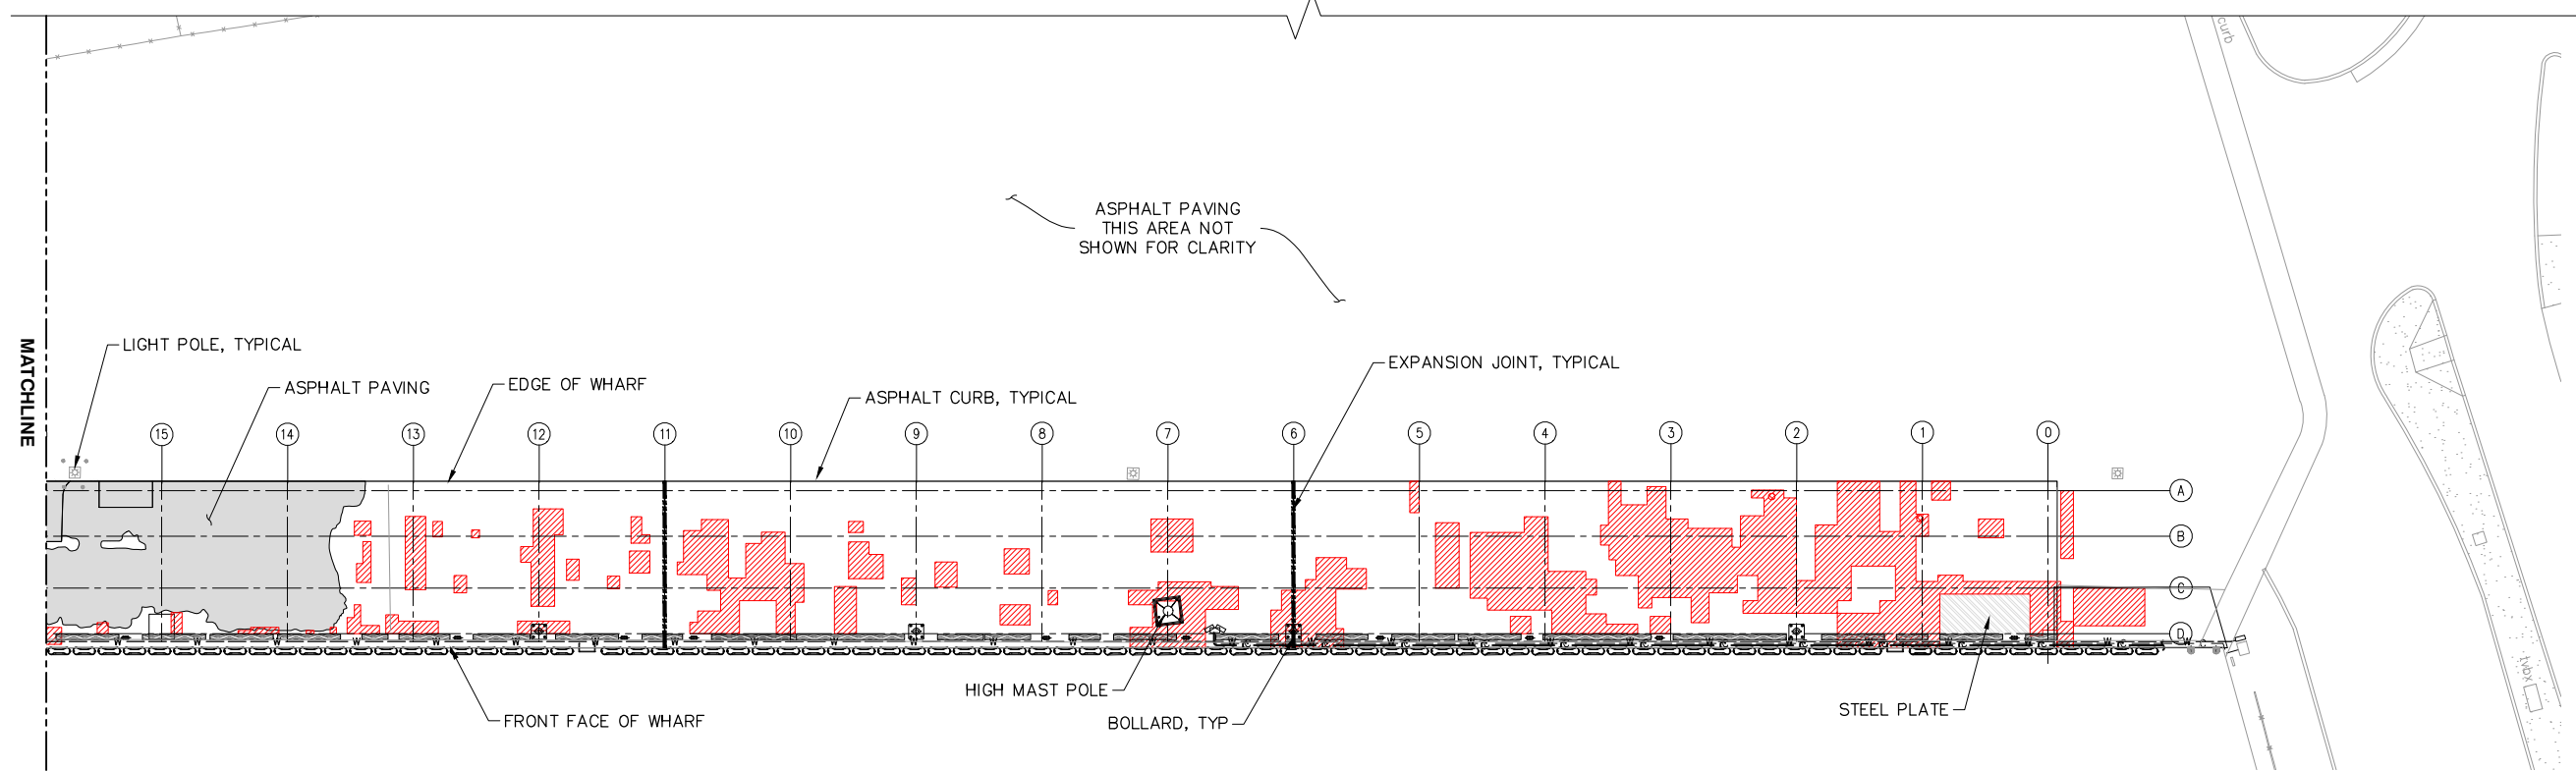
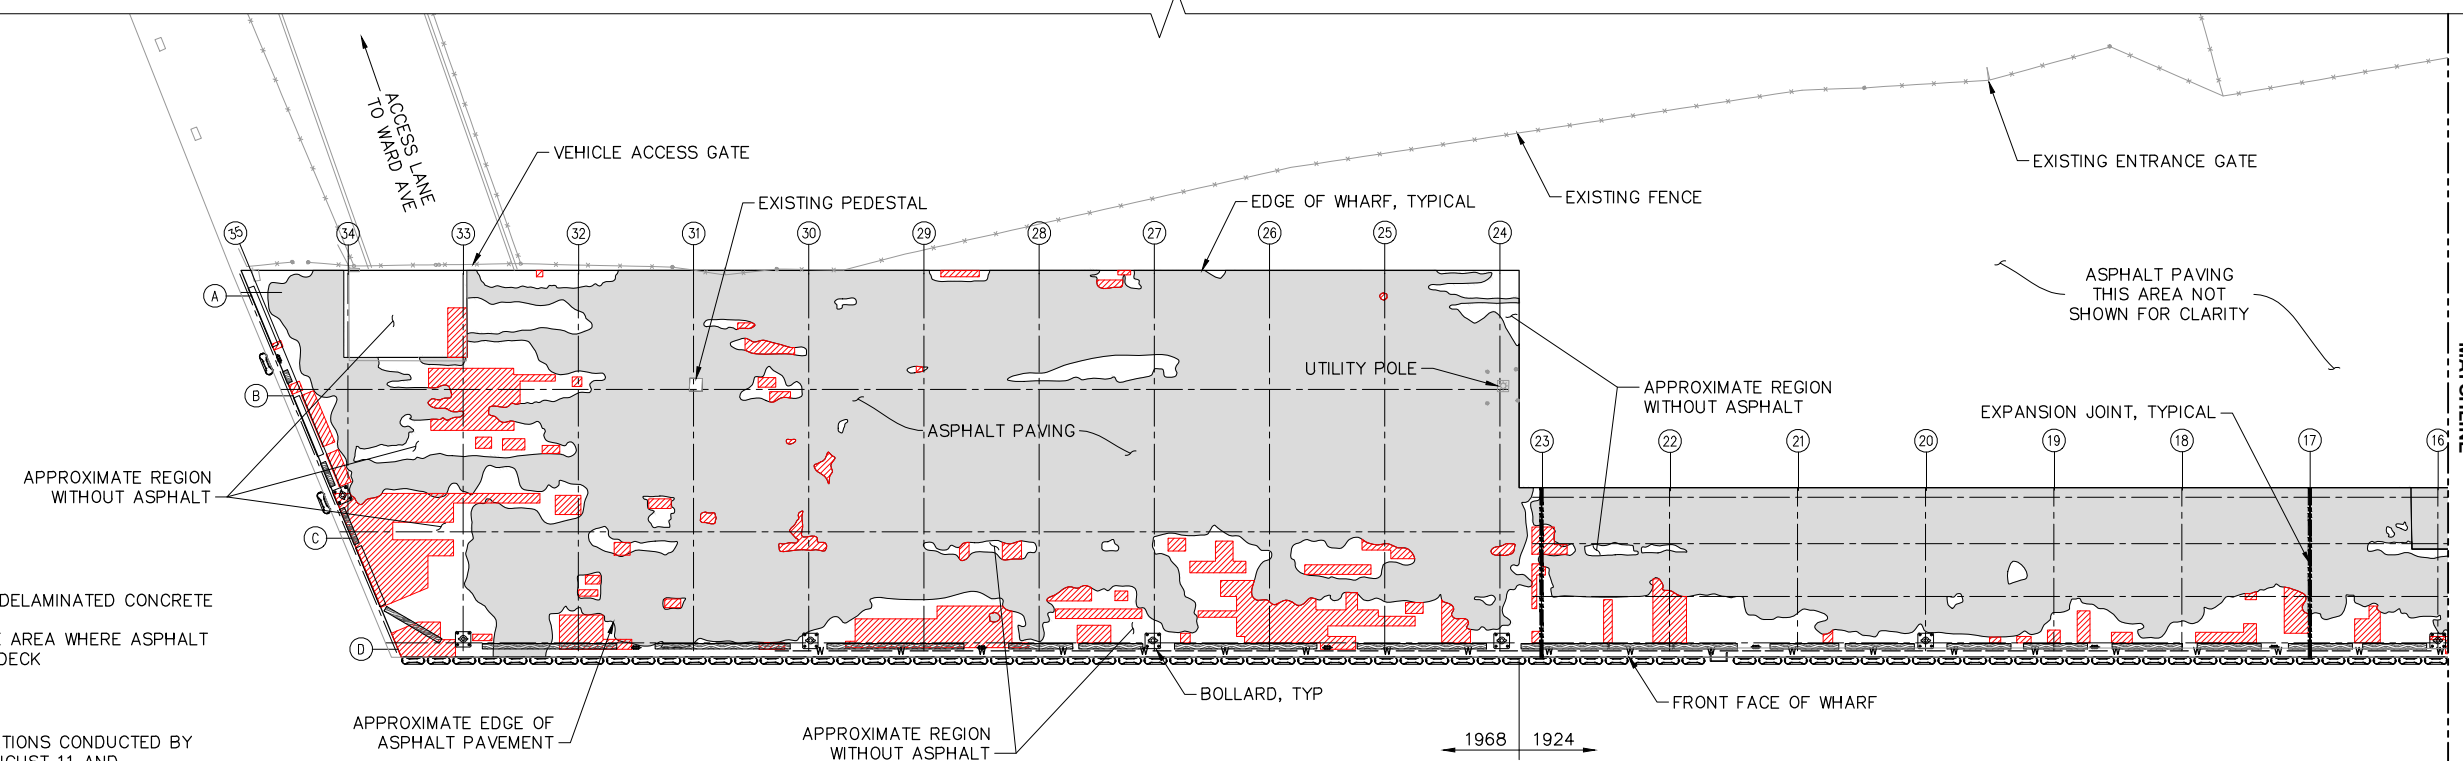
FISHERMAN'S WHARF STRUCTURAL  
INSPECTION AND EVALUATION  
**ABOVE DECK SPALL PLAN - OVERALL**

The wharf deck between Bents 13 and 35 were covered with a thin asphalt topping. The asphalt is in poor condition with visible cracks and delamination (see Figure 2 for approximate areas where asphalt no longer exists between Bent 13 and 35). The exposed edges of asphalt were between ½ to ¾ in. thickness.

A chain-drag survey was limited to the areas with exposed concrete deck. The purpose of this type of survey is to identify surface delaminations, horizontal cracks which are below the surface and have not yet propagated to the surface. Delaminated concrete is often caused by corrosion of the top layer of reinforcing steel. The extent of top deck concrete delamination is shown in Figure No. 2.

Approximately 30% of the deck surface between Bent Nos. 0 and 13 is delaminated. This is approximately a 300% increase in damaged area from the previous wharf inspection conducted in 2012. While sounding indicated the presence of delamination, the horizontal cracking did not propagate to the surface and there were no visual signs of exposed and corroding reinforcing steel.

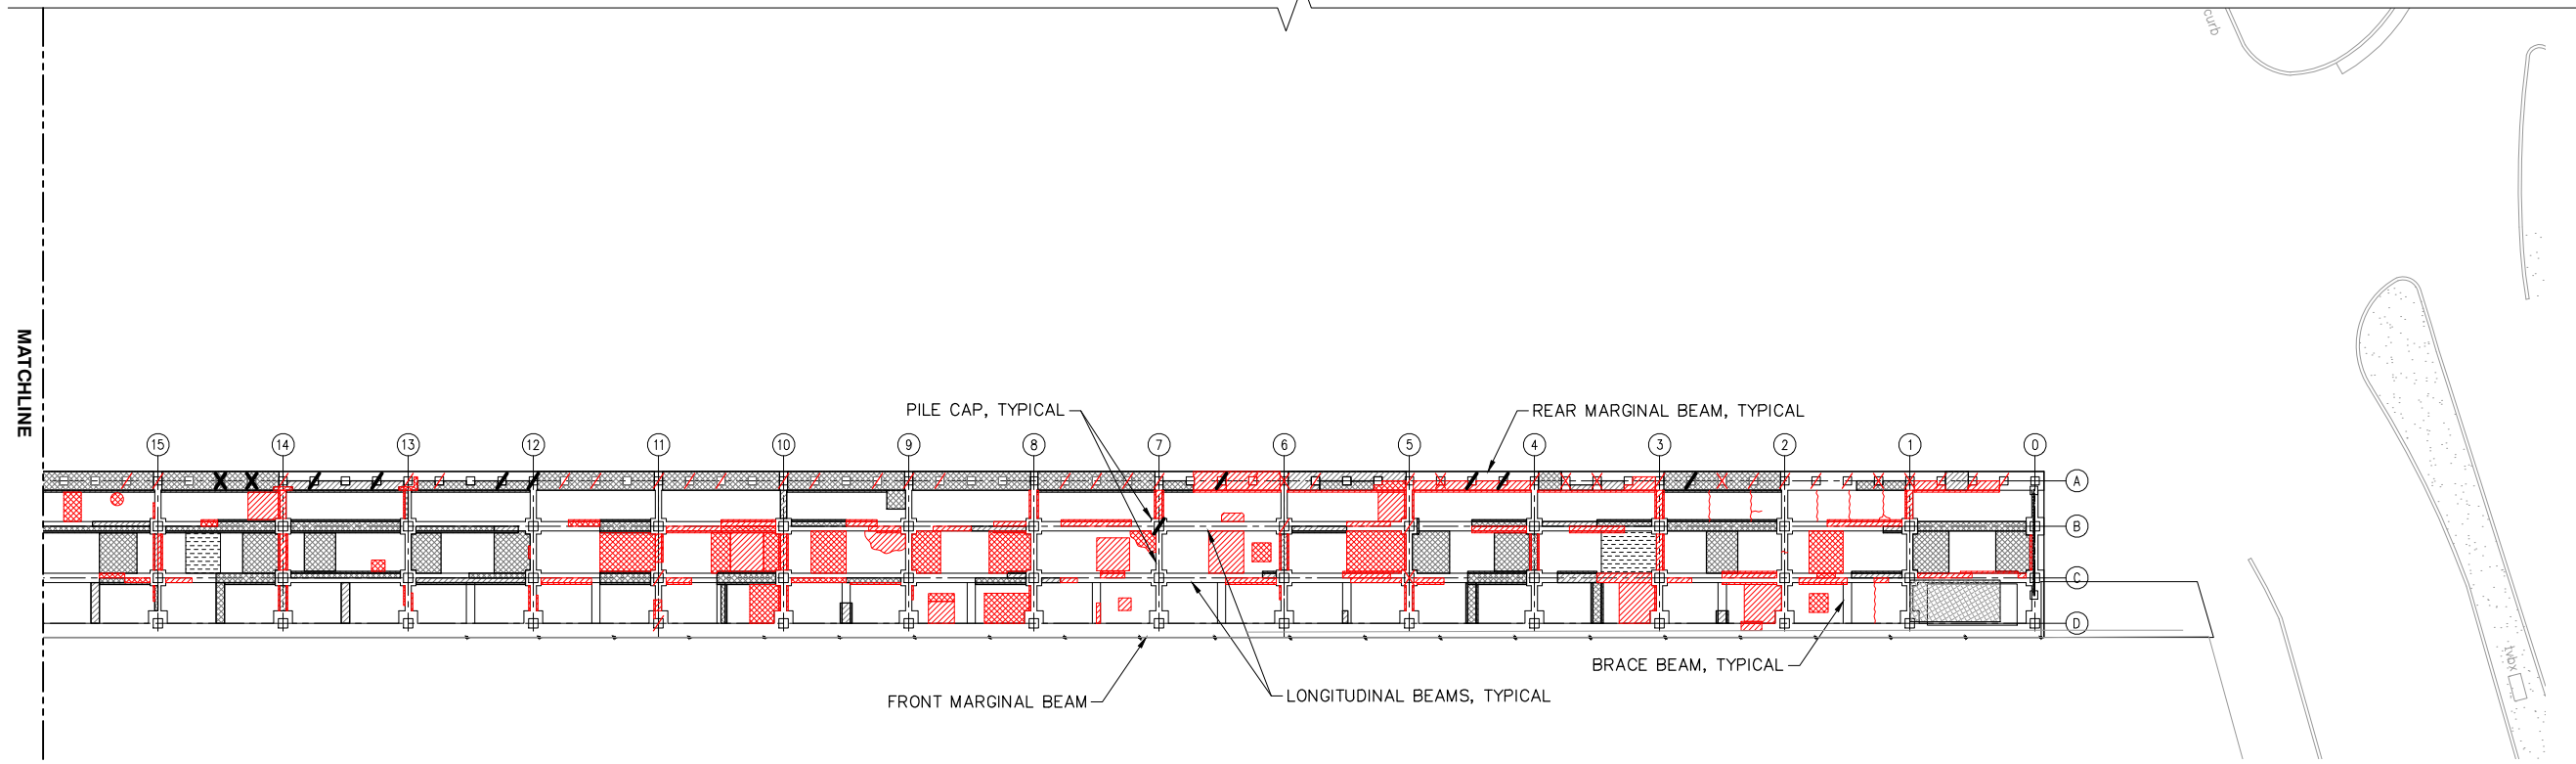
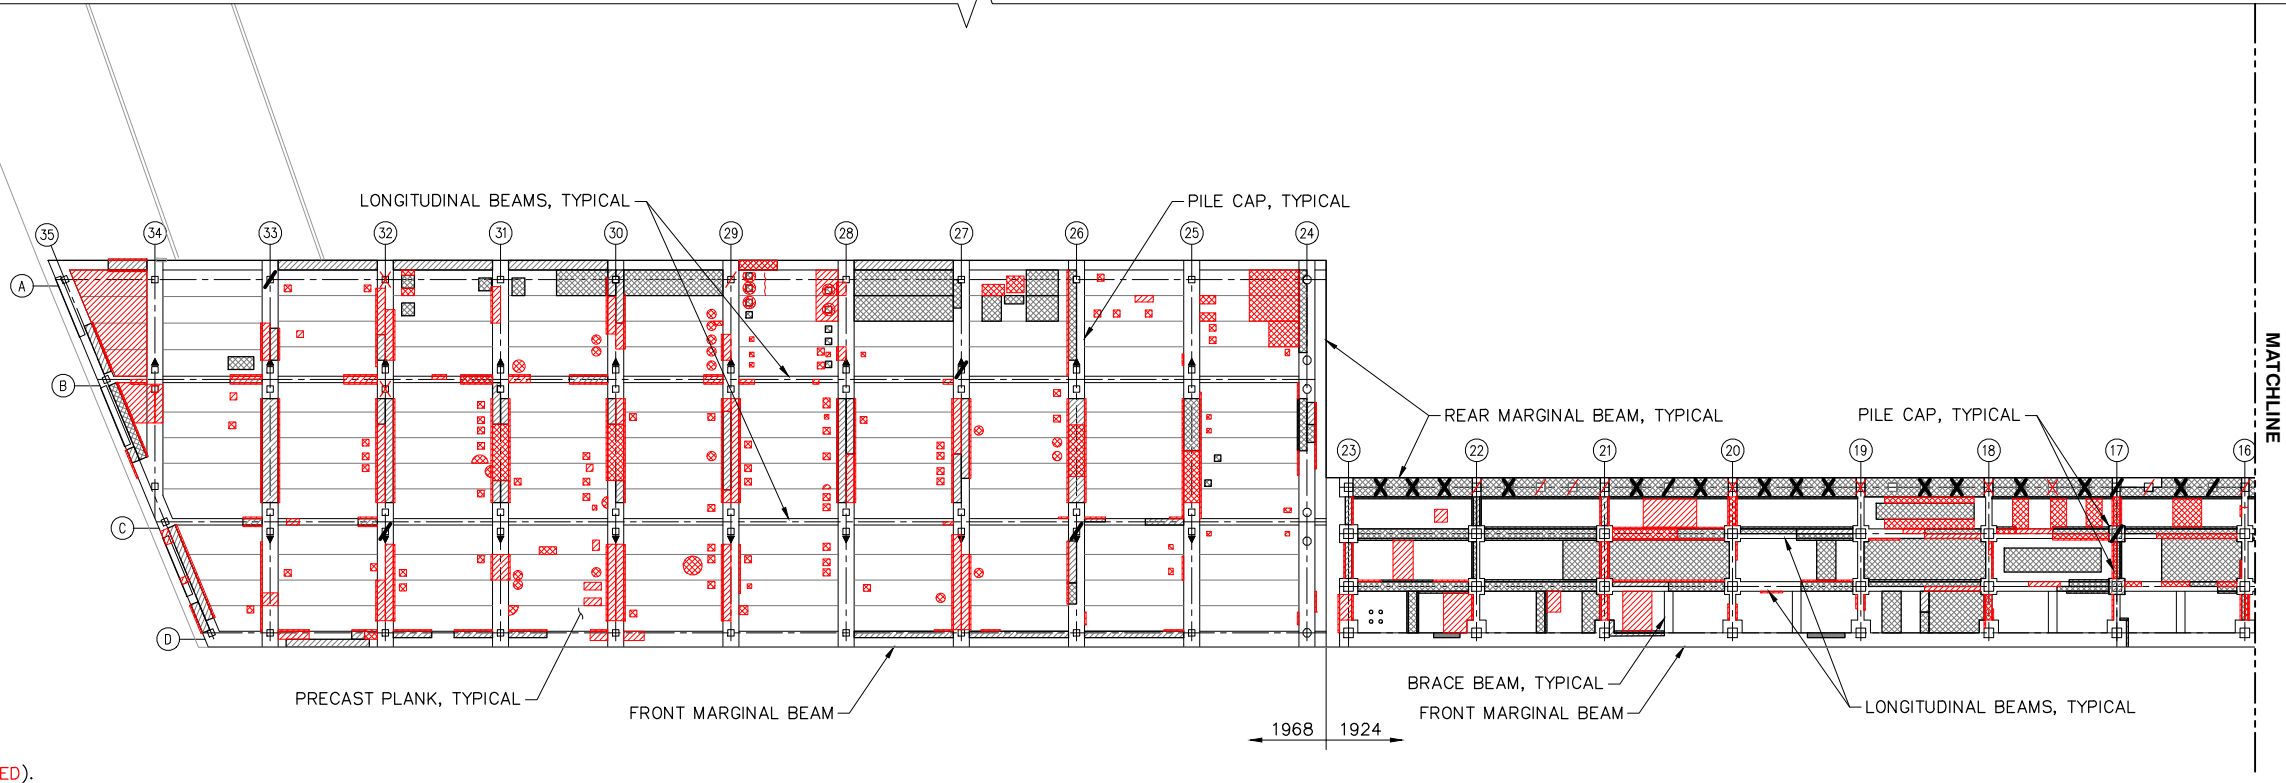
FISHERMAN'S WHARF STRUCTURAL  
INSPECTION AND EVALUATION  
**REFLECTED SOFFIT PLAN - OVERALL**

A Level I survey (visual / tactile) of the under-deck elements including the bulkhead, deck soffit, longitudinal beams, pile caps and pile tops was carried out. Figures 3 thru 10 reflect the increase in structural damages below the wharf deck that have occurred between this inspection and the previous wharf inspection conducted in 2012.
