Draft
Archaeological Inventory Survey Report for the
Block M Project, Kaka‘ako,
Honolulu Ahupua‘a, Honolulu (Kona) District, O‘ahu
TMK: [1] 2-3-002:001 (portion)

Prepared for
Victoria Ward Limited/Howard Hughes Corporation

Cultural Surveys Hawai‘i, Inc.
Kailua, Hawai‘i
(Job Code: KAKAAKO 122)

September 2014

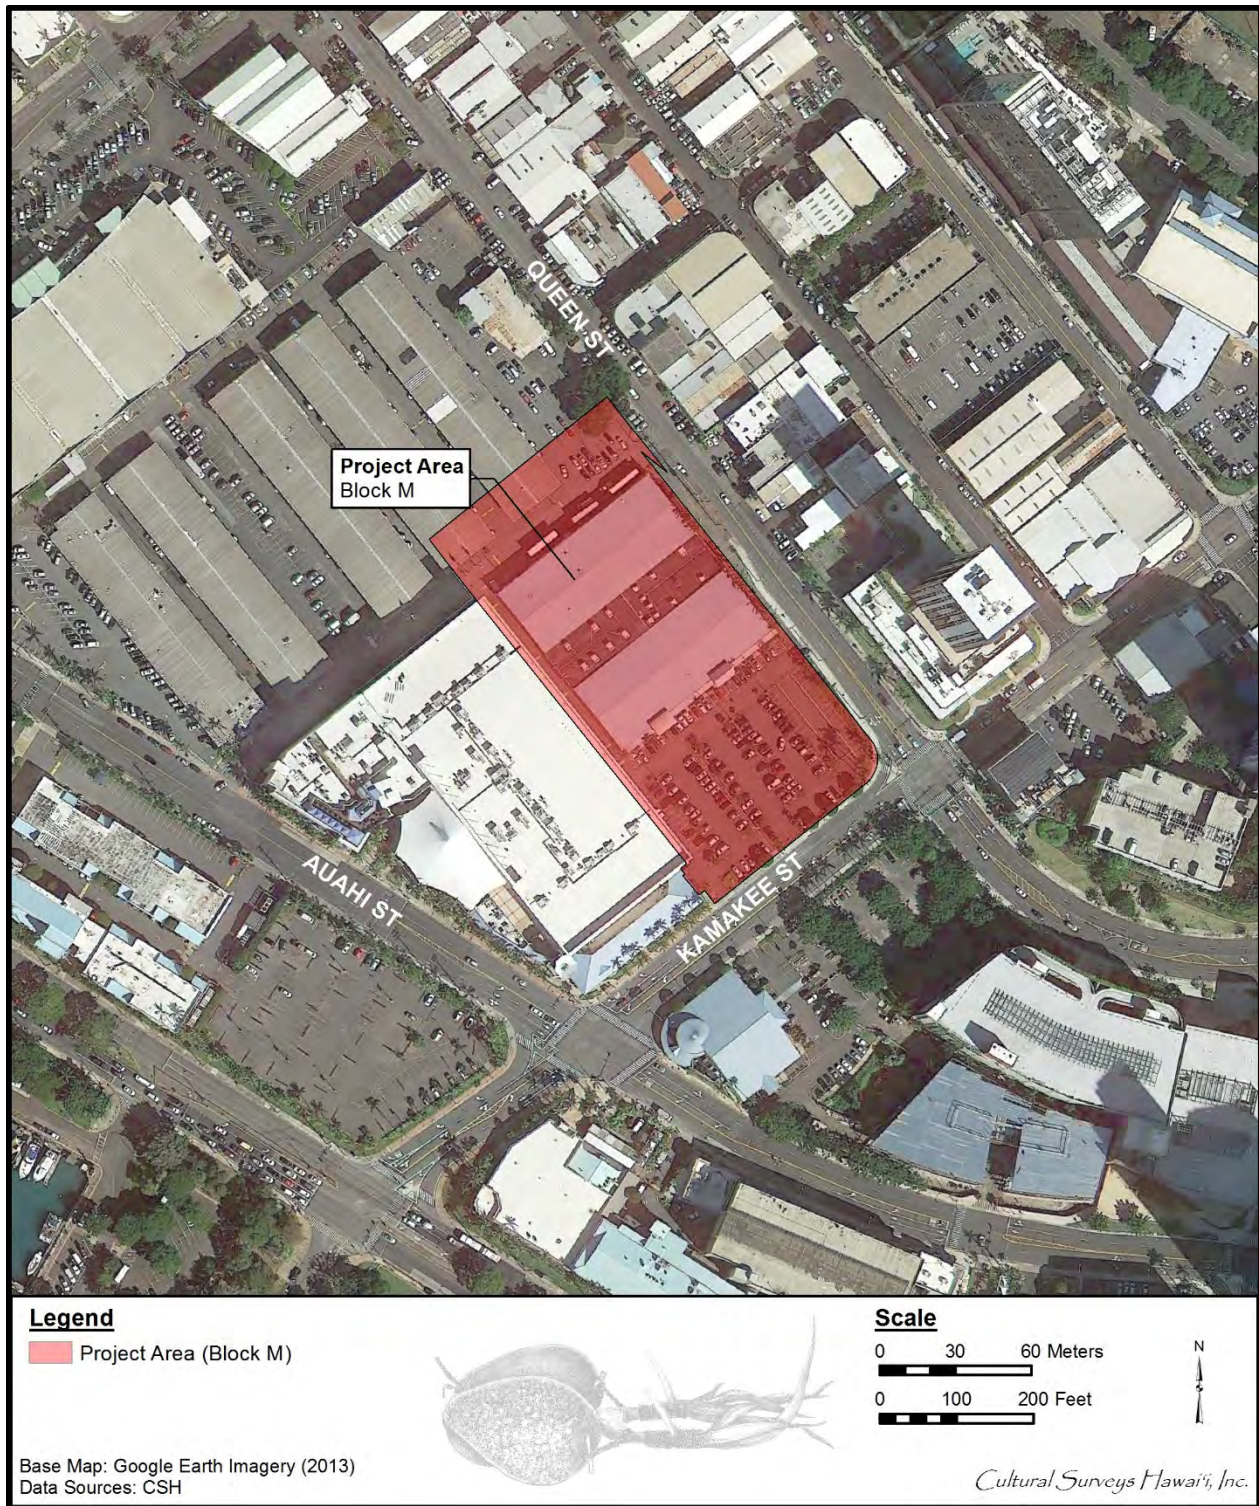
Figure 2. Tax map key (TMK): [1] 2-3-02, showing the location of the Block M project area (Hawai'i TMK Service 2012)

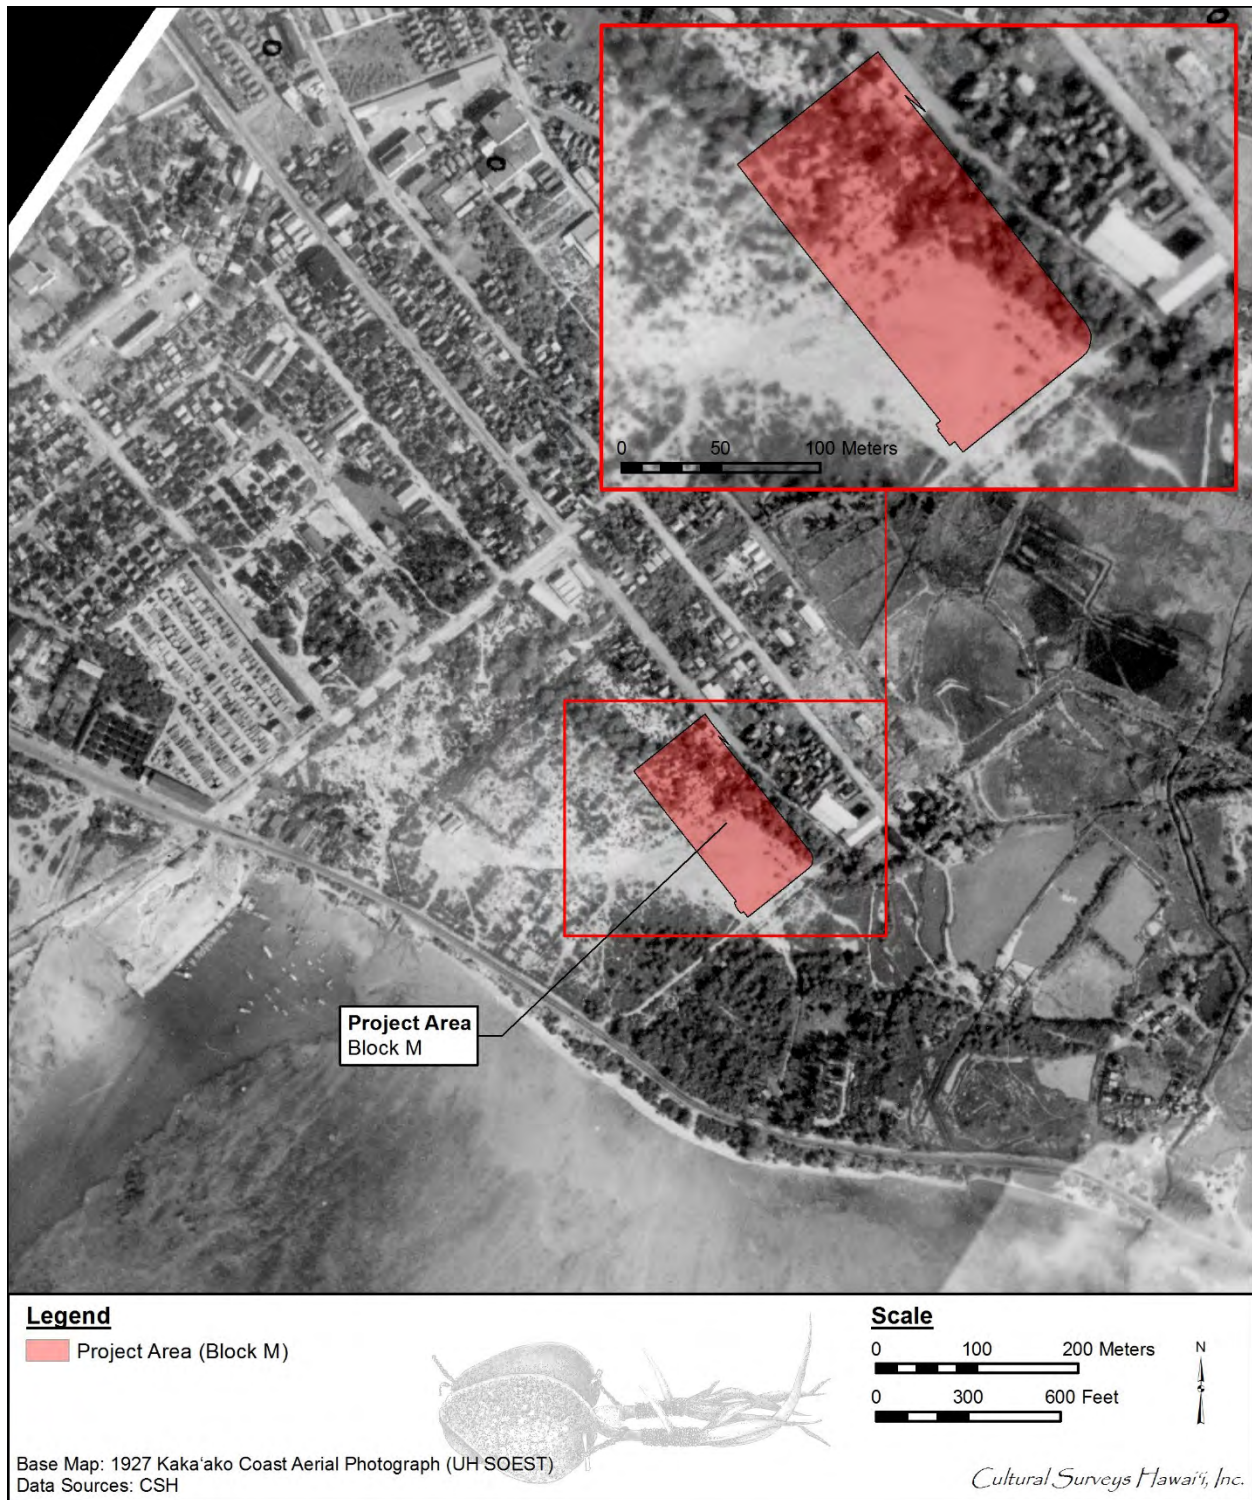
Figure 28. 1927 USGS aerial photograph of the Kaka'ako area, showing a single residence within the northern corner of Block M (USGS; mosaic of photograph sheets from Hawai'i Coastal Geology Group)

Background research indicates land reclamation activity within the project area occurred sometime between 1919 and 1927, following allocation of territorial funds for the dredging of Kawelo Basin in 1919 and prior to a 1927 aerial photograph which shows a white coral deposit covering the project area (see Figure 28). The narrow date range of these reclamation fill deposits provided a relative age indicating that the underlying strata were deposited prior to 1919 while all overlying strata were deposited after 1927.

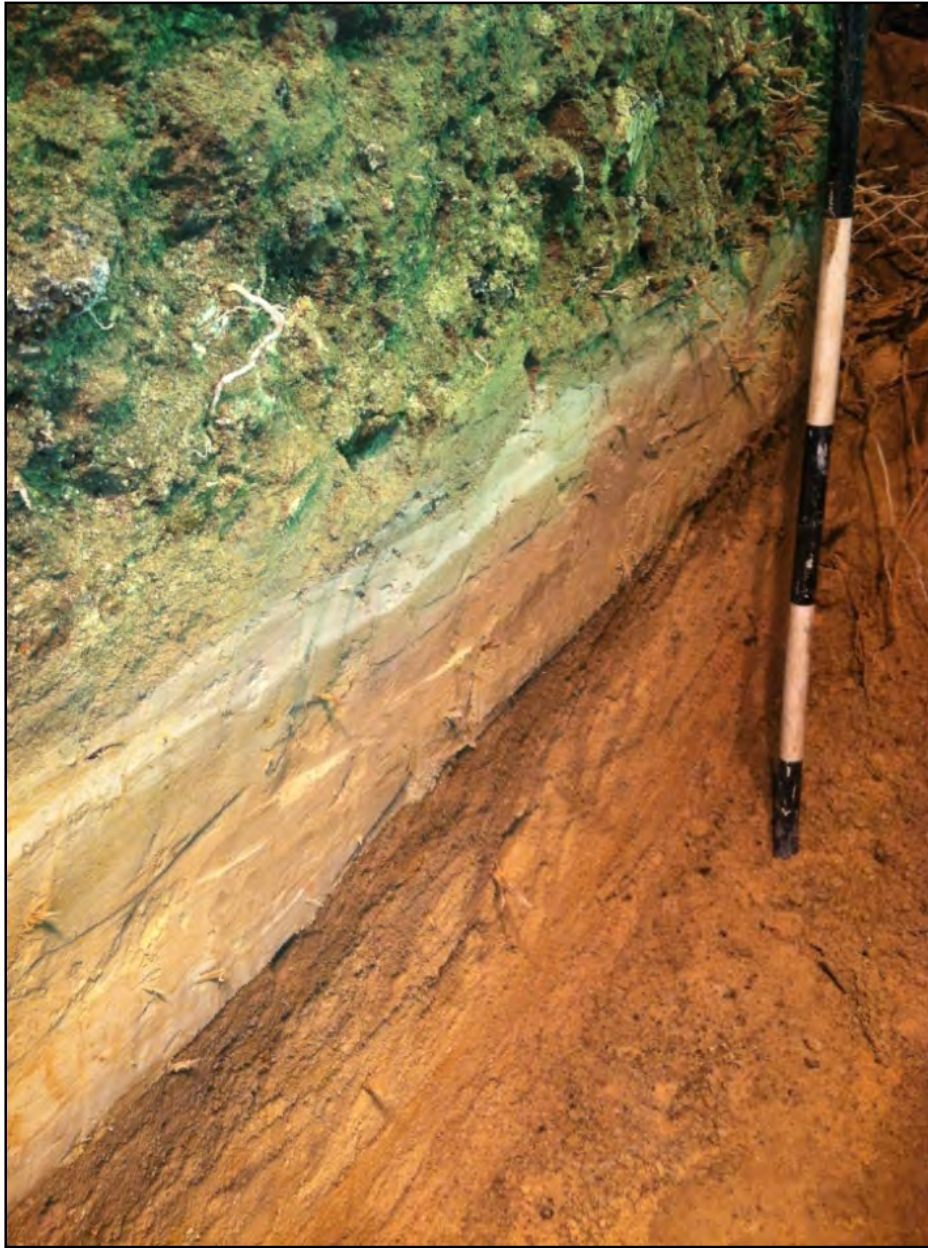
Figure 45. Profile wall of T-177 (HHCTCP City Center AIS), located within the *mauka* portion of the Block M project area, showing a buried sand A horizon overlying natural Jaucas sand (Hammatt 2013)

Between November 2011 and February 2013, CSH conducted an archaeological inventory survey for the Honolulu High-Capacity Transit Corridor Project (HHCTCP)—City Center, which extended from Kalihi Stream in the west to the Ala Moana Center in the east (Hammatt 2013). Two hundred-fifty test excavations were documented. A total of 19 historic properties were identified along the length of the project corridor. Although no historic properties were identified within the immediate vicinity of Block M, seven test excavations were completed within the Block M project area along the *mauka* boundary (Figure 44). Natural sand was documented within six of the seven trenches, with an upper boundary located between 60–120 cm below surface. Four test excavations also contained an overlying A horizon, with an upper boundary between 39–108 cmbs. The A horizon contained possible traditional Hawaiian cultural material within Test Excavations 175A and 177, consisting of possible marine shell midden, a piece of volcanic glass debitage, and charcoal (see Figure 44). A profile and photograph of Test Excavation 177 are shown in Figure 45 and Figure 46.

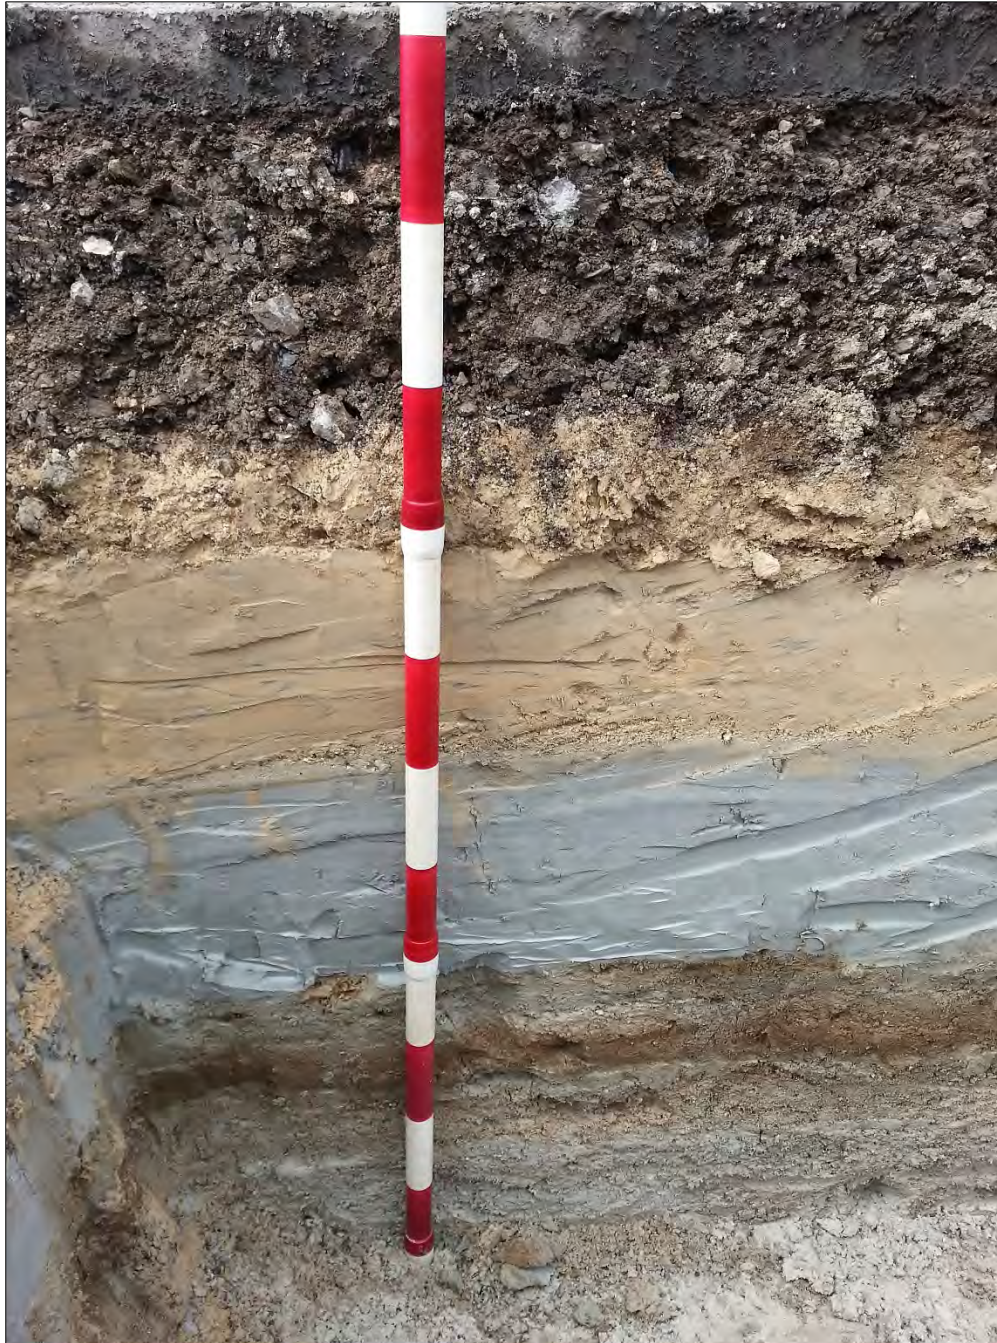
Figure 48. Early 1900s hydraulic (pump) dredge with post-depositional gleyed lower boundary

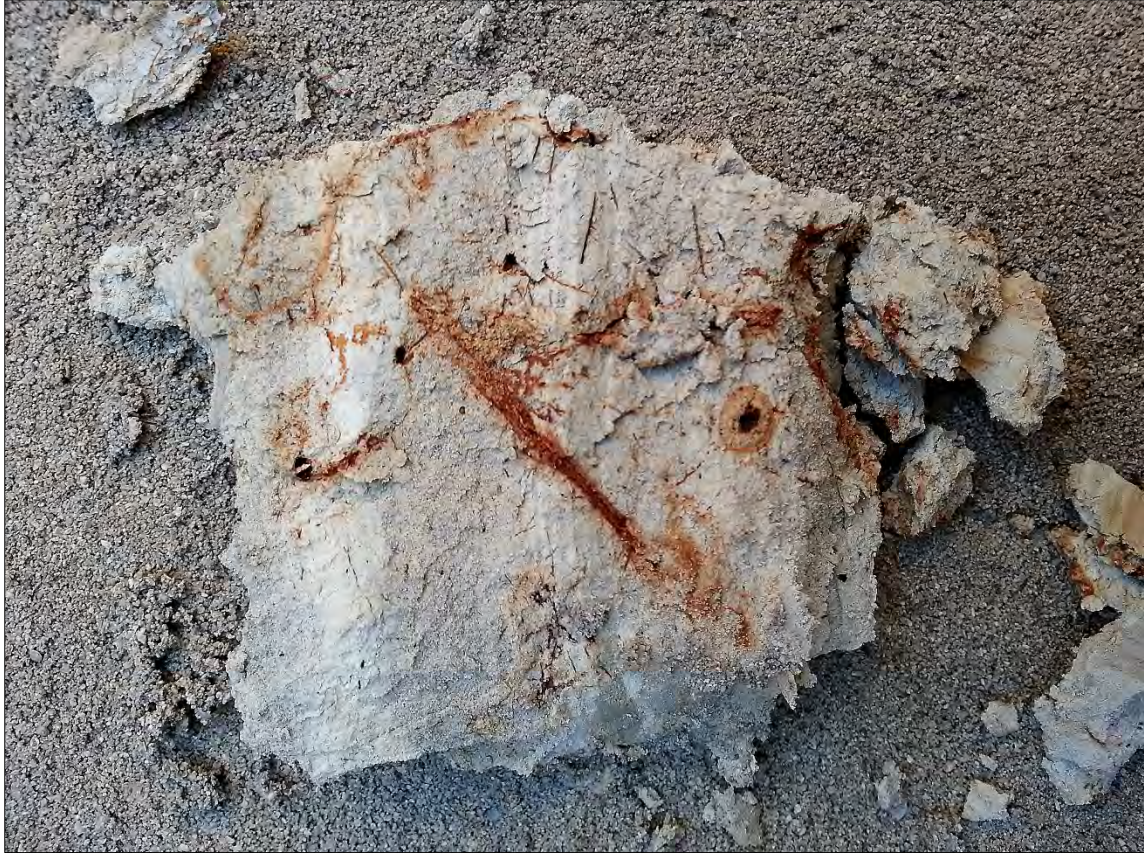
Figure 49. Hydraulic dredge material with ferrous manganese stains

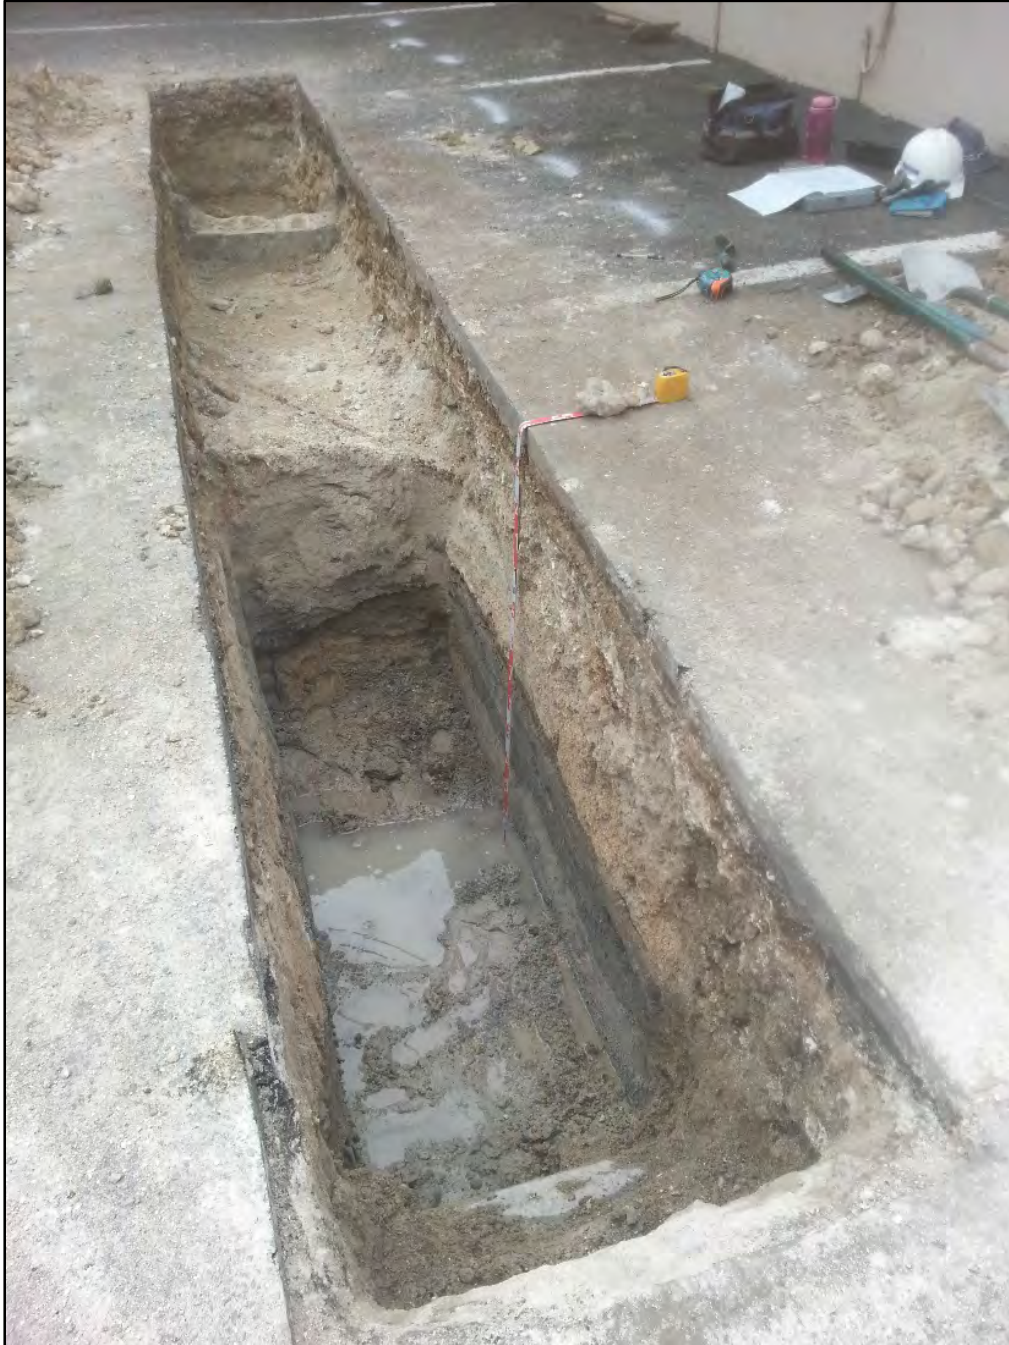
Figure 54. Photograph of T-1 showing a cinder block footing and utility lines within the *makai* portion of the test excavation and wetland sediments underlying modern and historic fill deposits within the *mauka* portion

T-1 documented recent fill deposits (Strata Ia–Id), overlying historic fill deposits (Strata IIa, IIb, III), resting over a natural wetland environment. Strata IIa and IIb consisted of crushed coral and hydraulic dredge material associated with Kaka'ako land reclamation efforts dating to 1919–1927. Underlying the hydraulic fill was a heavily mixed, culturally sterile, sand fill material (Stratum III), likely composed of locally procured sand and soil. This local fill material appeared to have been deposited to level and/or build up the ground surface and served as a historic land surface for a period of time prior to reclamation activities. The natural wetland A horizon appeared to have been removed during previous ground disturbance activities, which truncated the wetland clay sand (Stratum IVa).

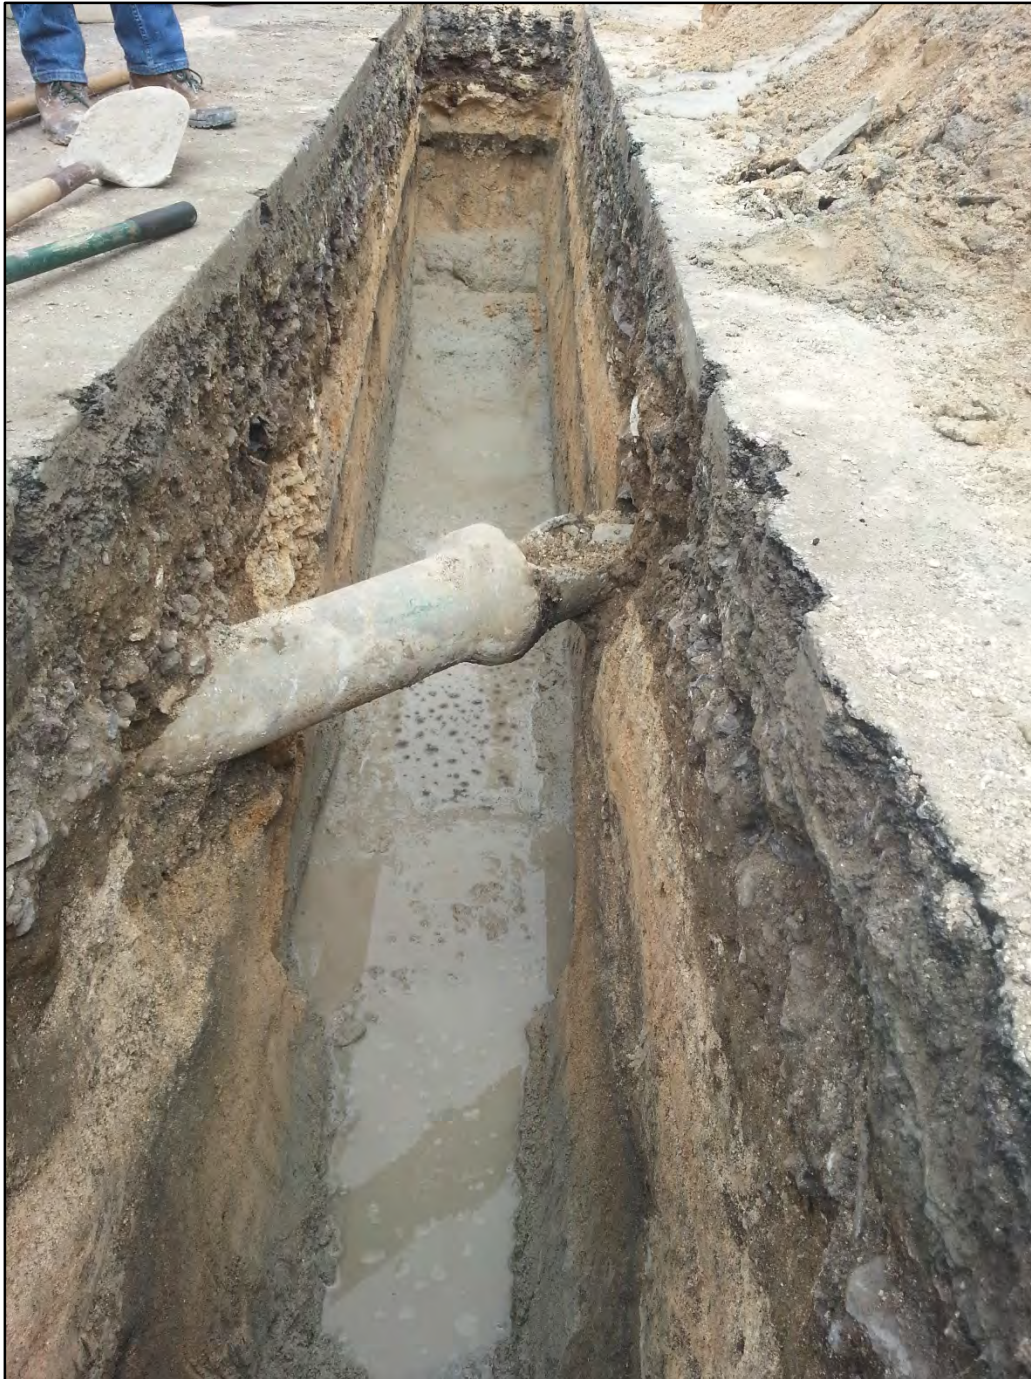
Figure 57. Photograph of T-2, showing both sidewalls

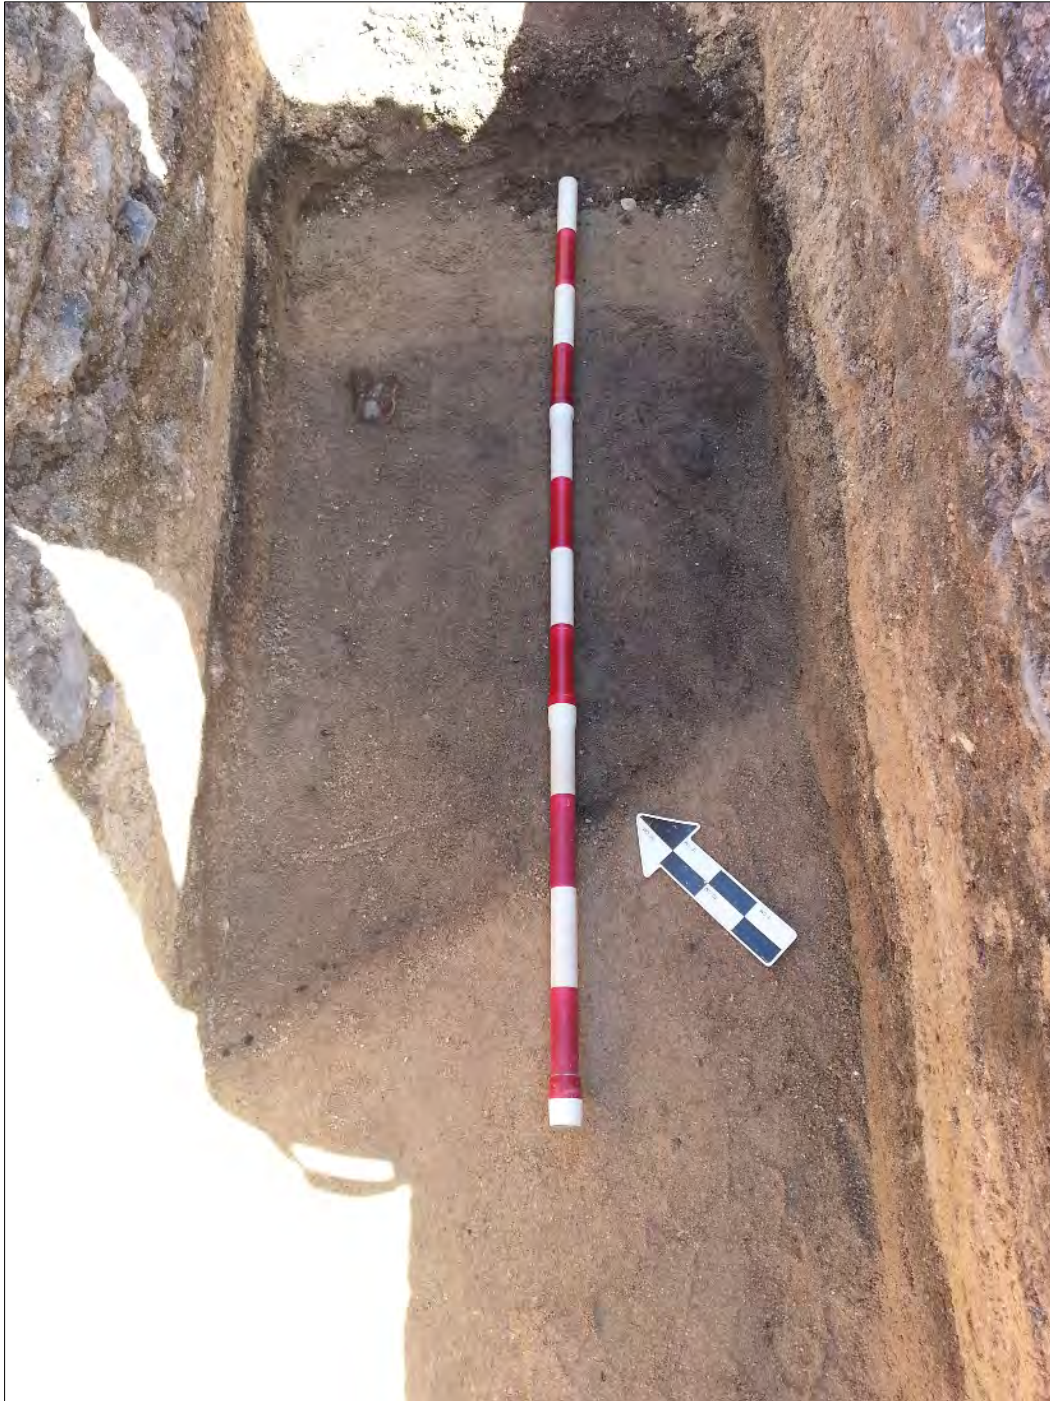
Figure 60. Photograph of T-2, SIHP # -7429 Feature 8, view to northeast

T-2 documented a natural loamy sand A horizon (Stratum IIIa), considered part of SIHP # -7429. The A horizon contained light cultural content consisting of fire-altered basalt cobbles and charcoal and four features, SIHP # -7429 Features 8–11. Feature 8, which measured 0.86 m long by 0.75 m wide and approximately 0.15 m deep, consisted of a wide, shallow pit containing charcoal-stained soil and fire-altered basalt and coral cobbles backfilled with Jaucas sand (Figure 59 through Figure 61). A 10-gallon (100%) screened sample of Feature 8 yielded marine midden consisting of *echinothrix diadema* sp. (*wana*, or sea urchin) (1.8 g), *Tellina palatam* (19.0 g), and *Turbo sandwicensis* (13.1 g). Feature 8 was interpreted as a fire pit for food consumption (*imu*). Charcoal collected from Feature 8 was sent for taxa identification and radiocarbon dating. The plant species present within the charcoal sample were identified as native Hawaiian species (*‘āheahea*, *kulu‘ī*, and *‘ūlei*) or Polynesian-introduced species (*kukui*). Radiocarbon dating yielded a relatively early pre-Contact date range of AD 1333-1337 (0.7% probability) or AD 1398-1449 (94.7% probability). Feature 9, which measured 0.4 m in diameter and 0.19 m deep, similarly contained charcoal staining and fire-affected basalt cobbles, and was interpreted as a fire pit for food consumption (*imu*) (see Figure 58 and Figure 61). A 100% screen yielded a small amount of marine midden consisting of *Tellina palatam* (1.0 g) and crustacean (0.1 g). Feature 10 was a slight discoloration of the soil matrix that protruded from Stratum IIIa (see Figure 59 and Figure 62). Feature 10 measured 0.14 m long by 0.1 m wide and 0.17 m deep and contained a small amount a marine shell midden (Isognomidae) (see Figure 62). The function of Feature 10 is indeterminate. Feature 11, which measured 0.14 m in diameter and 0.12 m deep, was also a slight discoloration of the soil matrix and was absent of material culture (see Figure 58). The function of Feature 11 is indeterminate; however, the light stains suggests ephemeral use or activities.

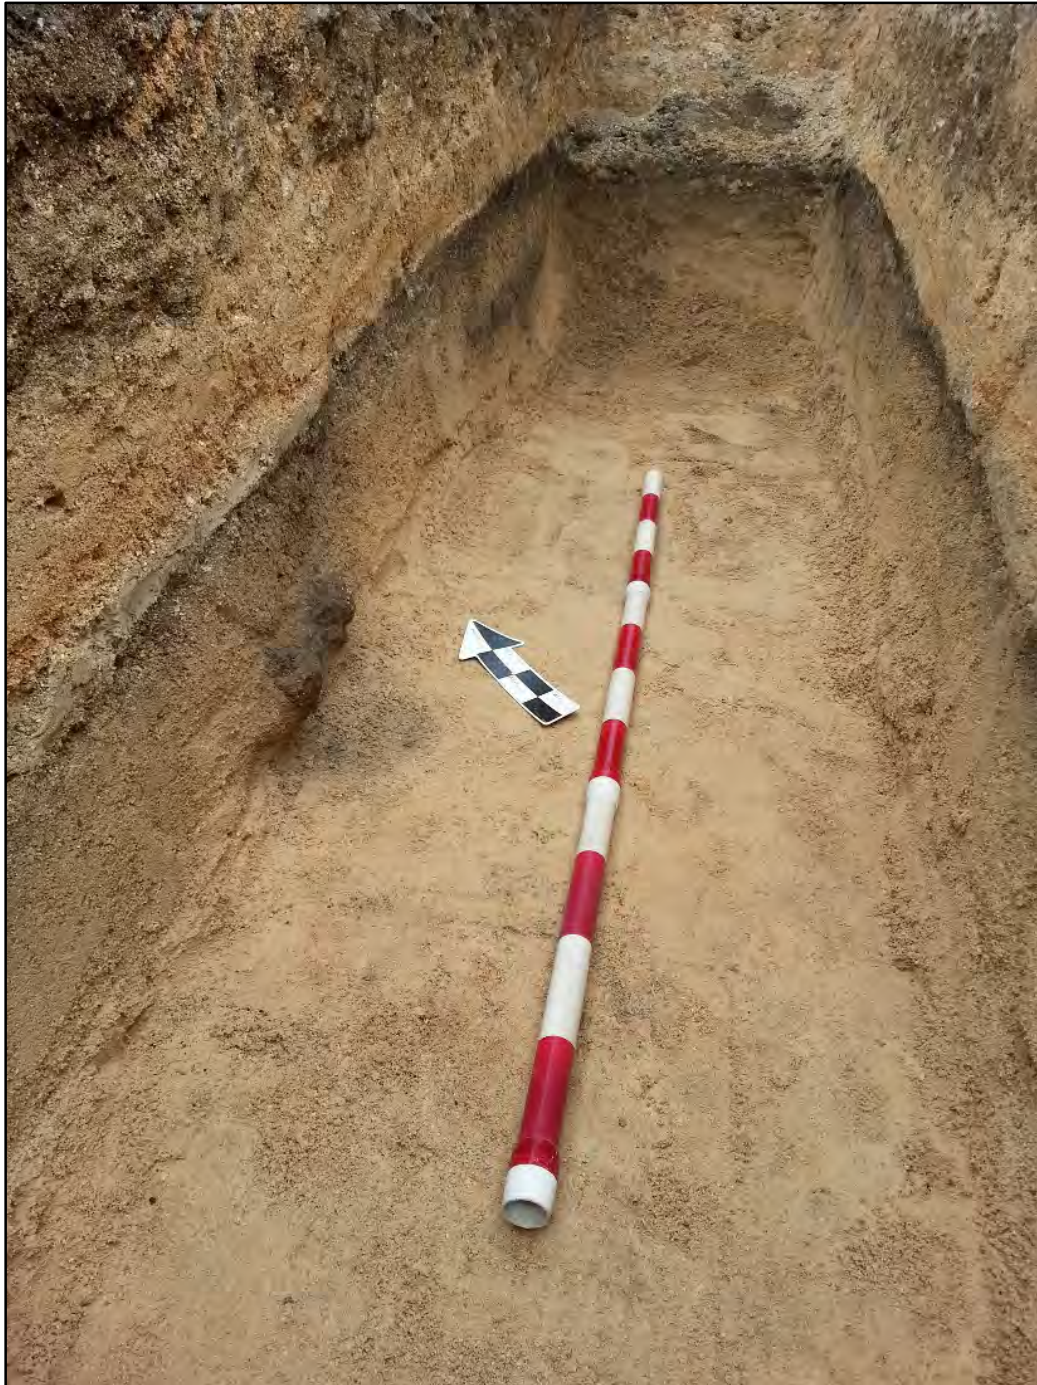
Figure 61. Photograph of T-2, *mauka* end, showing SIHP # -7429 Feature 8 (rear) and Feature 9 (fore), view to northeast

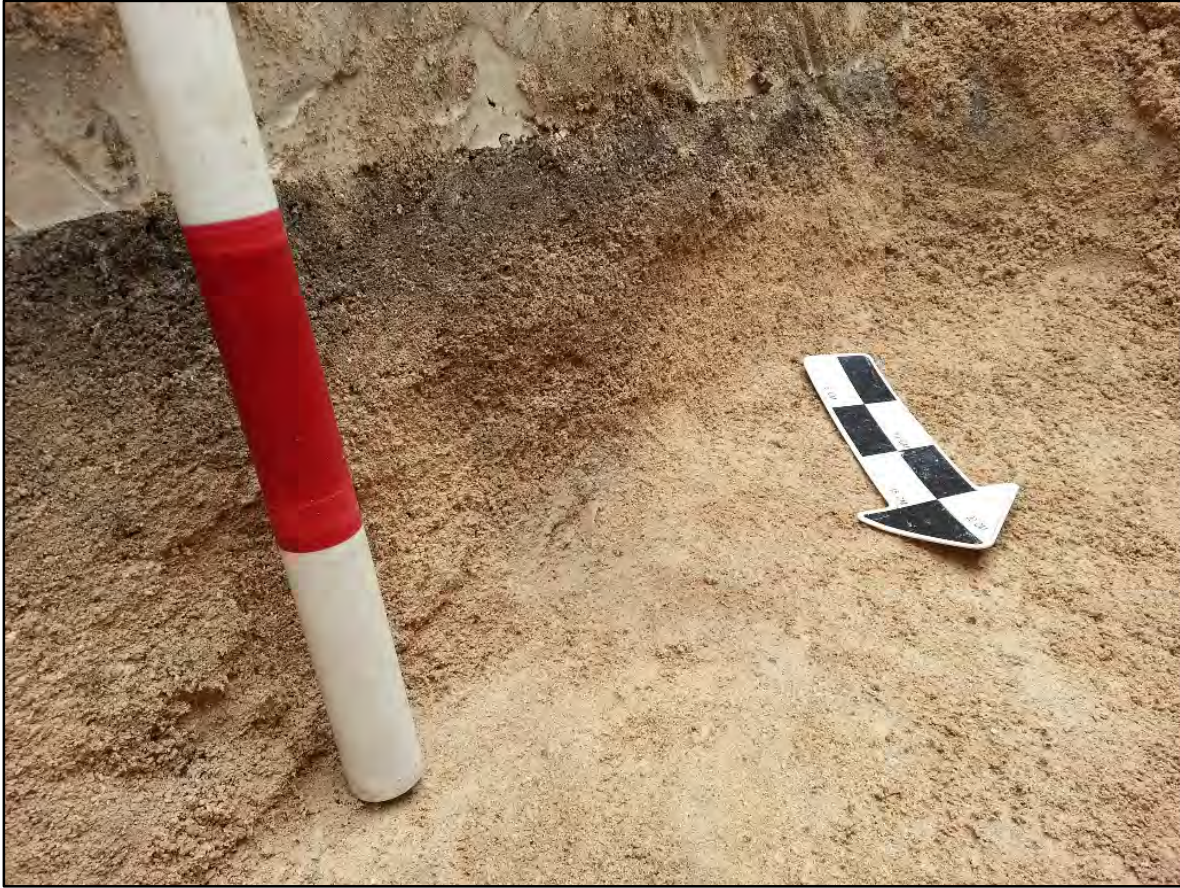
Figure 62. Photograph of T-2, SIHP # -7429 Feature 10, view to south

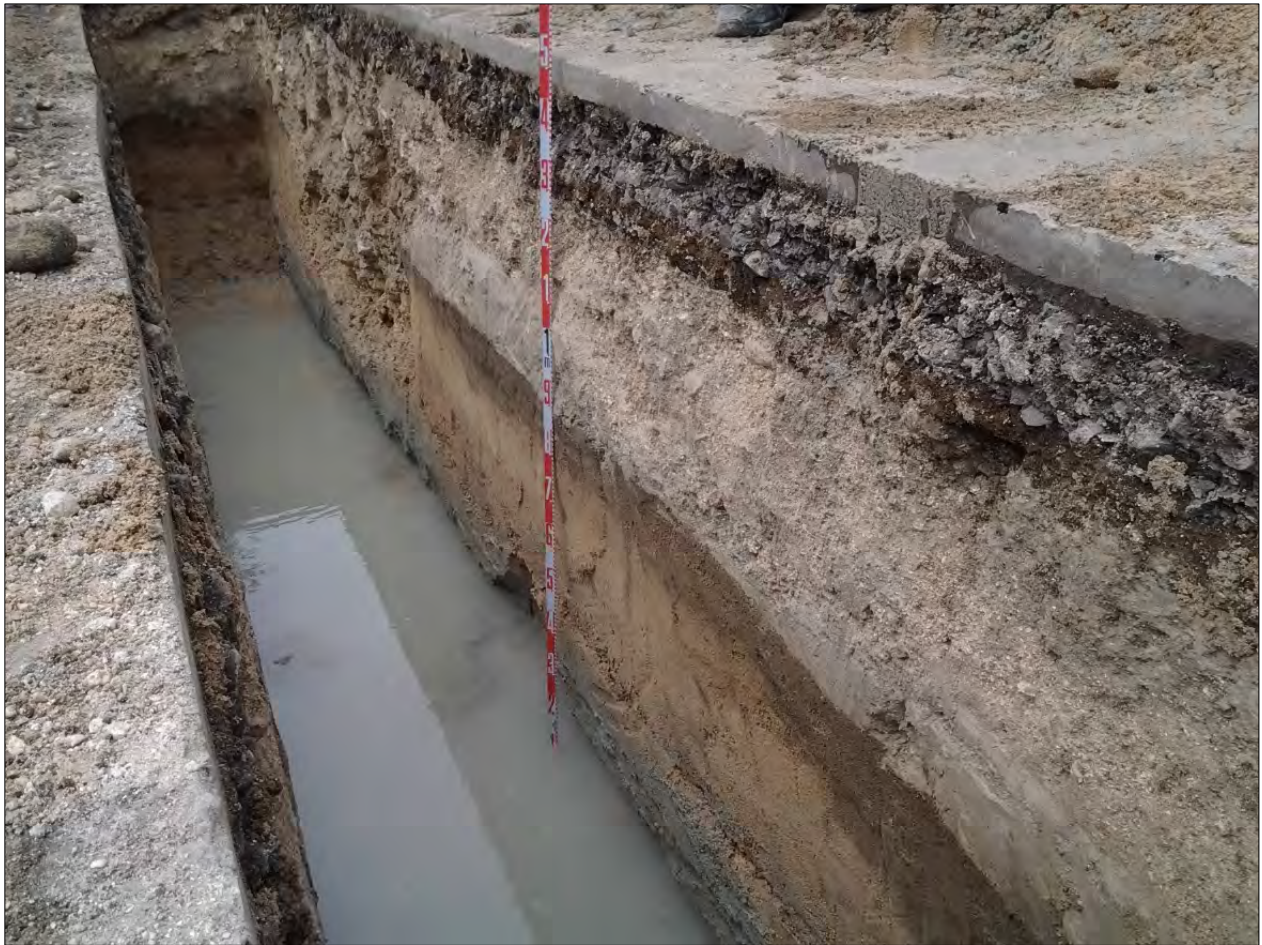
Figure 63. Photograph of T-3 northwest wall, view to southwest

Test Excavation 3 (T-3), an exterior excavation located in the alleyway between the current Office Depot building and Warehouse Building 5, was oriented northeast-southwest and measured 6.0 m long by 0.7 m wide. The base of excavation was determined by the presence of the hard coral shelf at 1.47 mbs. The stratigraphy of T-3 consisted of asphalt surface (Stratum Ia), base course (Stratum Ib), and very gravelly sandy loam fill (Stratum Ic) overlying 1919–1927 Kaka‘ako reclamation fill deposits consisting of cobbly sand (crushed coral) (Stratum IIa) and hydraulic fine sandy clay (Stratum IIb), overlying a natural loamy sand A horizon (SIHP # -7429) (Stratum IIIa), Jaucas sand (Stratum IIIb), and sandy clay wetland sediment (Stratum IV) (Figure 63 and Figure 64, and Table 6). An extremely cobbly sand pit feature was observed in the *makai* portion of T-3, extending through Strata IIa–IIIb.

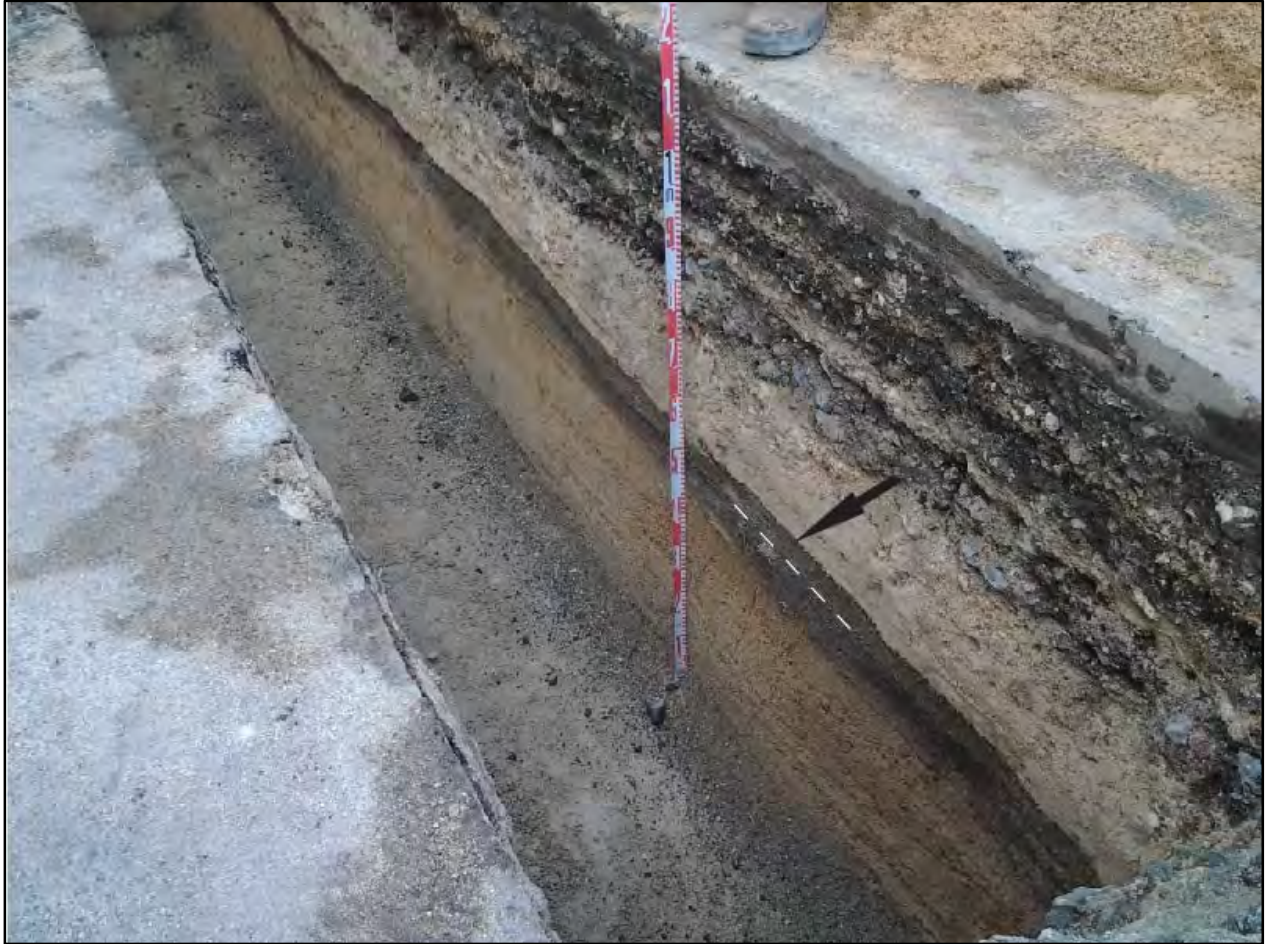
Figure 66. Photograph of T-4 northwest wall, showing Stratum III (redeposited local loamy sand, indicated by the arrow) overlying the in situ loamy sand A horizon (Stratum IVa); interface indicated by the dashed white line, view to southwest

Stratum III consisted of a fine loamy sand that appeared to be comprised of reworked local soil (i.e., A horizon material) deposited over an in situ, loamy sand, A horizon (Stratum IVa) that was truncated during previous ground disturbance activities (Figure 66). Similar reworked loamy sand fill deposits were documented throughout the project area, overlying an in situ A horizon (Stratum IVa) and underlying the Kaka'ako reclamation fill deposits (Strata IIa and IIb). This local fill material may have been deposited to level and/or build up the ground surface and may have served as a historic land surface for a period of time prior to reclamation activities.

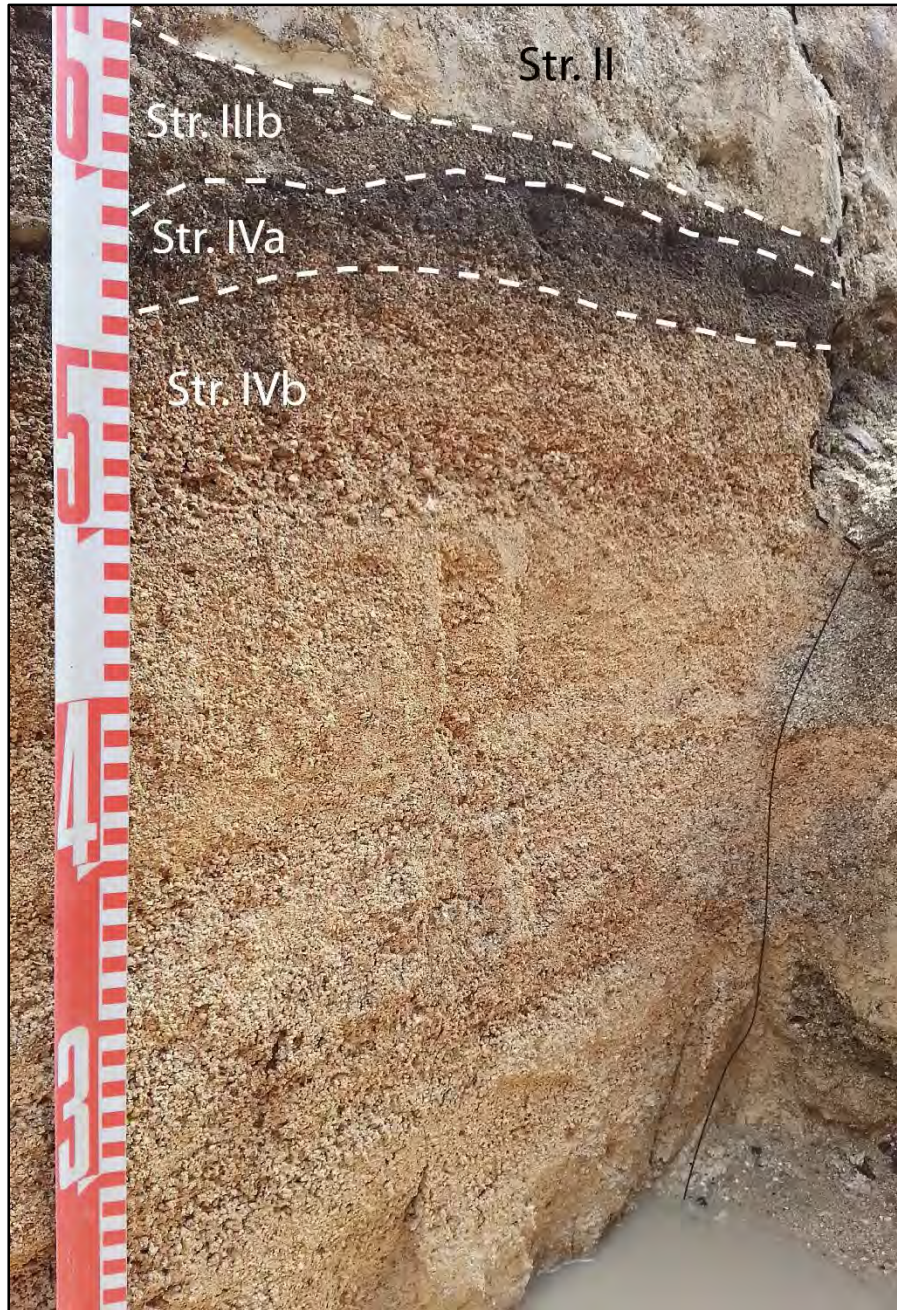
Figure 71. T-5 southeast wall, close-up of Stratum IIIb (sand fill) overlying Stratum IVa (natural A horizon), view to south

T-5 documented two redeposited, locally procured sandy loam fill deposits, containing historic trash (Strata IIIa and IIIb) and considered part of SIHP # -7429. Stratum IIIa was a discontinuous layer of very dark grayish brown sediment containing small glass and ceramic fragments, charcoal, rusted metal; portions of it appeared to have been partly removed prior to or during the deposition of hydraulic clay fill (Stratum II). The underlying Stratum IIIb was a somewhat lighter colored discontinuous loamy sand layer, similar to the locally procured sand fill documented within the surrounding test excavations and which likely served as a living surface for a period of time prior to Kaka'ako land reclamation. Stratum IIIb contained small glass fragments, rusted metal, a ceramic utility pipe fragment, and faunal material (Figure 71 and Figure 72). Faunal material consisted of fish vertebra (7.3 g), *Canis lupus familiaris* (dog) vertebra fragments (0.1 g), *Bos taurus* (cow) rib and long bone fragments (cut with a metal saw blade—cut marks (kerf) and striations visible along the cross-section were consistent with blades used in commercial butcher shops) (17.6 g), and a cow molar (4.8 g). Faunal material was also identified within the overlying Stratum Ic fill consisting of cf. *Sus scrofa* (pig) irregular bone fragments (1.4 g) and a *Bos taurus* rib fragment and an unmodified foot bone (60.3 g); all but the cow foot bone, were cut with a metal saw blade. Cut marks (kerf) and striations visible along the cross-section were consistent with blades used in commercial butcher shops.

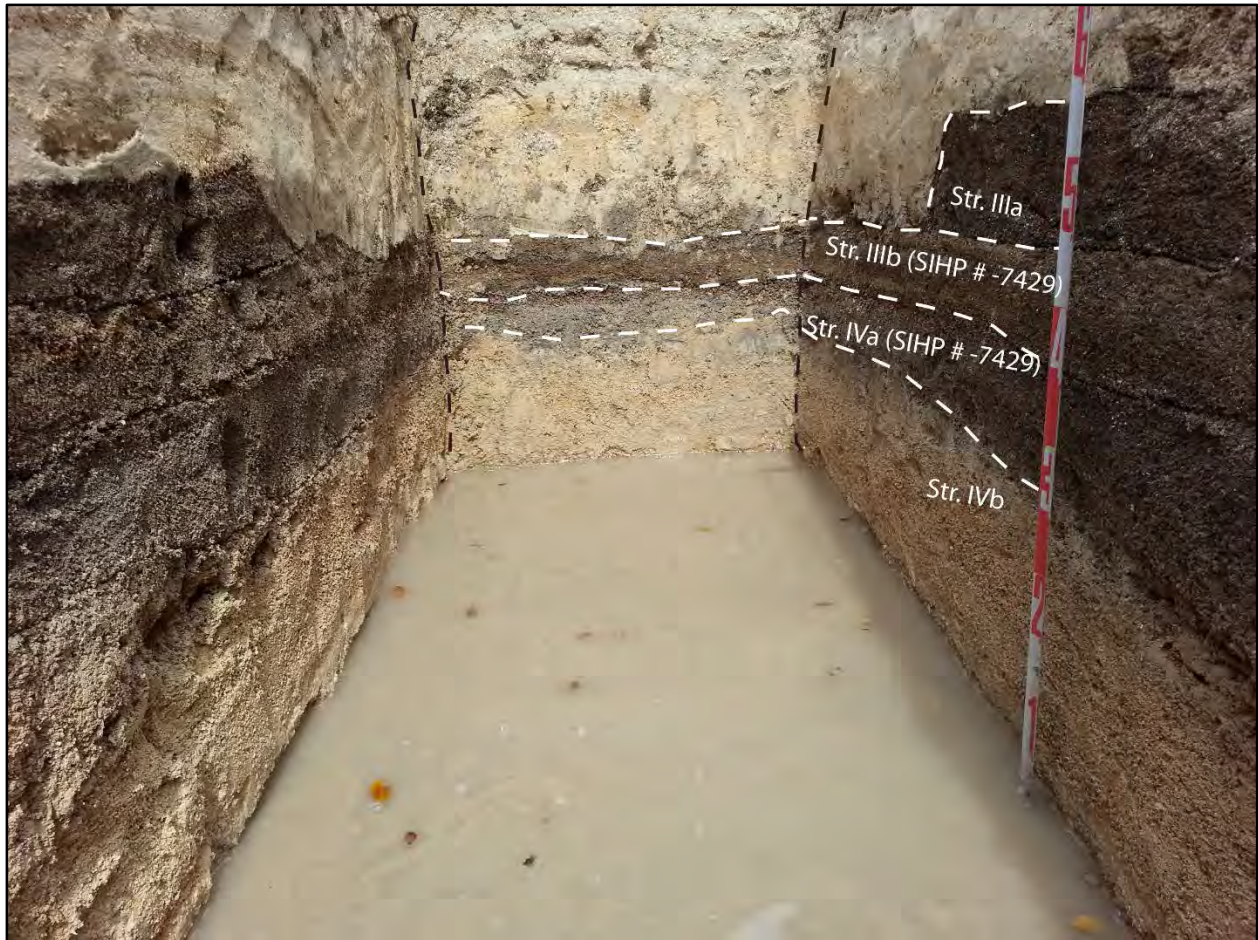
Figure 72. Photograph of T-5, *mauka* portion, showing redeposited sand fill layers (Strata IIIa and IIIb) overlying a clay sand A horizon (Stratum IVa), view to northeast

T-5 also documented undulating natural topography as evidenced by high sand deposits within the *makai* portion of the trench which sloped gently down in the *mauka* direction where the terrestrial loamy sand A horizon transitioned to a more clay sand wetland A horizon. The low lying *mauka* portion of T-5 likely sustained periodic inundations of water. The redeposited sand fill layers (Strata IIIa and IIIb) were located over top this low-lying area and may reflect historic efforts to level the low lying wetlands prior to Kaka'ako land reclamation efforts. The natural A horizon was carefully inspected (100% hand troweled), however, no cultural material was identified.
