Draft
Archaeological Inventory Survey Report for the
Block M Project, Kaka‘ako,
Honolulu Ahupua‘a, Honolulu (Kona) District, O‘ahu
TMK: [1] 2-3-002:001 (portion)

Prepared for
Victoria Ward Limited/Howard Hughes Corporation

Cultural Surveys Hawai‘i, Inc.
Kailua, Hawai‘i
(Job Code: KAKAAKO 122)

September 2014

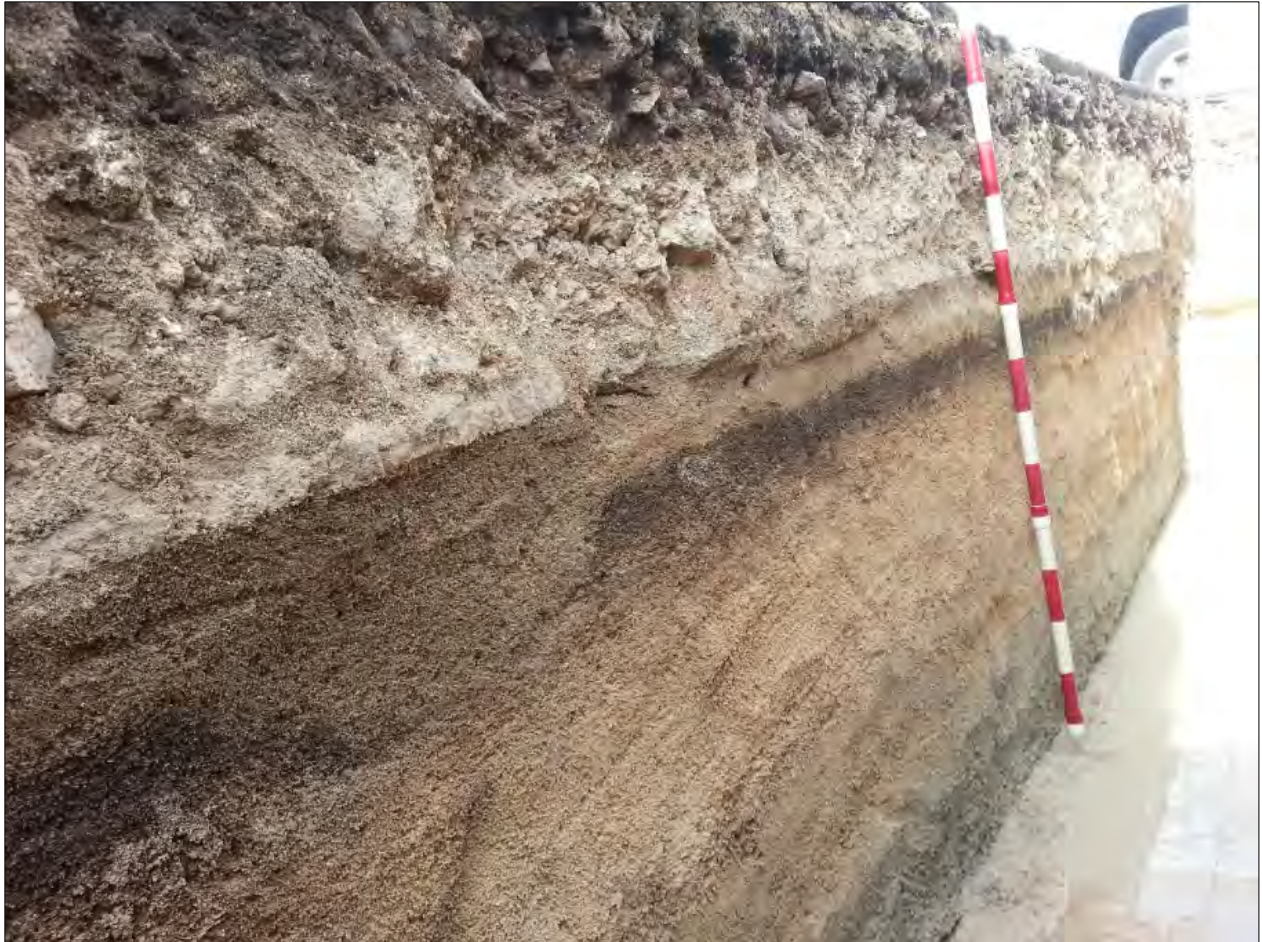
Figure 73. Photograph of T-6 northwest wall, view to north

T-6 documented multiple episodes of historic landscape alterations. Overlying and truncating the natural loamy sand A horizon (Stratum IVa) was a deposit of mixed loamy sand (Stratum III), likely locally procured and utilized to level and/or build up the ground surface. This alteration of the natural landscape occurred sometime prior to the 1919–1927 Kaka‘ako reclamation activities which deposited hydraulic dredge (Stratum IVb) and crushed coral (Stratum IVa) ovetop Stratum III. A small amount of glass bottle fragments was identified in both the hydraulic dredge and the redeposited sand fills, substantiating a historic time period for these land modifications.

A 1-gallon field screen of the A horizon (Stratum IVa) yielded small amounts of charcoal flecking, natural marine shell, and brackish water snails. Careful troweling of the remaining material indicated a culturally sterile matrix.

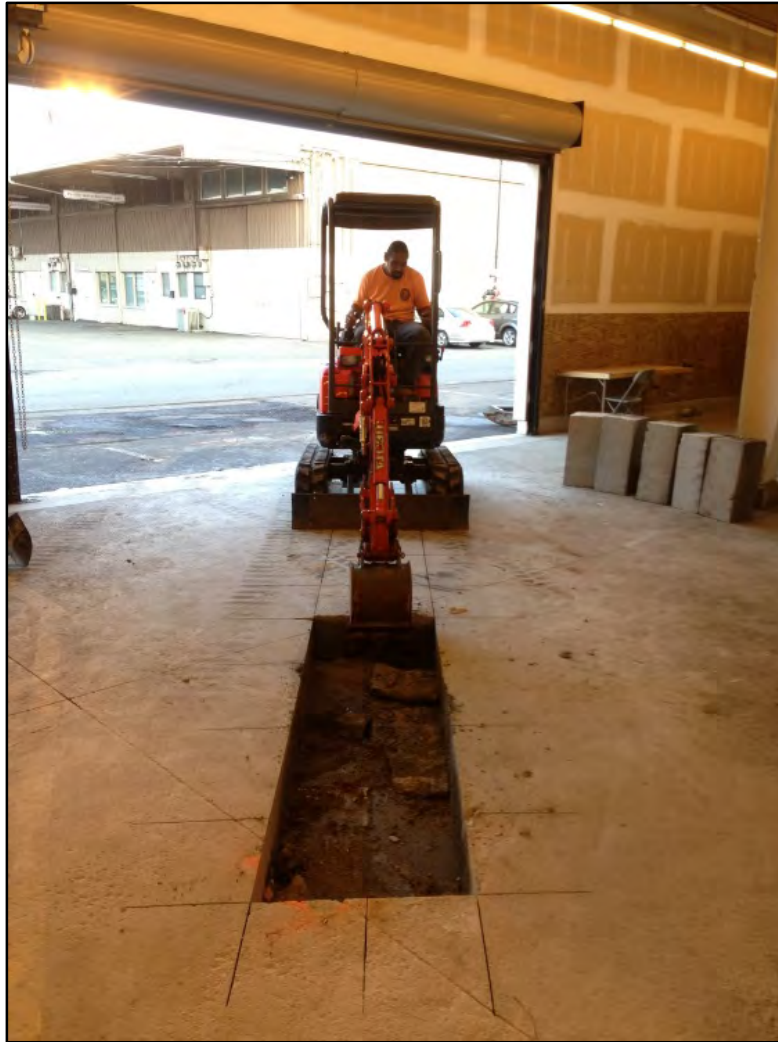
Figure 75. Location of T-7 within the loading dock of the former Nordstrom Rack building, showing removal of the thick concrete loading dock slab

Test Excavation 7 (T-7), an interior excavation located within the loading dock of the former Nordstrom Rack building in the southwest corner of the project area, was oriented southeast-northwest and measured 6.2 m long by 0.6 m wide. The base of excavation was initially determined by the presence of the water table; however, excavations continued for an additional 0.12 m to a maximum depth of 1.7 mbs. The stratigraphy of T-7 consisted of the concrete surface (Stratum Ia), a buried asphalt layer (Stratum Ib), and associated base course (Stratum Ic) overlying 1919–1927 Kaka‘ako reclamation fill deposits consisting of very gravelly coarse sand (crushed coral) (Stratum IIa) and hydraulic (dredge) sandy clay (Stratum IIb) overlying a possible disturbed natural loam A horizon (Stratum III) and natural marine sand (Stratum IV) (Figure 75 through Figure 77, and Table 10). A metal utility pipe with an associated utility pit was observed in the central portion of T-7 and a 1-m thick concrete slab was observed in the south (*makai*) end; as a result, portions of T-7 were left unexcavated.

T-7 documented remnants of a commercial warehouse foundation, considered part of SIHP # - 7686. According to mid-twentieth century aerial photographs and maps, three rectangular warehouse structures were constructed within the project area sometime between 1939 and 1943. T-7 documented a concrete footing located immediately below the current concrete loading dock floor, which appeared to mark the edge of the northernmost warehouse. Identified just north of the concrete footing was a buried asphalt layer (Stratum Ib) and associated base course (Stratum Ic), also immediately below the concrete surface, which likely represented the asphalt alleyway alongside the warehouse and which was associated with the commercial complex.

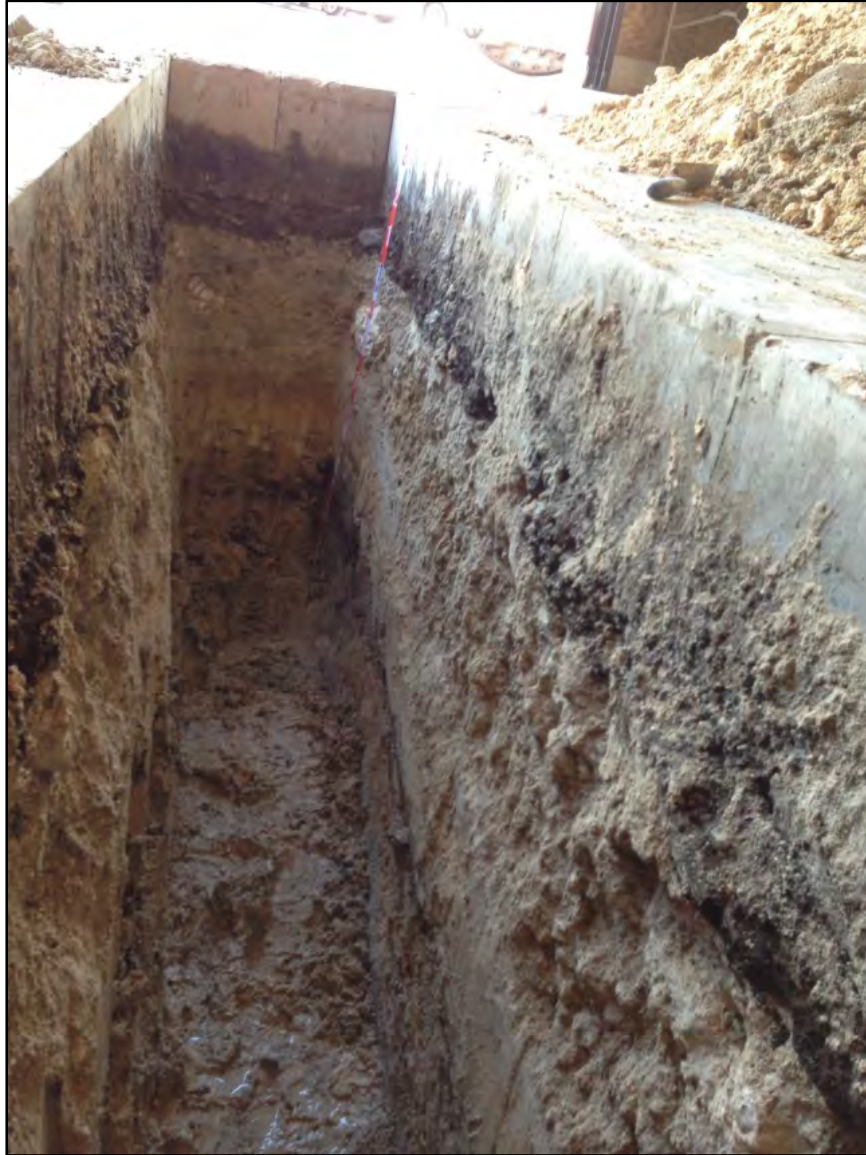
Figure 76. Photograph of T-7 east wall, view to north

Located beneath the warehouse and roadway remnants were Kaka‘ako reclamation fill deposits (Strata IIa and IIb) overlying natural wetland sediment (Stratum IV), including a disturbed wetland A horizon containing organics (Stratum III).

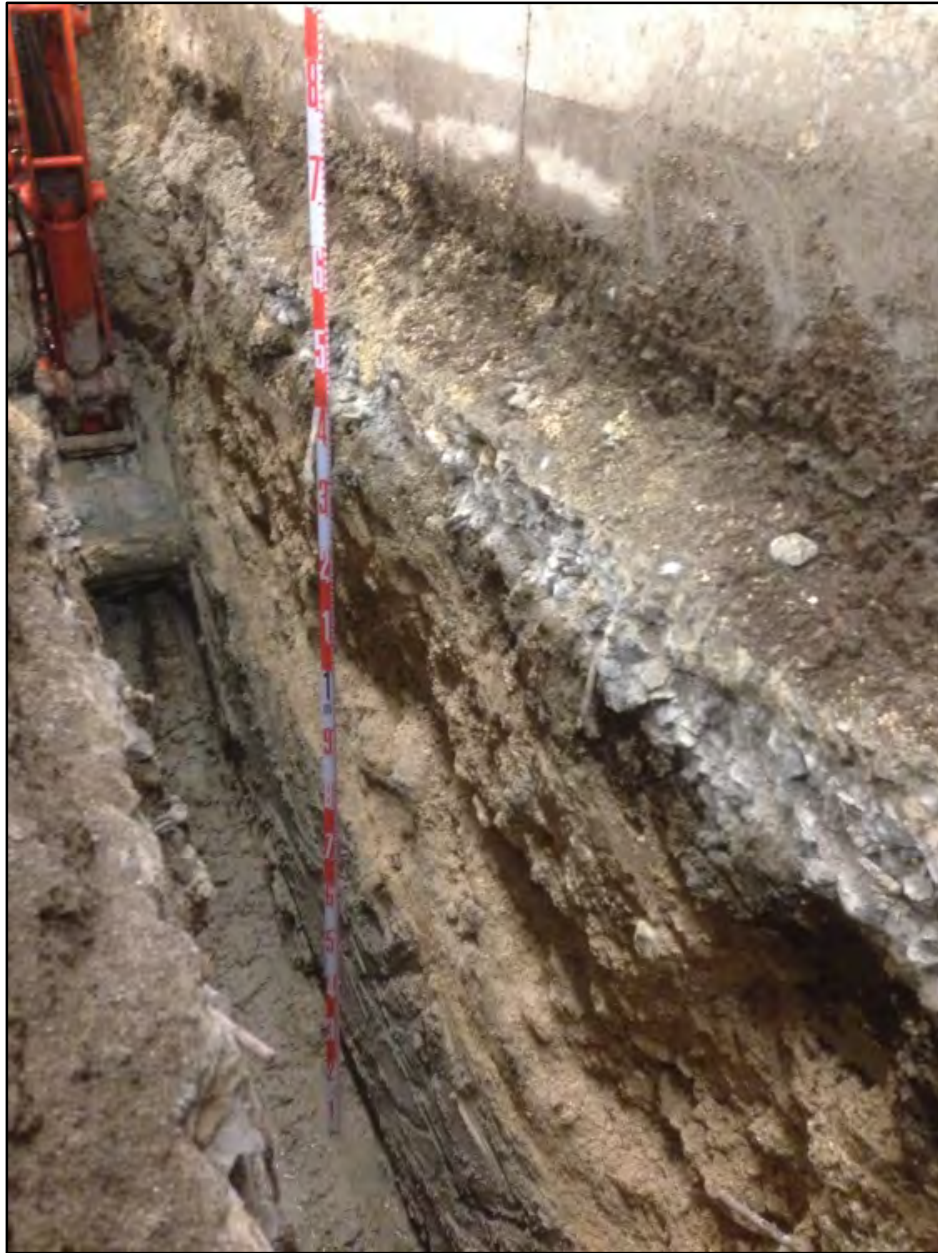
Figure 79. Photograph of T-8 southeast wall, view to east

Test Excavation 8 (T-8), an interior excavation located within the back storage space of the former Nordstrom Rack building, was oriented southwest-northeast and measured 6.2 m long by 0.6 m wide. The base of excavation was determined by the presence of the hard coral shelf at 1.92 mbs. The stratigraphy of T-8 consisted of the concrete surface (Stratum Ia), associated base course (Stratum Ib), a buried concrete surface (Stratum Ic), and associated base course (Stratum Id), 1919–1927 Kaka'ako reclamation fill deposits consisting of cobbly sand (crushed coral) (Stratum IIa) and hydraulic (dredge) clay (Stratum IIb) overlying a wetland loamy clay A horizon (Stratum IIIa) and wetland clay sand (Stratum IIIb). (Figure 78,

Figure 79, and Figure 81, and Table 11). Three utility fill deposits were also observed within the central portion of the trench overlying a utility line (Strata Ie–Ig).

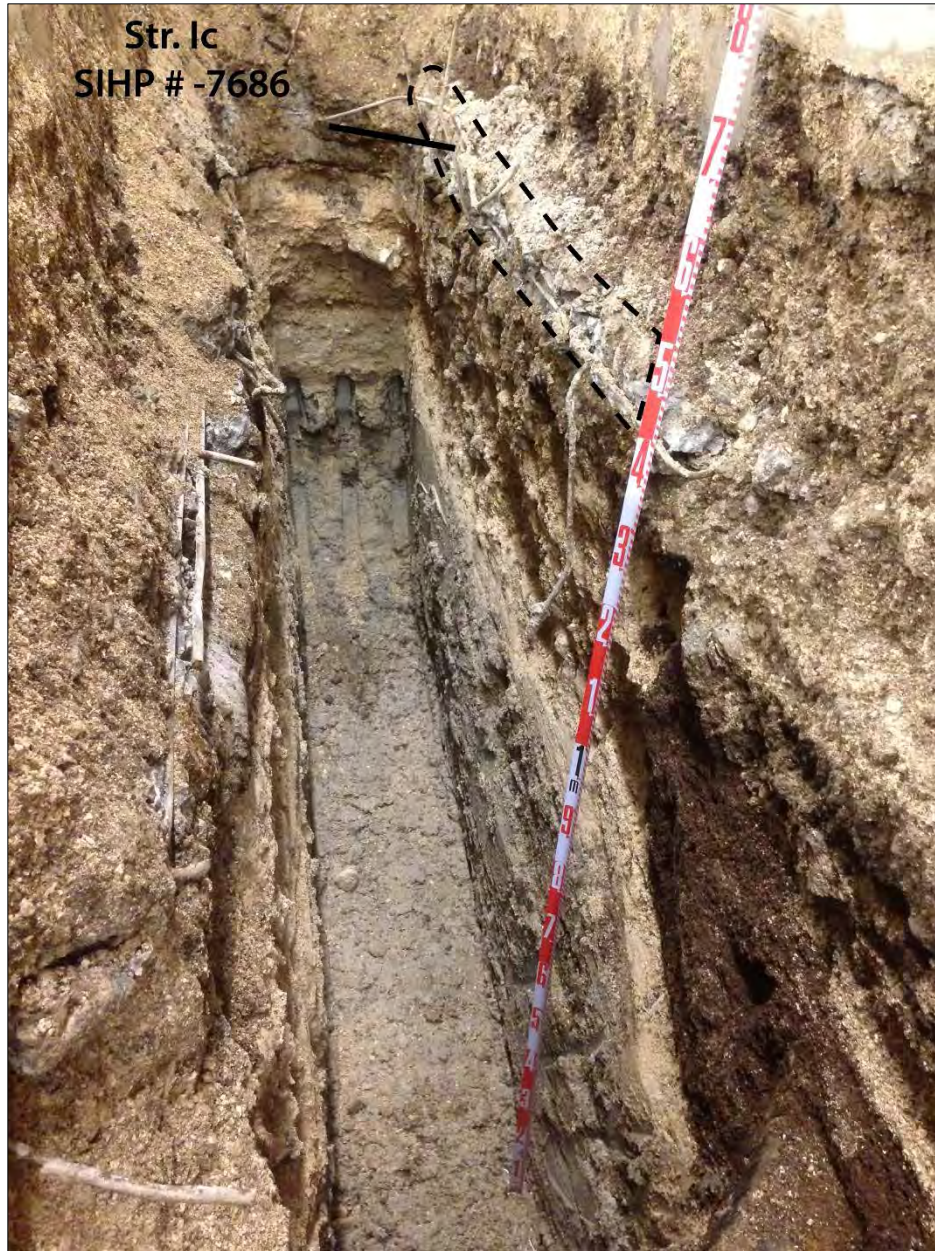
Figure 80. T-8, historic concrete foundation (Stratum Ic, SIHP # -7686), view to east

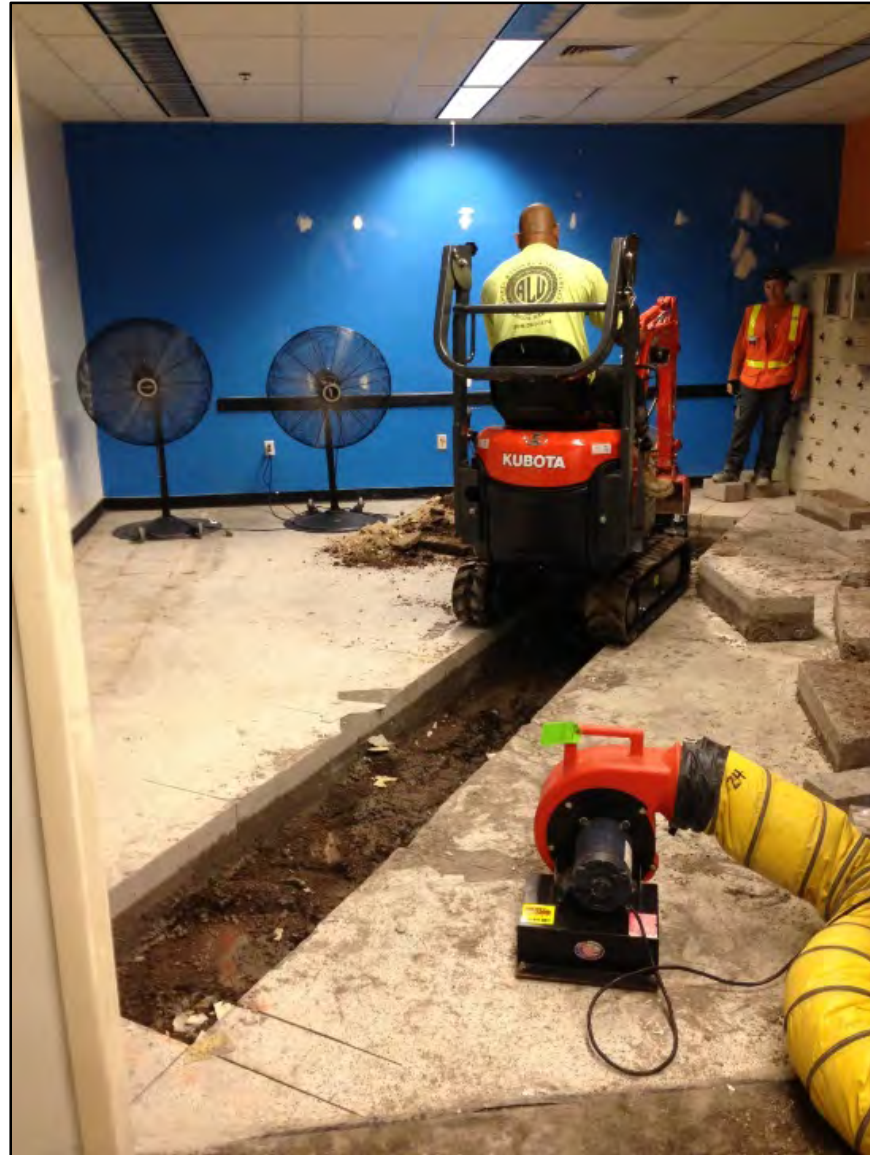
Figure 82. Location of T-9 within the back room of the former Nordstrom Rack commercial store

Test Excavation 9 (T-9), an interior excavation located within the former Nordstrom Rack building, was oriented north-south and measured 6.1 m long by 0.6 m wide. The base of excavation was initially determined by the presence of the water table; however, excavations continued for an additional 0.15 m to a maximum depth of 1.65 mbs. The stratigraphy of T-9 consisted of a concrete and laminated tile surface (Stratum Ia) and associated base course (Stratum Ib) overlying a buried asphalt surface (Stratum Ic) and associated base course (Stratum Id) within the southern portion of the trench and a buried concrete surface (Stratum Ie) and associated base course (Stratum If) within the northern portion. These modern infrastructure layers overlay 1919–1927 Kaka‘ako reclamation fill deposits consisting of extremely gravelly sand (crushed coral) (Stratum IIa) and hydraulic (dredge) clay (Stratum IIb), a redeposited, locally procured loamy sand (Stratum III), a natural loamy sand A horizon (Stratum IVa), Jaucas sand (Stratum IVb), and marine clay sand sediment (Stratum V) (Figure 82 through Figure 84, Figure 86, and Table 12).

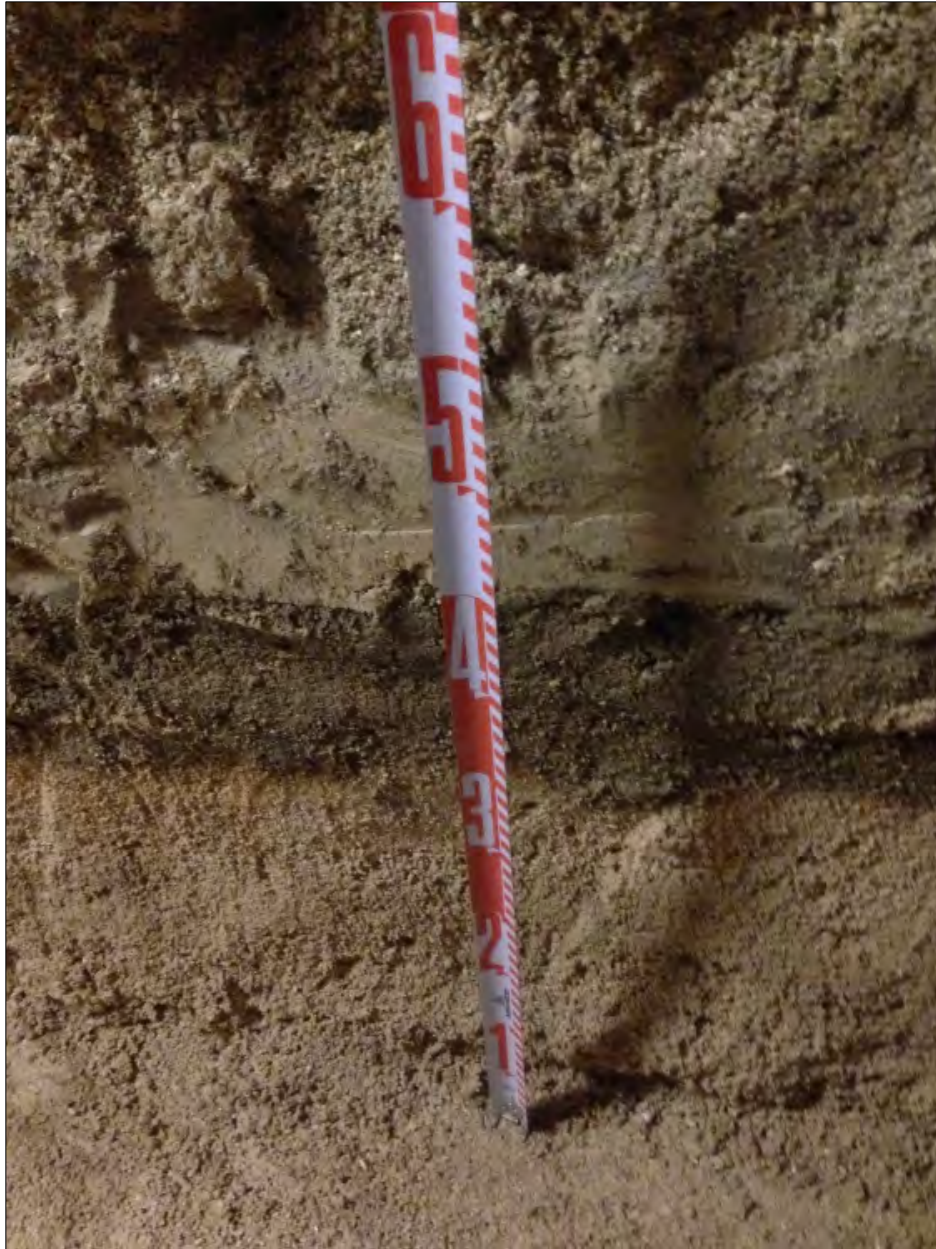
Figure 84. T-9, close-up photograph of crushed coral (Stratum IIa), hydraulic fill (Stratum IIb), and redeposited local sand fill (Stratum III) overlying a thin, dark-stained A horizon (Stratum IVa), and Jaucas sand (Stratum IVb)

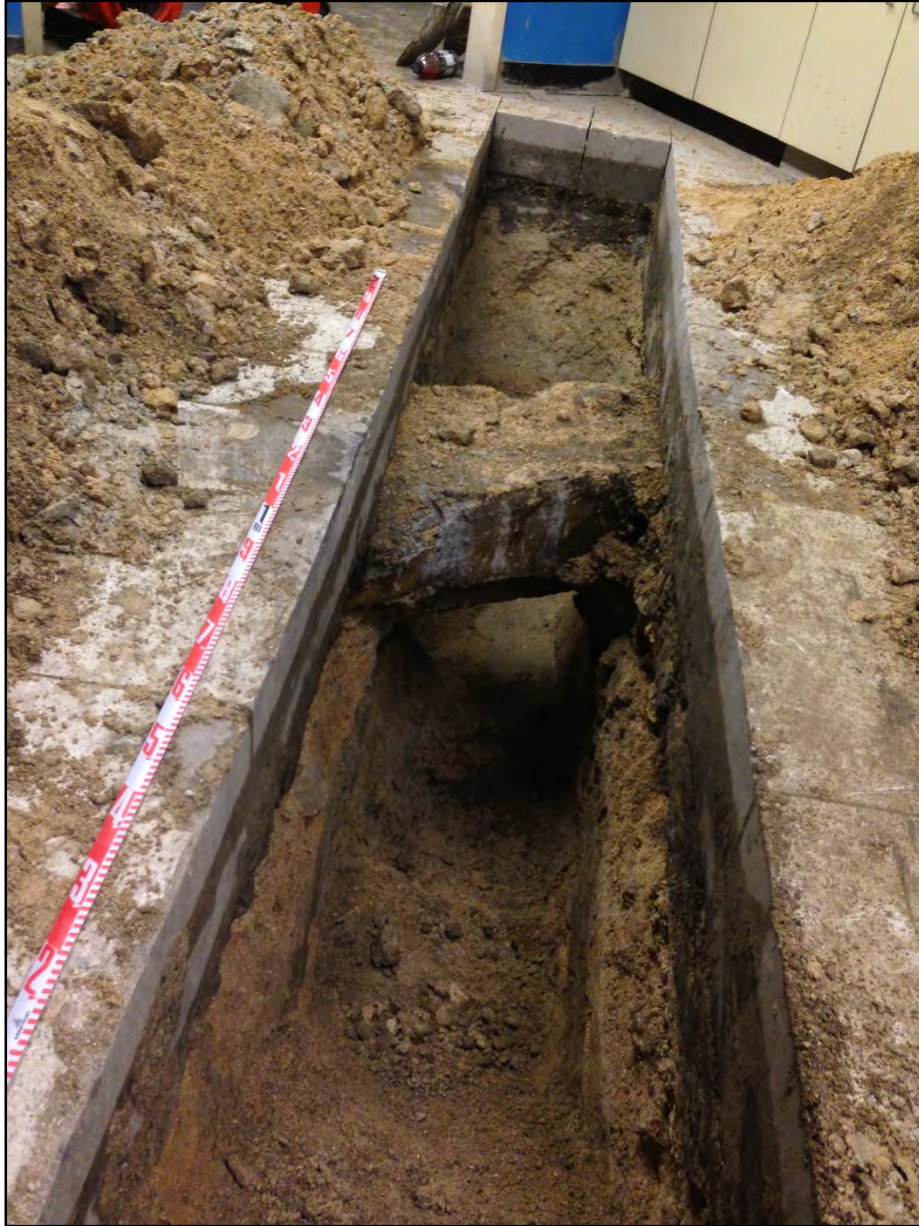
Figure 87. Photograph of T-9 showing a concrete footing associated with SIHP # -7686, view to north

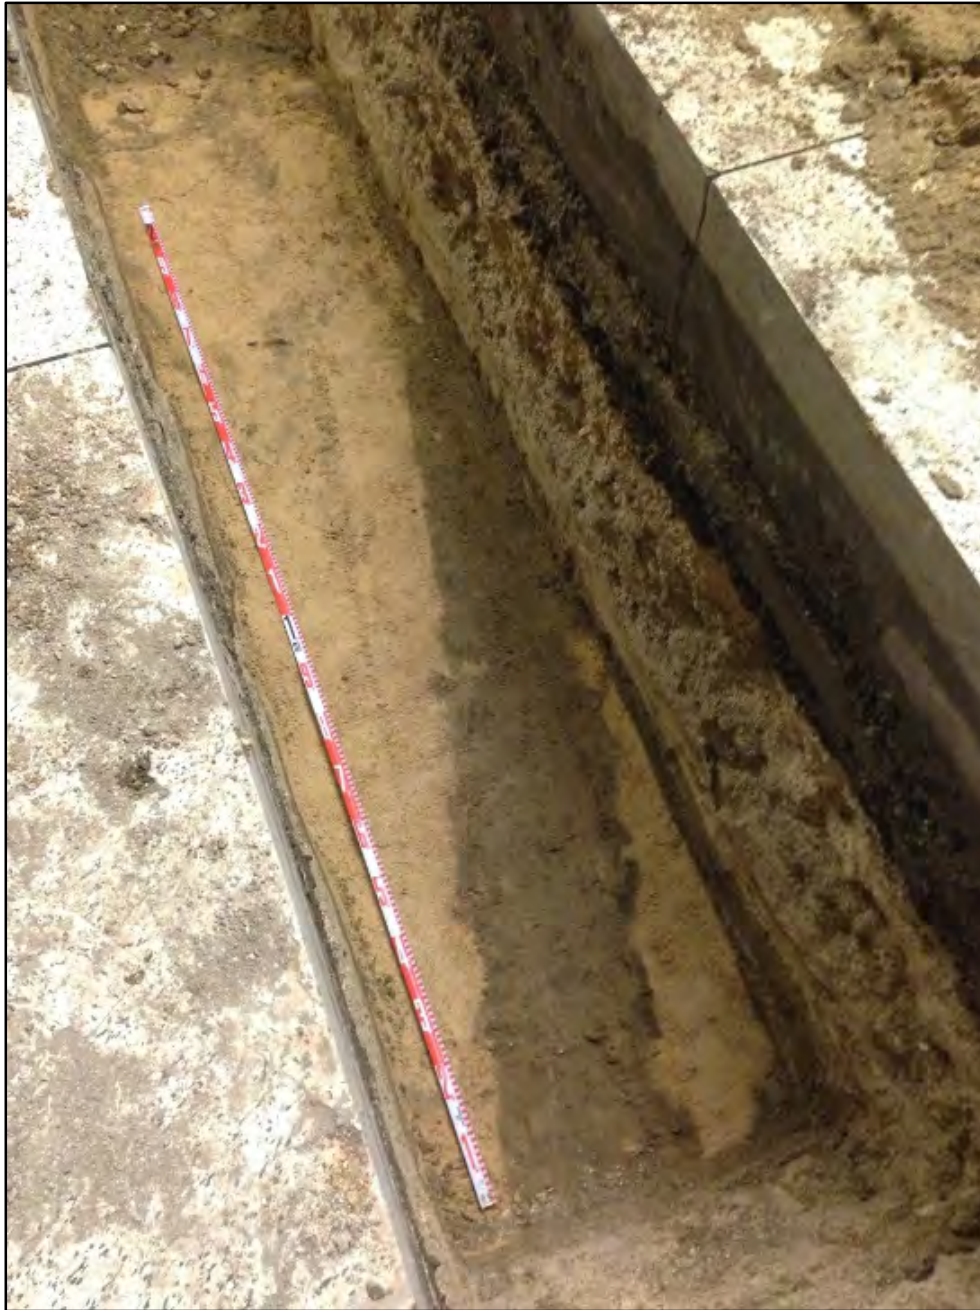
Figure 88. Photograph of shallow, linear discoloration extending from the A horizon into Jaucas sand, view to south

Beneath the remnant commercial infrastructure, T-9 documented a culturally sterile loamy sand A horizon (Stratum IVa). A 5-gallon screen of the A horizon yielded no cultural content. A very shallow, linear discoloration of sediment matrix that measured approximately 1.8 m in length by 0.3 m wide by 3 cm deep extended from the A horizon into the underlying Jaucas sand. Given its ephemeral signature, the discoloration was interpreted as representative of natural erosion processes or an undulation within the A horizon (Figure 88). A 5-gallon screen of the sediment yielded no content.

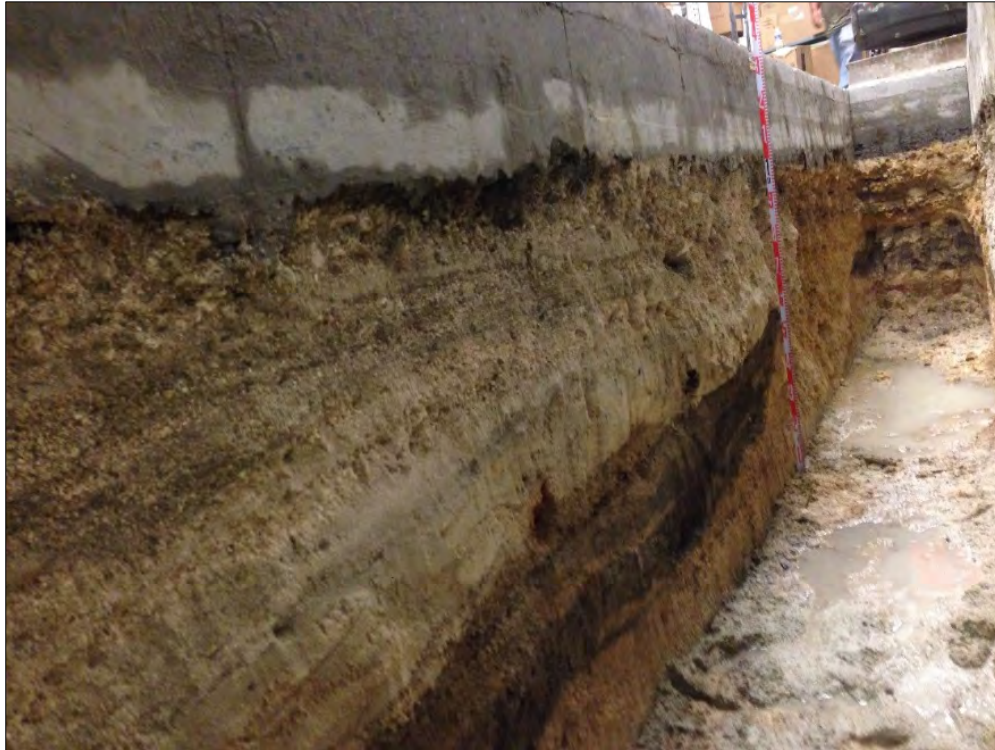
Figure 89. Photograph of T-10 northwest wall, view to southwest

Test Excavation 10 (T-10), an interior excavation located in the stockroom of the Office Depot building, was oriented northeast-southwest and measured 6.1 m long by 0.6 m wide. The base of excavation was determined by the presence of the water table at 1.45 mbs. The stratigraphy of T-10 consisted of the current concrete surface (Stratum Ia), a buried concrete surface (Stratum Ib), associated base course (Stratum Ic), and gravelly sand utility fill material (Stratum Id), overlying 1919–1927 Kaka‘ako reclamation fill deposits consisting of coarse sand (crushed coral) (Stratum IIa) and hydraulic (dredge) fine silty sand marine sandy clay (Stratum IV), and marine sand (Stratum V) (Figure 89 and Figure 90, and Table 13). Strata Ic, IIa, IIb, IIIa, and IIIb were truncated in the southwest (*makai*) end by previous ground disturbance activities, possibly related to a utility installation, then subsequently filled with crushed coralline sand mixed with oxidized metal fragments and broken glass (Stratum Id).

As with T-7 through T-9, T-10 documented remnants of a commercial warehouse foundation, considered part of SIHP # -7686. The warehouse remnants consisted of a buried concrete surface (Stratum Ib) and associated base course (Stratum Ic) that extended across the length of the test excavation. The current commercial building surface (Stratum Ia) was constructed directly over top this earlier commercial surface.

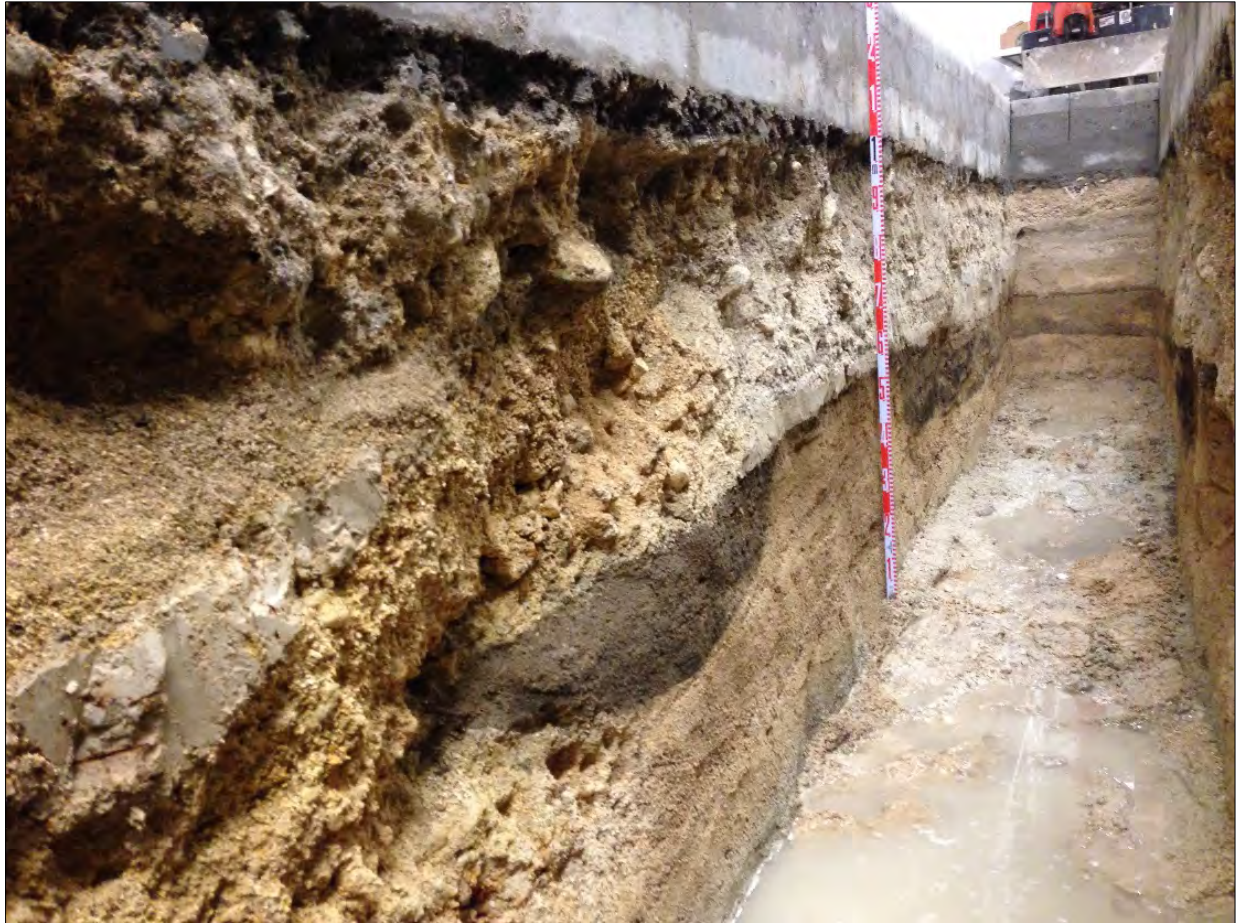
Figure 91. Photograph of T-10 southeast sidewall, showing the Stratum IIIa undulating lower boundary, view to northeast

Beneath the remnant commercial infrastructure, T-10 documented a disturbed buried A horizon (Stratum IIIa) heavily striated with Jaucas sand, below the crushed coral and hydraulic fill material associated with land reclamation (1919–1927). Stratum IIIa had an abrupt to diffuse irregular, broken lower boundary (Figure 91). A bulk sample of the A horizon (11 gallons) was screened in the field; no cultural material was observed.

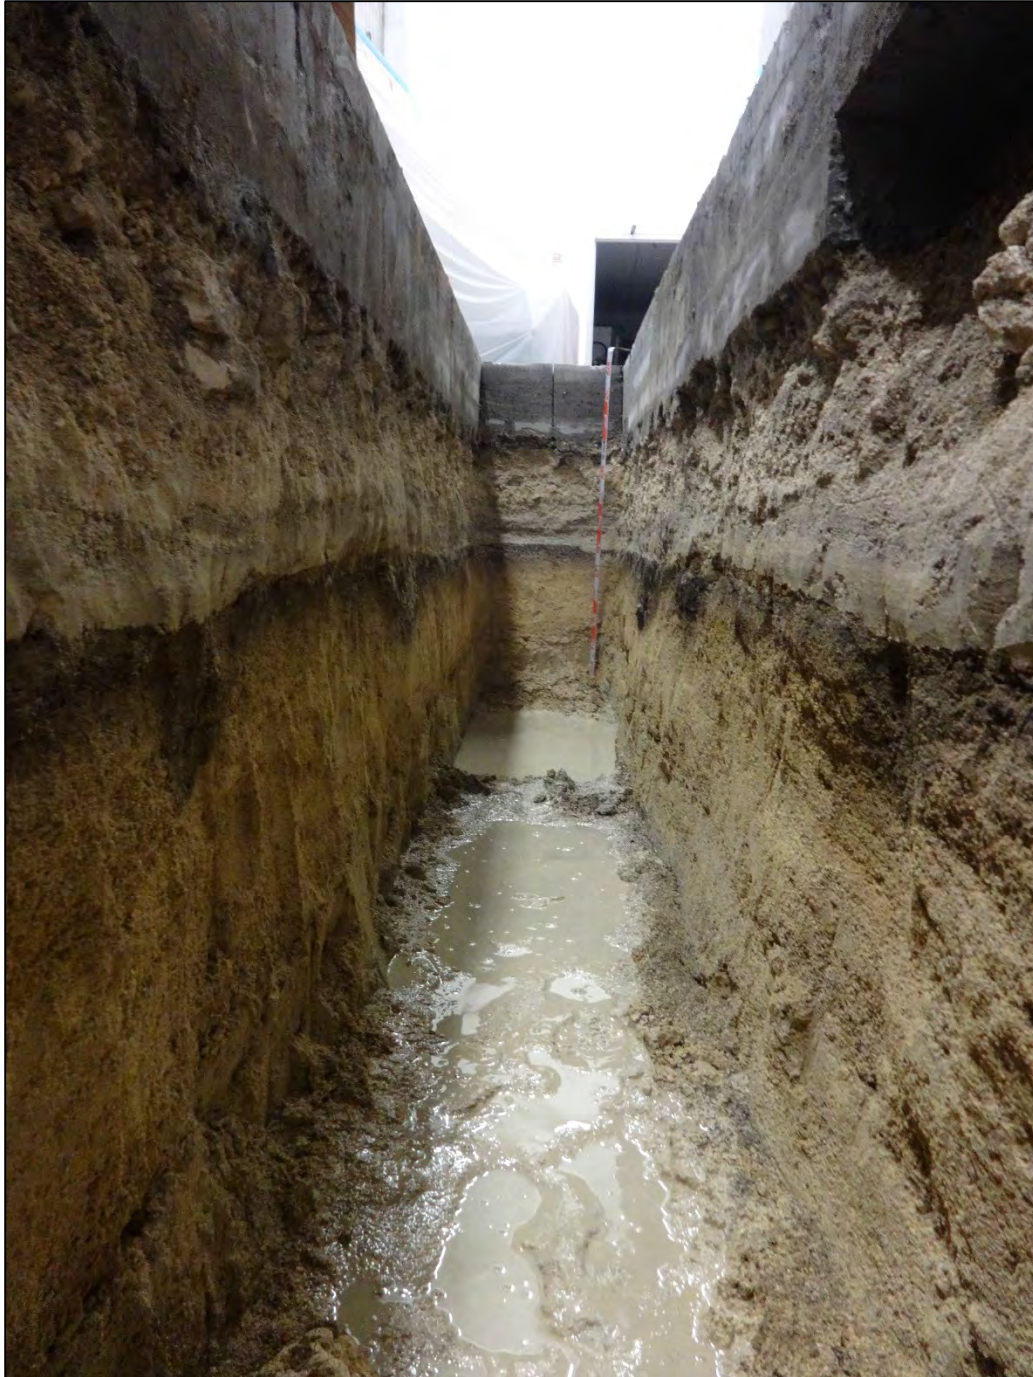
Figure 92. Photograph of T-11, view to northwest

Test Excavation 11 (T-11), an interior excavation located within the stockroom of the Office Depot building, was oriented southwest-northeast and measured 6.1 m long by 0.6 m wide. The base of excavation was determined by the presence of the water table at 1.48 mbs. The stratigraphy of T-11 consisted of the concrete surface (Stratum Ia) overlying a buried concrete surface (Stratum Ib), overlying 1919–1927 Kaka'ako reclamation fill deposits consisting of extremely gravelly sand (crushed coral) (Stratum IIa) and hydraulic (dredge) very fine sand (Stratum IIb) overlying a redeposited, locally procured fine sand (Stratum III), overlying a natural loamy sand A horizon (Stratum IVa), Jaucas sand (Stratum IVb), loamy sand wetland sediment (Stratum V), and marine sand (Stratum VI) (Figure 92 and Figure 93, and Table 14).

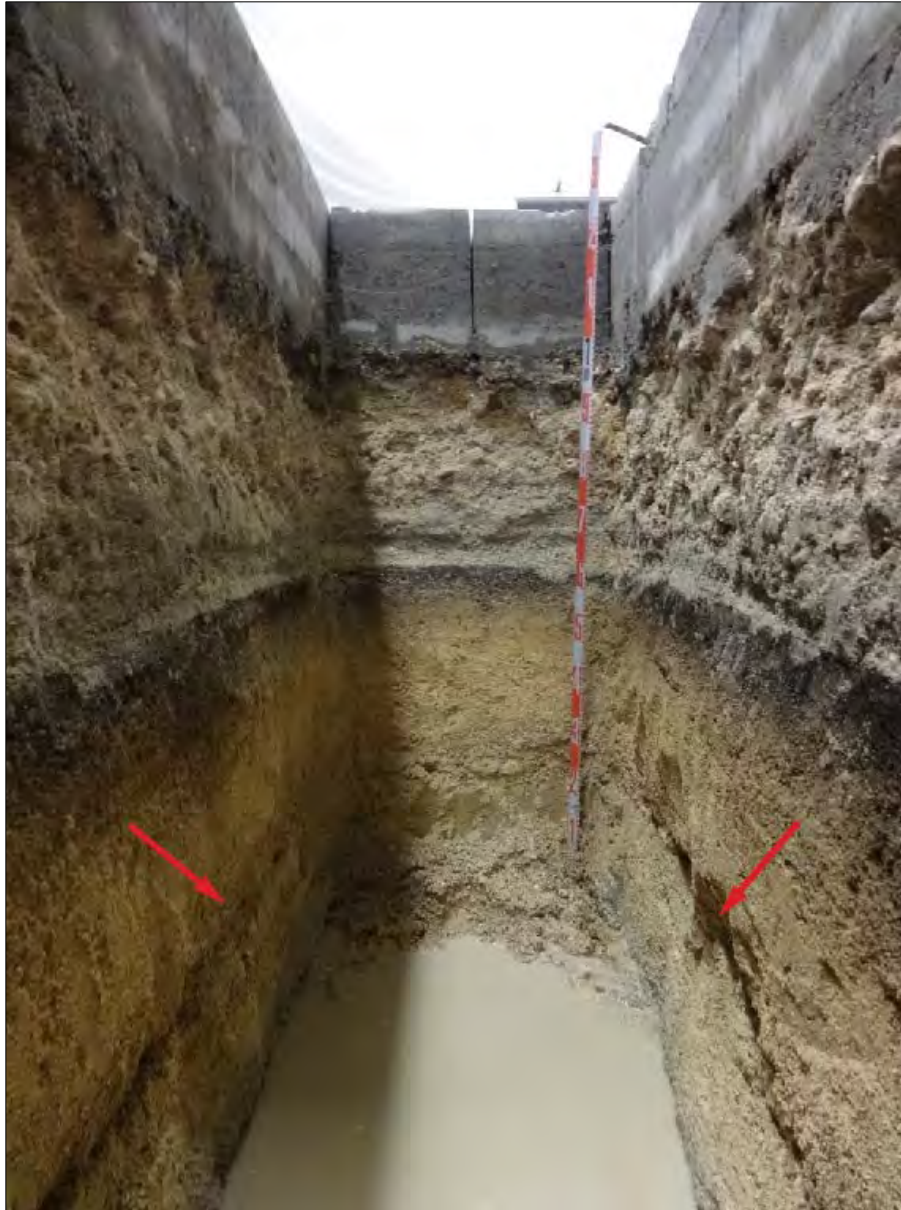
Figure 94. Photograph of T-11 northwest (*mauka*) end, showing a thin indurate layer between Strata IVb and V, view to northwest

The natural A horizon (Stratum IVa) evidenced a slightly scalloped, undulating lower boundary, while the upper boundary appeared to have been truncated by previous ground disturbance activities, leveled, and heavily compacted particularly in the northwest portion. A 5-gallon sample of the A horizon was screened in the field and yielded no cultural material. The underlying Jaucas sand (Stratum IVb) abruptly transitioned at its lower boundary to a thin indurate layer of coarse sand that either represents a different depositional environment or compaction from the weight of overlying deposits combined with water table fluctuations and calcification of the sediment grains (Figure 94).

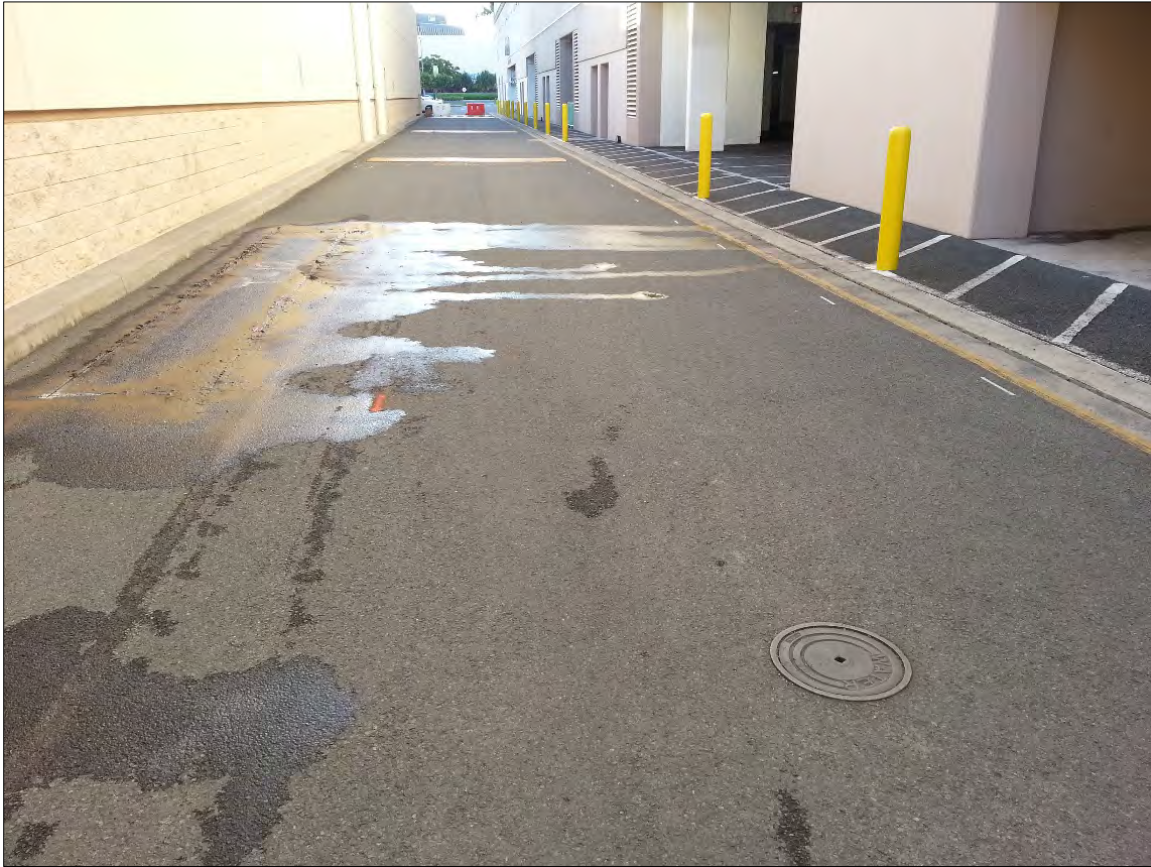
Figure 95. Location of T-12 within the alleyway between the Ward Theaters and the former Nordstrom Rack building, view to southeast

Test Excavation 12 (T-12), an exterior excavation located within the alleyway between the Ward Theater parking garage and the former Nordstrom Rack building, was oriented southeast-northwest and measured 6.1 m long by 0.7 m wide. The base of excavation was determined by the presence of a utility jacket at a maximum depth of 1.03 mbs. According to the project area utility maps, the location of T-12 provided the only potential gap within a network of utilities extending through the alleyway. The stratigraphy of T-12 consisted of asphalt and utility fill down to the level of the utility jacket within the majority of the test excavation. However, the northeast sidewall retained the previous stratigraphic sequence, which consisted of the asphalt road surface (Stratum Ia), associated base course (Stratum Ib), and extremely gravelly sandy silt (Stratum Ic) overlying 1919–1927 Kaka‘ako reclamation fill deposits consisting of very gravelly sand (crushed coral) (Stratum IIa) and hydraulic (dredge) silty clay to a gravelly sandy loam (Stratum IIb) (Figure 95 through Figure 97 and Table 15).

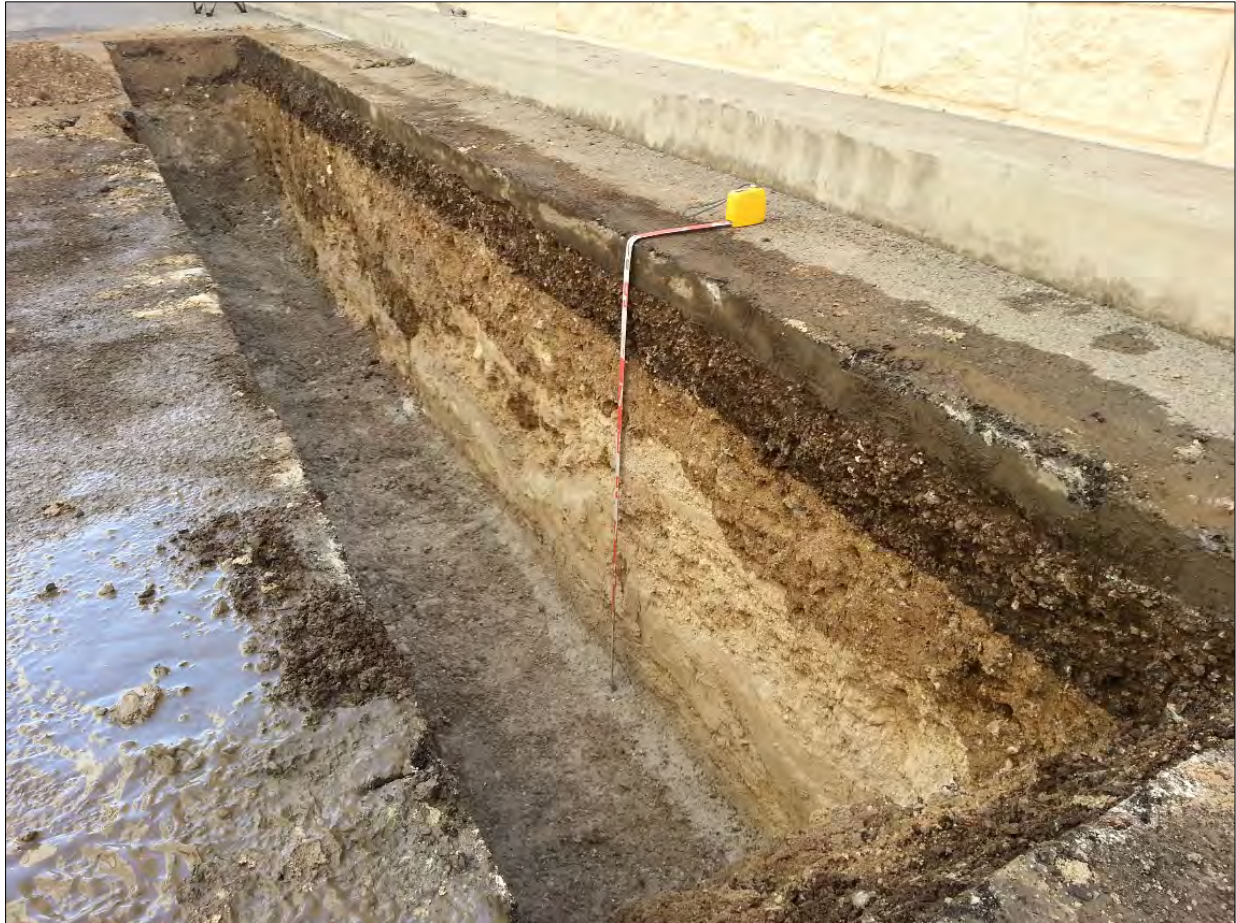
Figure 96. Photograph of T-12 northeast wall, view to northwest

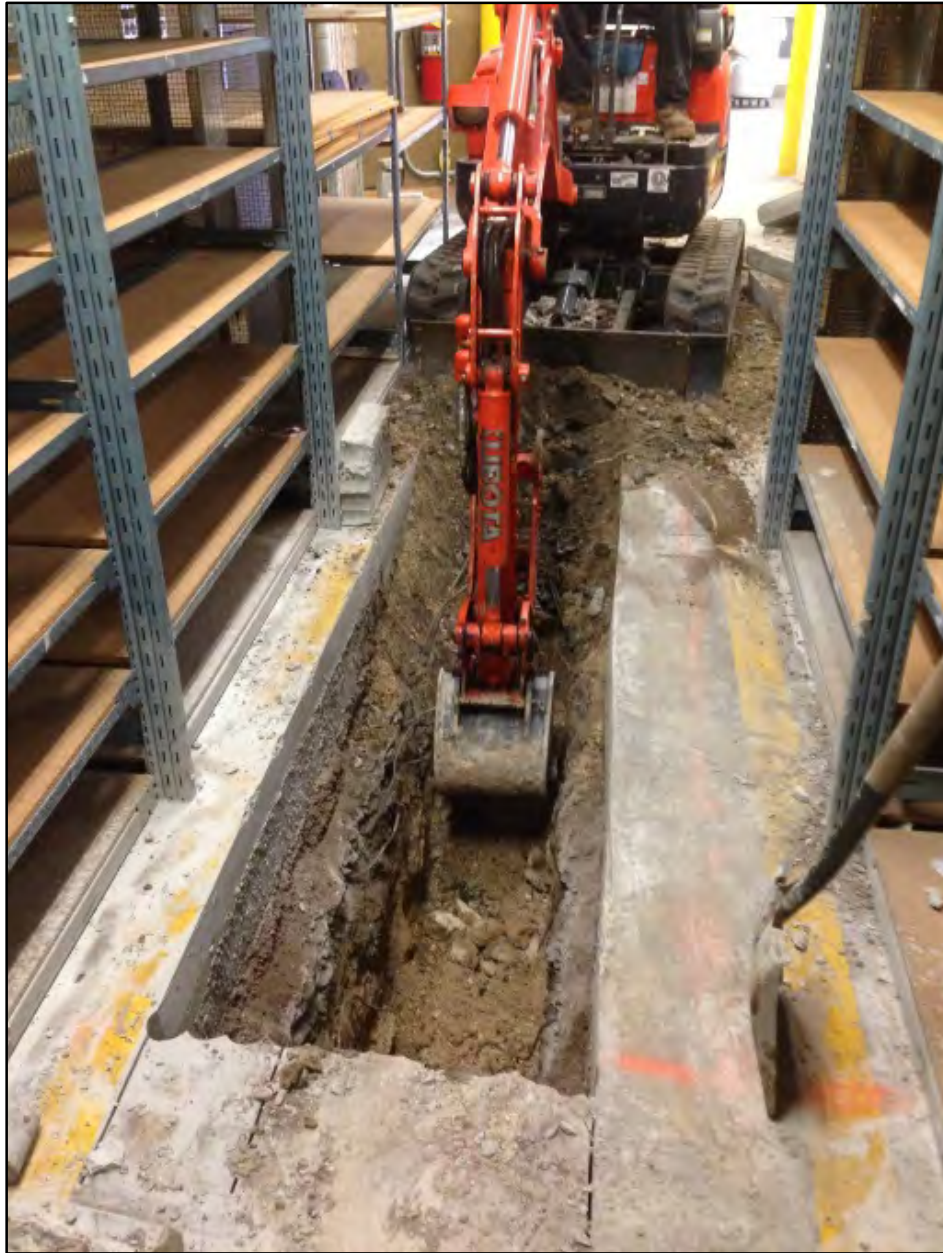
Figure 98. Location of T-13 within the back storage area of a commercial establishment

Test Excavation 13 (T-13), an interior excavation located within the former Nordstrom Rack building, was oriented northwest-southeast and measured 6.2 m long by 0.45 m wide (Figure 98). The base of excavation was determined by the presence of the water table at a depth of 1.87 mbs. The stratigraphy of T-13 consisted of the current concrete surface (Stratum Ia) overlying a buried concrete surface (Stratum Ib) and associated base course (Stratum Ic), overlying an additional layer of concrete (Stratum Id) and associated base course (Stratum Ie), overlying 1919–1927 Kaka'ako reclamation fill deposits consisting of very gravelly sand (crushed coral) (Stratum IIa) and hydraulic (dredge) clay (Stratum IIb), overlying a natural loamy clay A horizon (Stratum IIIa) and sandy clay wetland sediment (Stratum IIIb) (Figure 99 and Figure 100, and Table 16). T-13 was initially 0.6 m wide; however, due to the difficulty in cutting through the third concrete layer (Stratum Id), it was shortened slightly to 0.45 m in width.

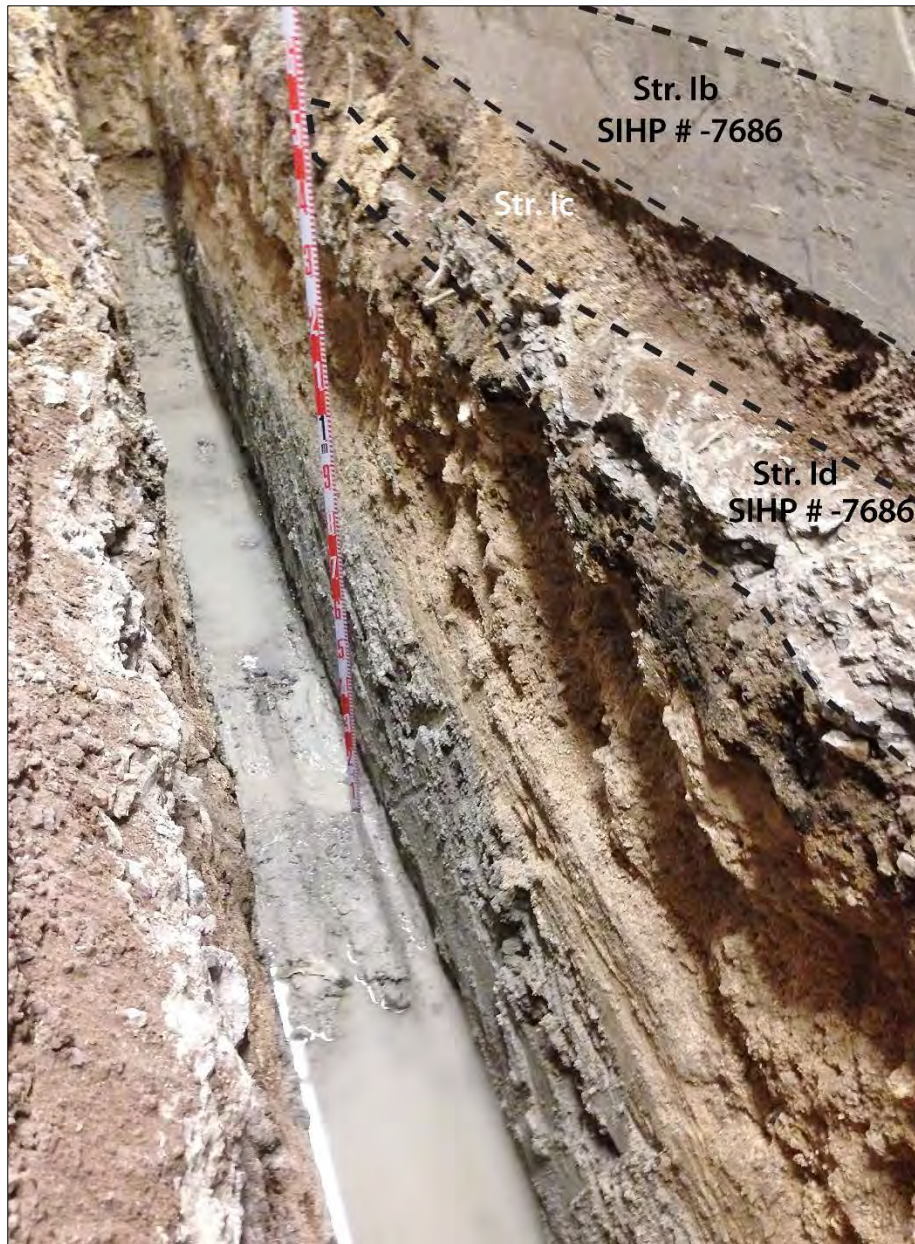
Figure 99. T-13 northeast wall, view to north

T-13 documented remnants of commercial warehouse infrastructure, considered part of SIHP # -7686. The warehouse remnants consisted of two buried concrete surfaces (Strata Ib and Id) and respective associated base courses (Strata Ic and Ie), which extended across the length of the test excavation. The current commercial building surface (Stratum Ia) was constructed directly over top this earlier commercial infrastructure.

Beneath the remnant commercial infrastructure, T-13 documented natural wetland sediments consisting of a highly organic, peaty deposit (Stratum IIIa) overlying a wetland sandy clay containing brackish water snails and organics (Stratum IIIb). A column sample extracted from Strata IIIa and IIIb was sent for pollen analysis. The two samples show a strong contrast from one another as the lower sample from Stratum IIIb (136–139 cmbs) was primarily dominated by Cyperaceae pollen (79.7%) and Nama (12.4%). This reflects a wetland vegetation consisting of Wet Coastal Sedgeland surrounded by a sparse Nama Herbland on the sandy uplands. Conversely, the sediment in Stratum IIIa sample (130–133 cmbs) became a peat and the vegetation composition changed drastically. Within Stratum IIIa, Cyperaceae pollen percentage fell to 5.4% and Nama increased to 72.4%. Concurrently, Fabaceae pollen increased tenfold to 20.2% within Stratum IIIa. These changes indicate a great reduction in the presence of the wetland vegetation coupled with increased disturbance in the sparse upland Herbland. Total pollen concentration increased tenfold in Stratum IIIa and charcoal concentrations increased from 266,149 pieces/ml to 930,000 pieces/ml, suggesting increased disturbance by fire in the surroundings and possibly a transformation of the wetland by burning. Results from Stratum IIIa does not represent intact wetland vegetation, but, rather a highly disturbed plant community. See Section 5.3 for the full results of the pollen analysis.
