Draft
Archaeological Inventory Survey Report for the
Block M Project, Kaka‘ako,
Honolulu Ahupua‘a, Honolulu (Kona) District, O‘ahu
TMK: [1] 2-3-002:001 (portion)

Prepared for
Victoria Ward Limited/Howard Hughes Corporation

Cultural Surveys Hawai‘i, Inc.
Kailua, Hawai‘i
(Job Code: KAKAAKO 122)

September 2014

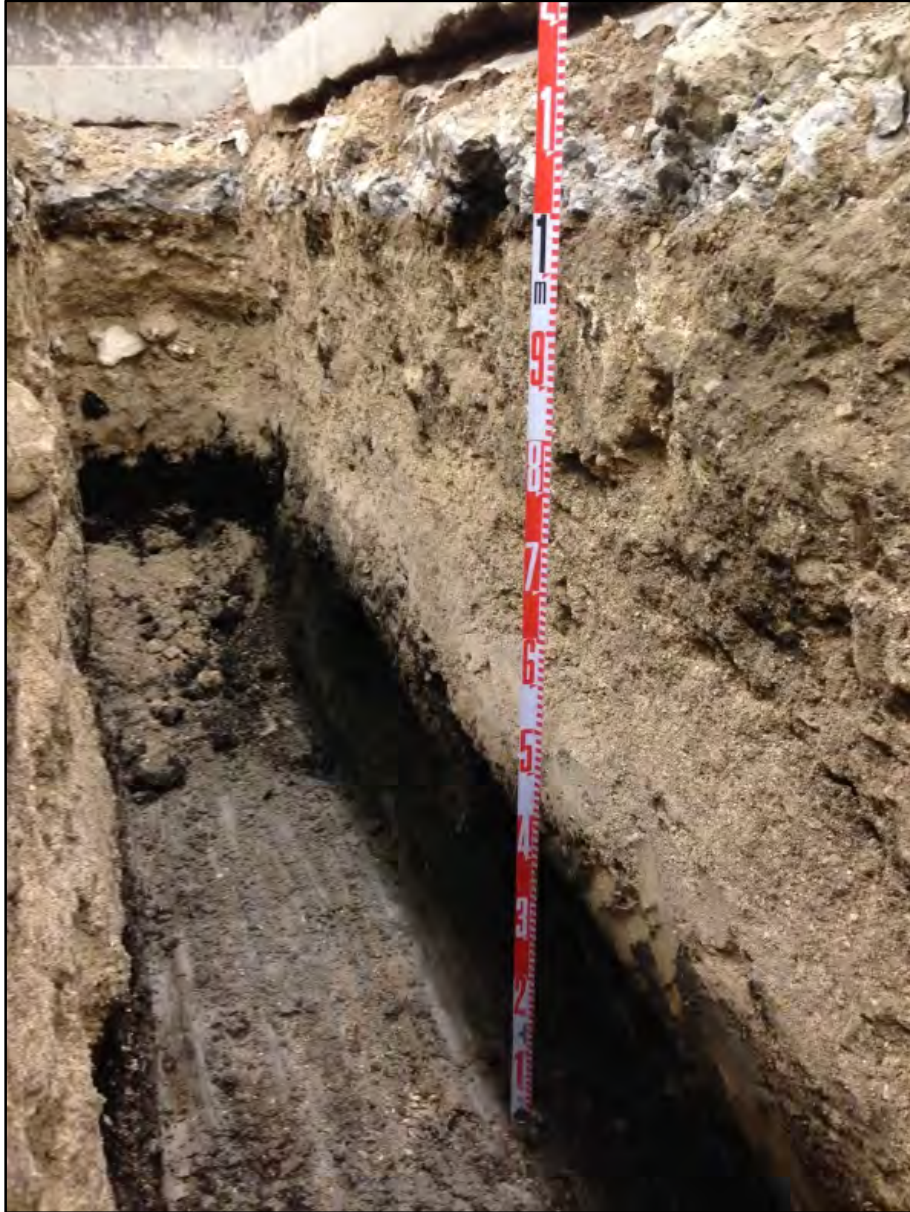
Figure 102. T-14 west wall, view to south

Test Excavation 14 (T-14), an interior excavation located within the former Nordstrom Rack building, was oriented southeast-northwest and measured 6.1 m long by 0.62 m wide (Figure 101). The base of excavation was determined by the presence of the hard coral shelf at 1.7 mbs. The stratigraphy of T-14 consisted of the current concrete surface (Stratum Ia) and gravely sand base course (Stratum Ib) overlying two buried concrete surfaces (Strata Ic–Id), overlying 1919–1927 Kaka‘ako reclamation fill deposits consisting of gravelly sand (crushed coral) (Stratum IIa) and hydraulic (dredge) clay (Stratum IIb) overlying an extremely gravelly silty sand fill with historic debris (Stratum III), over a marine sand deposit (Stratum IV) (Figure 102 and Figure 104, and Table 17).

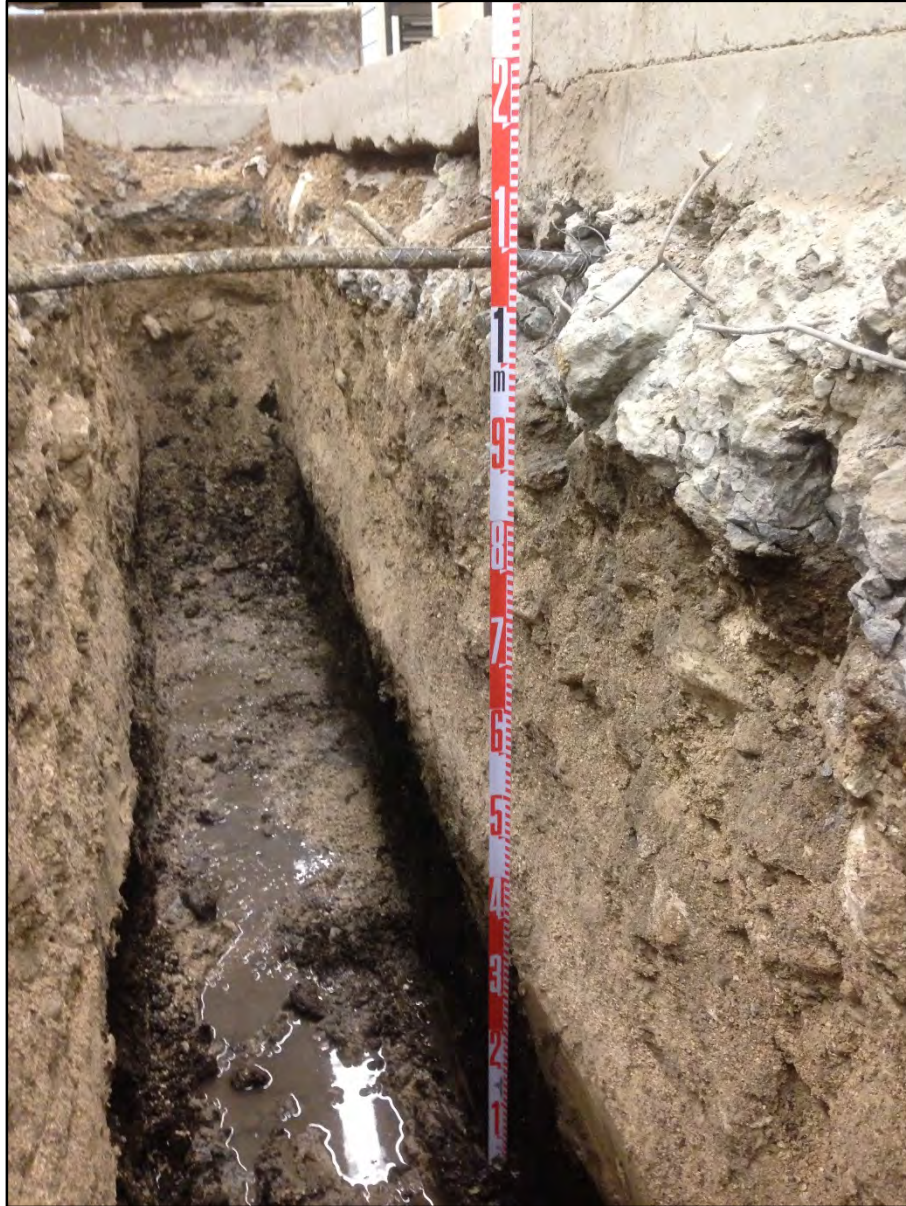
Figure 105. Photograph showing multiple concrete surfaces consisting of the current commercial floor (Stratum Ia) directly overlying an earlier concrete surface associated with SIHP # -7686 (Stratum Ic), overlying an additional buried concrete surface containing rebar and wire (Stratum Id) (SIHP # -7686)

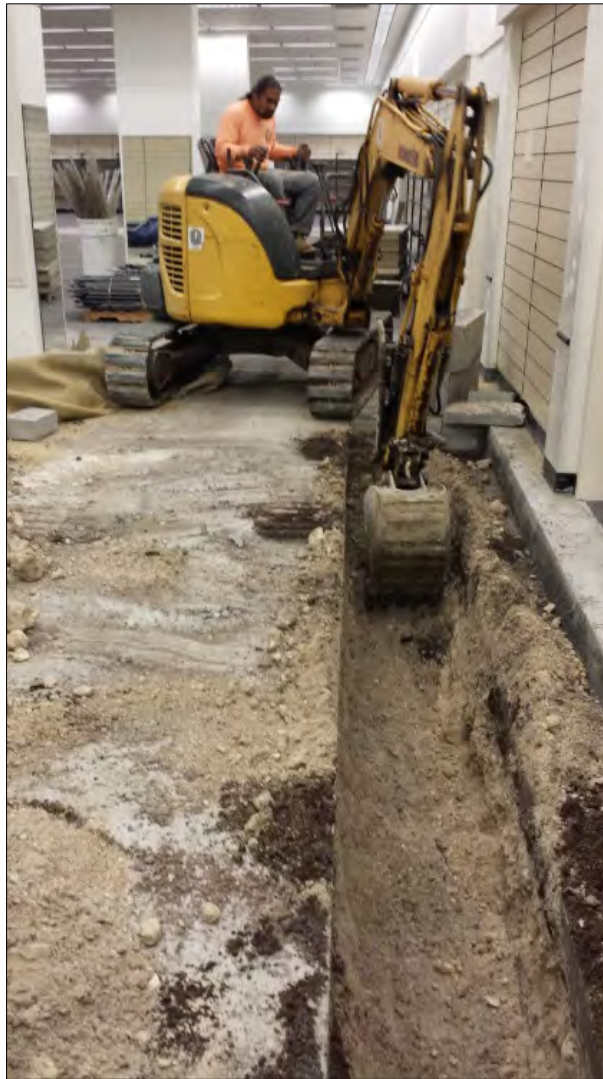
Figure 106. Location of T-15 within interior commercial space, view to southwest

Figure 106). The base of excavation was determined by the presence of the hard coral shelf at a depth of 1.65 mbs. The stratigraphy of T-15 consisted of the current concrete surface (Stratum Ia) overlying a second concrete layer (Stratum Ib) and associated base course (Stratum Ic), overlying an additional layer of concrete (Stratum Id) and associated base course (Stratum Ie), overlying 1919–1927 Kaka‘ako reclamation fill deposits consisting of extremely gravelly sand (crushed coral) (Stratum IIa) and hydraulic (dredge) clay (Stratum IIb), overlying a loamy sand A horizon (Stratum IIIa), Jaucas sand (Stratum IIIb), and a clay sand marine deposit (Stratum IV) (Figure 107 and Figure 109, and Table 18).

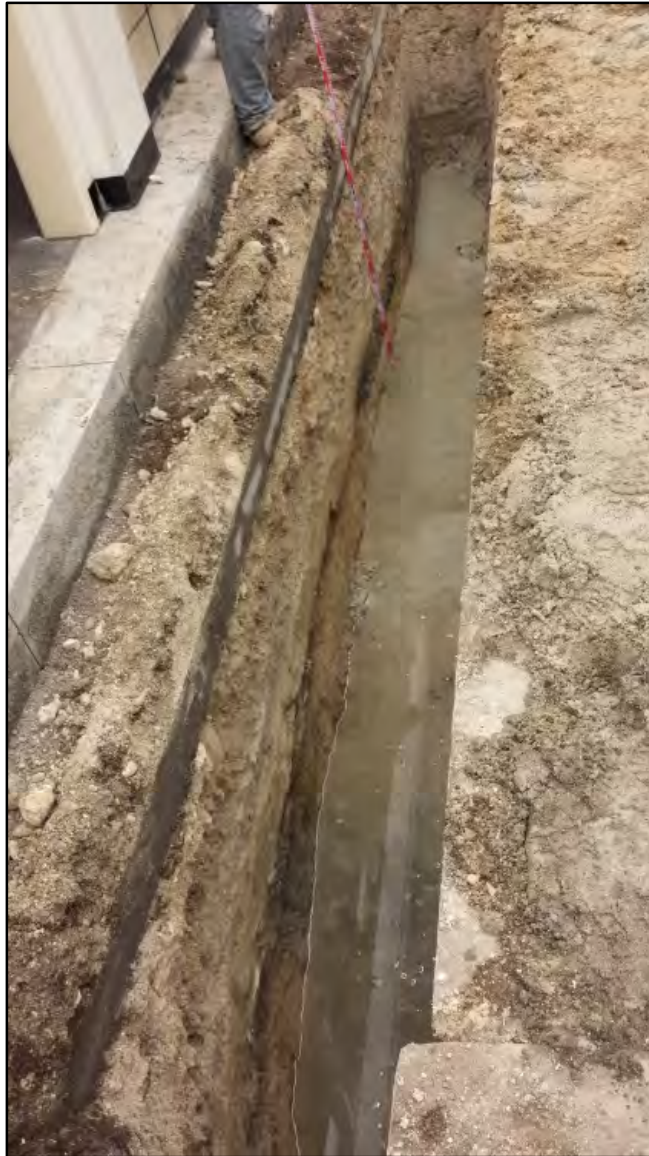
Figure 107. T-15 northwest wall, view to north

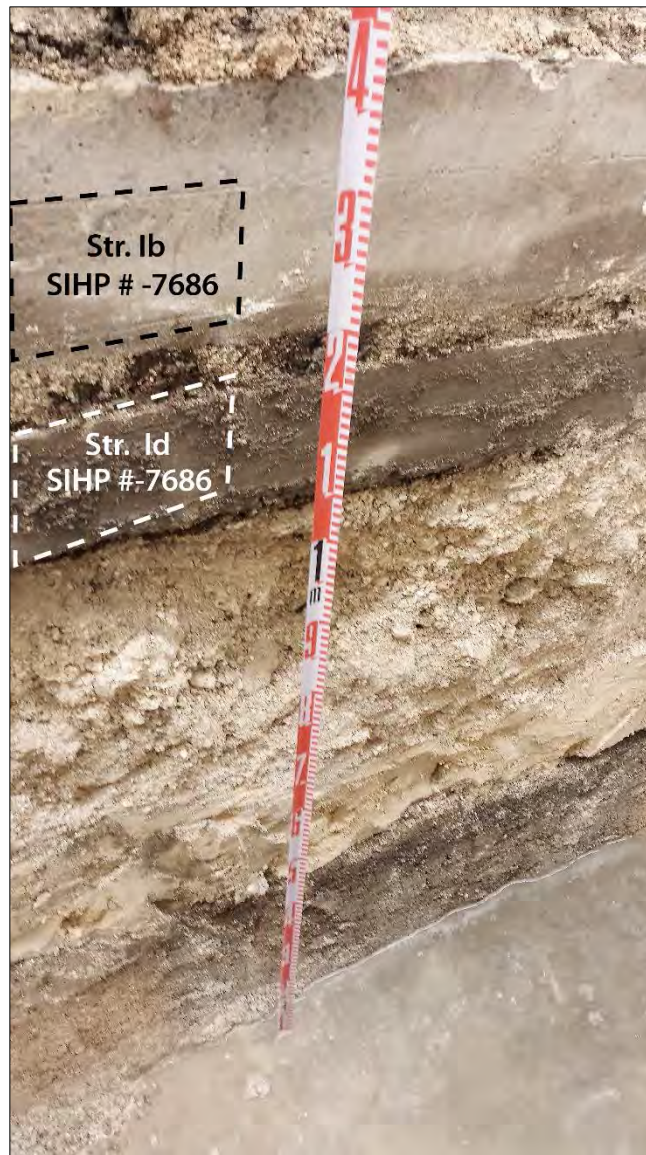
Figure 108. Photograph of T-15, showing SIHP # -7686, view to southeast

T-15 documented remnants of commercial warehouse infrastructure, considered part of SIHP # -7686 (Figure 108). The warehouse remnants consisted of two buried concrete surfaces (Strata Ib and Id) (Figure 110). Stratum Ib and its associated base course (Stratum Ic) were located directly beneath the current commercial floor and over top an additional buried concrete surface (Stratum Id) and base course (Stratum Ie).

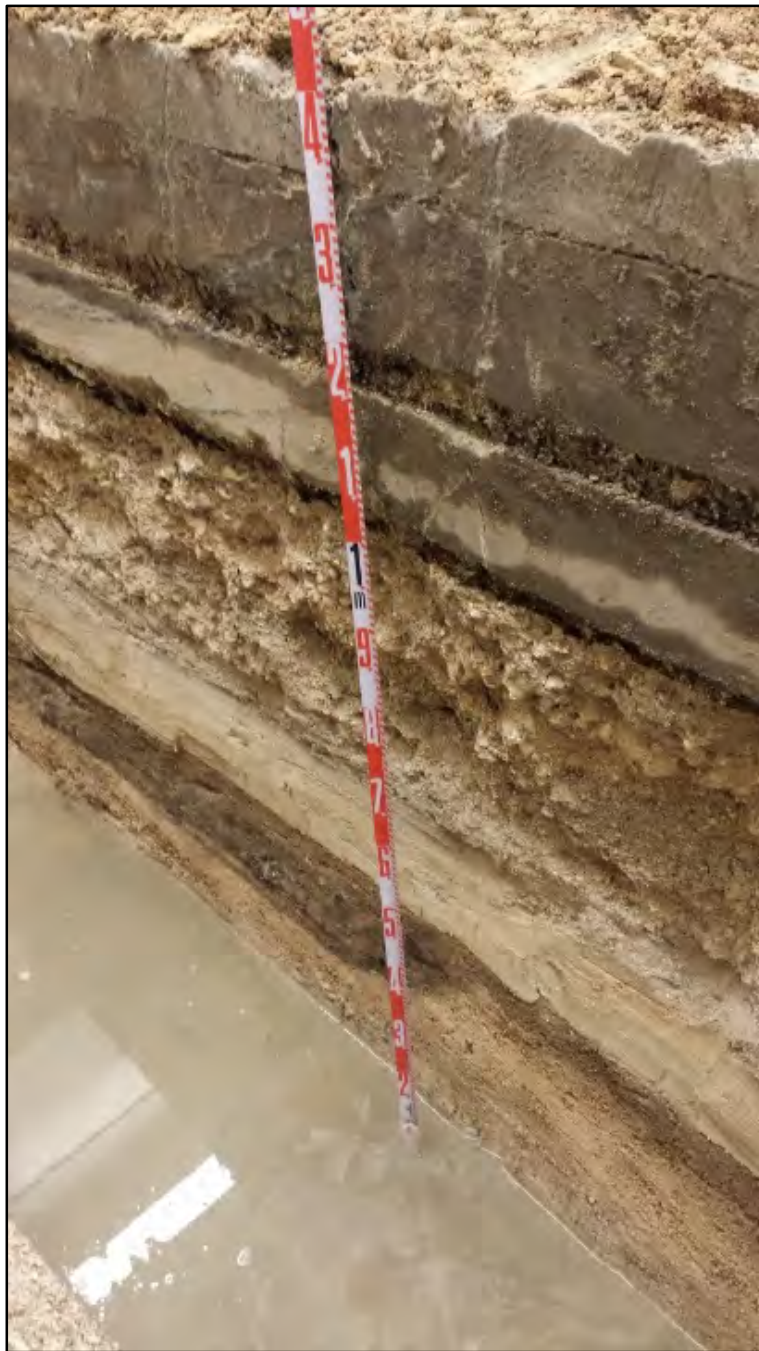
Figure 110. Close-up of southeast wall, showing multiple concrete layers (Strata Ia, Ib, Id) overlying crushed coral and hydraulic dredge fill (Strata IIa–IIb) overlying a natural loamy sand A horizon (Stratum IIIa) and Jaucas sand (Stratum IIIb), view to east

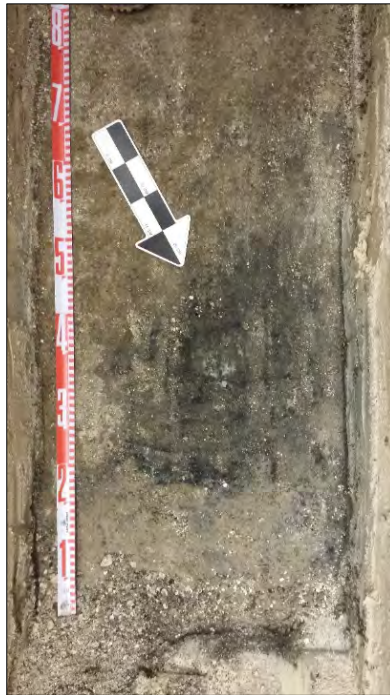
Figure 111. Plan view of anomalous ash lens in the northeast (*mauka*) end of T-15, view to southwest

Beneath the concrete remnants, T-15 documented the presence of a natural loamy sand A horizon (Stratum IIa). The A horizon was significantly disturbed, as evidenced by heavy compaction and truncation. The compaction was most notable at the northeast and southwest ends (*mauka* and *makai*) which may have been a result of various uses of the former land surface. Within Stratum IIa, in the northeast (*mauka*) end, there was an anomalous culturally sterile ash lens that was compact and friable (Figure 111). This lens is most likely a disturbance of some sort. Bulk samples were screened from both Stratum IIa (5 gallons) and the ash lens (1 gallon); no cultural material was observed. A second anomalous pit was observed in the southwest (*makai*) end, located within Stratum IIb and terminating in Stratum III (Figure 112). The pit did not appear to have originated from Stratum IIa and the soil matrix of the pit contents was similar to Stratum III marine sand, but was slightly darker in color. A 5-gallon bulk sample of Stratum III was screened in the field; no cultural material was observed.

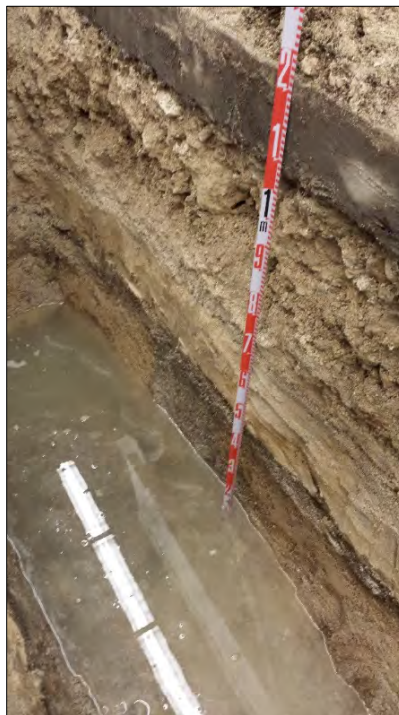
Figure 112. Anomalous pit within Strata IIb and III on the southwest (*makai*) end of T-15

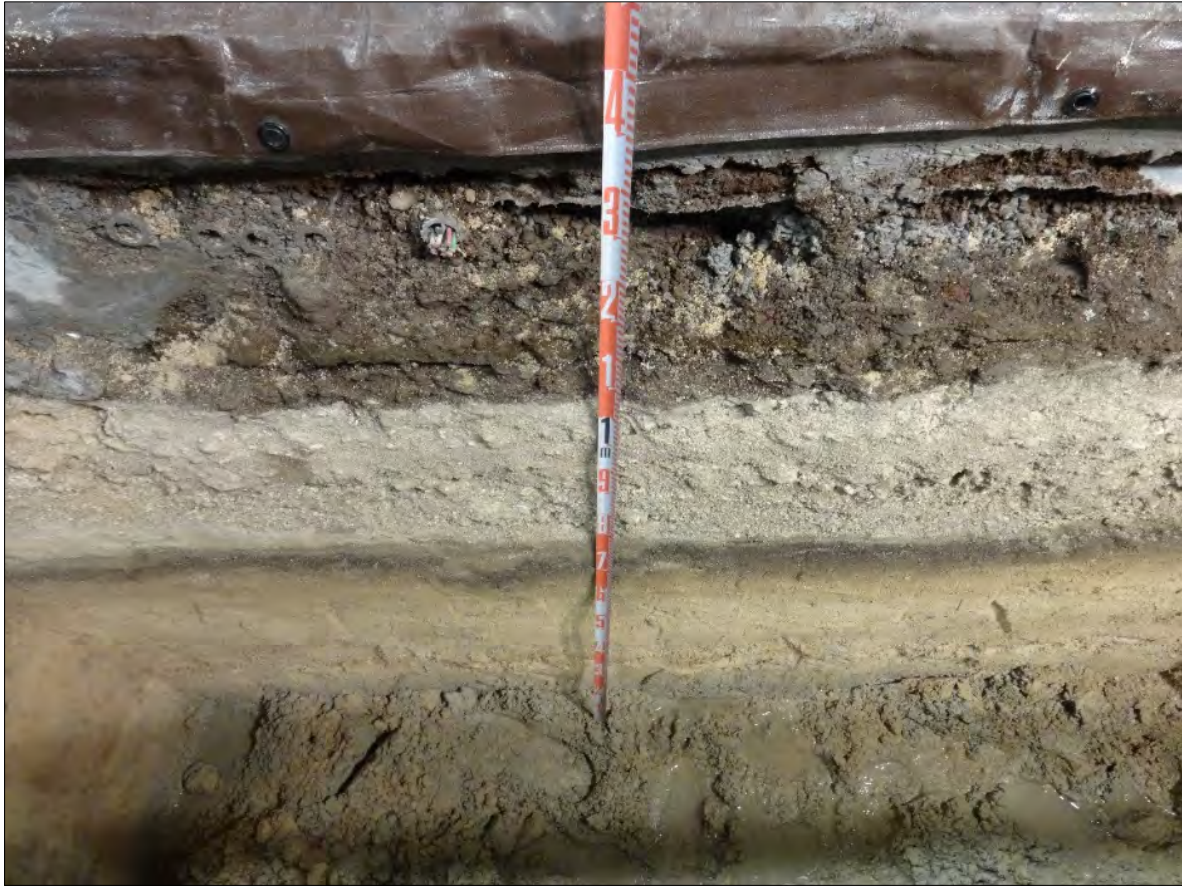
Figure 114. T-16 southwest wall, view to southwest

Test Excavation 16 (T-16), an interior excavation located within the Office Depot Building, was oriented southeast-northwest and measured 6.1 m long by 0.61 m wide (Figure 113). The base of excavation was determined by the presence of the decomposing coral shelf at 1.51 mbs. The stratigraphy of T-16 consisted of a concrete and laminated tile surface (Stratum Ia), associated gravelly sand with visqueen barrier (Stratum Ib), a buried concrete surface (Stratum Ic), compacted gravel fill (Stratum Id), very gravelly silty sand (Stratum Ie), and gravelly sandy loam (Stratum If), overlying 1919–1927 Kaka‘ako reclamation fill deposits consisting of very gravelly coarse sand (crushed coral) (Stratum IIa) and hydraulic (dredge) silty sand (Stratum IIb), overlying a redeposited, locally procured loamy sand (Stratum III), overlying a natural loamy sand A horizon (Stratum IVa), Jaucas sand (Stratum IVb), fine sand (Stratum V), and gravelly clay sand (Stratum VI) (Figure 114 and Figure 116, and Table 19). The lower boundary of Stratum IVb contained a thin indurate layer of cemented sand that separated the Jaucas sand from the sandy clay below. Utility conduits were observed at the northwest and southeast ends at approximately 0.2 mbs and as a result portions of the trench were left unexcavated.

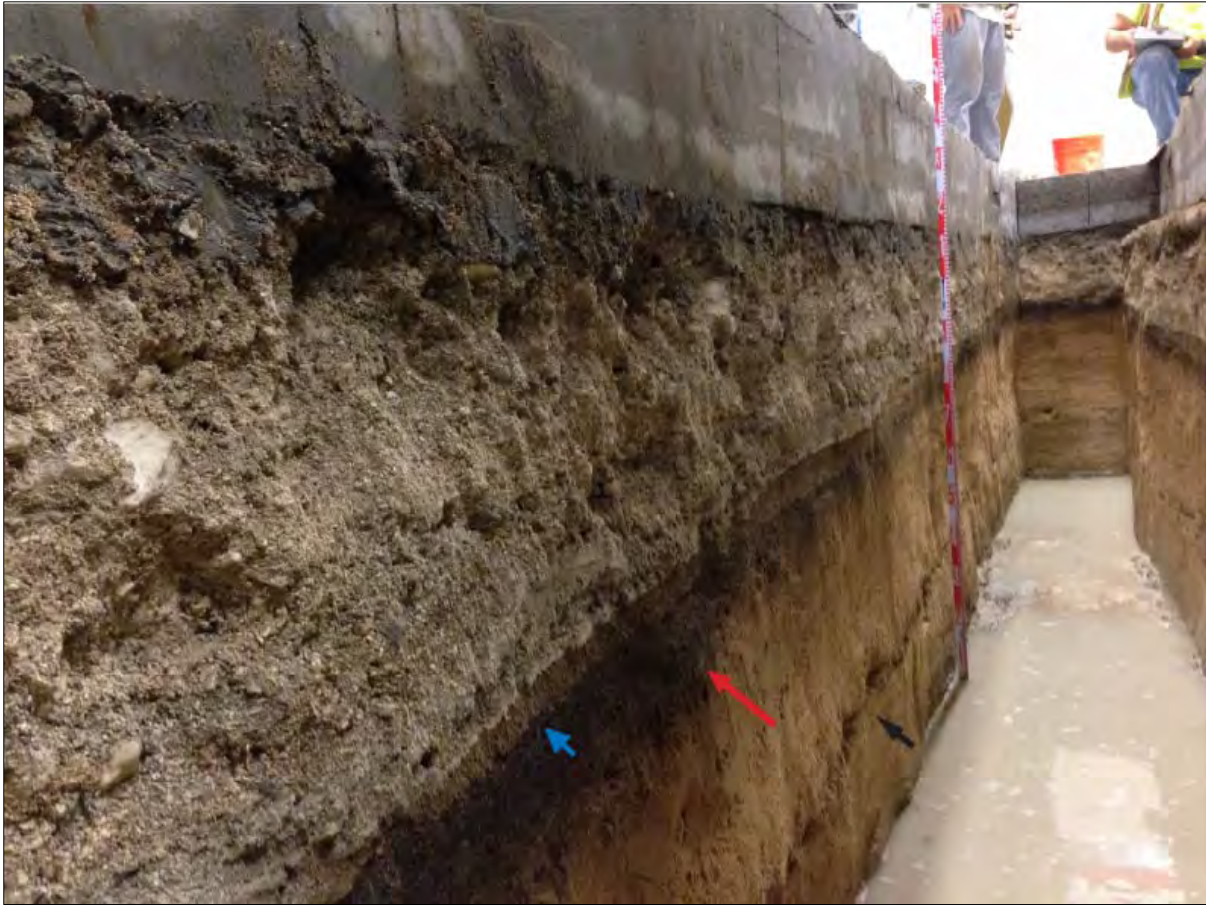
Figure 117. T-17 northwest wall, showing a layer of redeposited fill sand (Stratum III) (blue arrow) overlying the in situ A horizon (Stratum IVa) (red arrow), Jaucas sand (Stratum IVb), and the thin indurated lower boundary of the Jaucas sand (black arrow), view to north

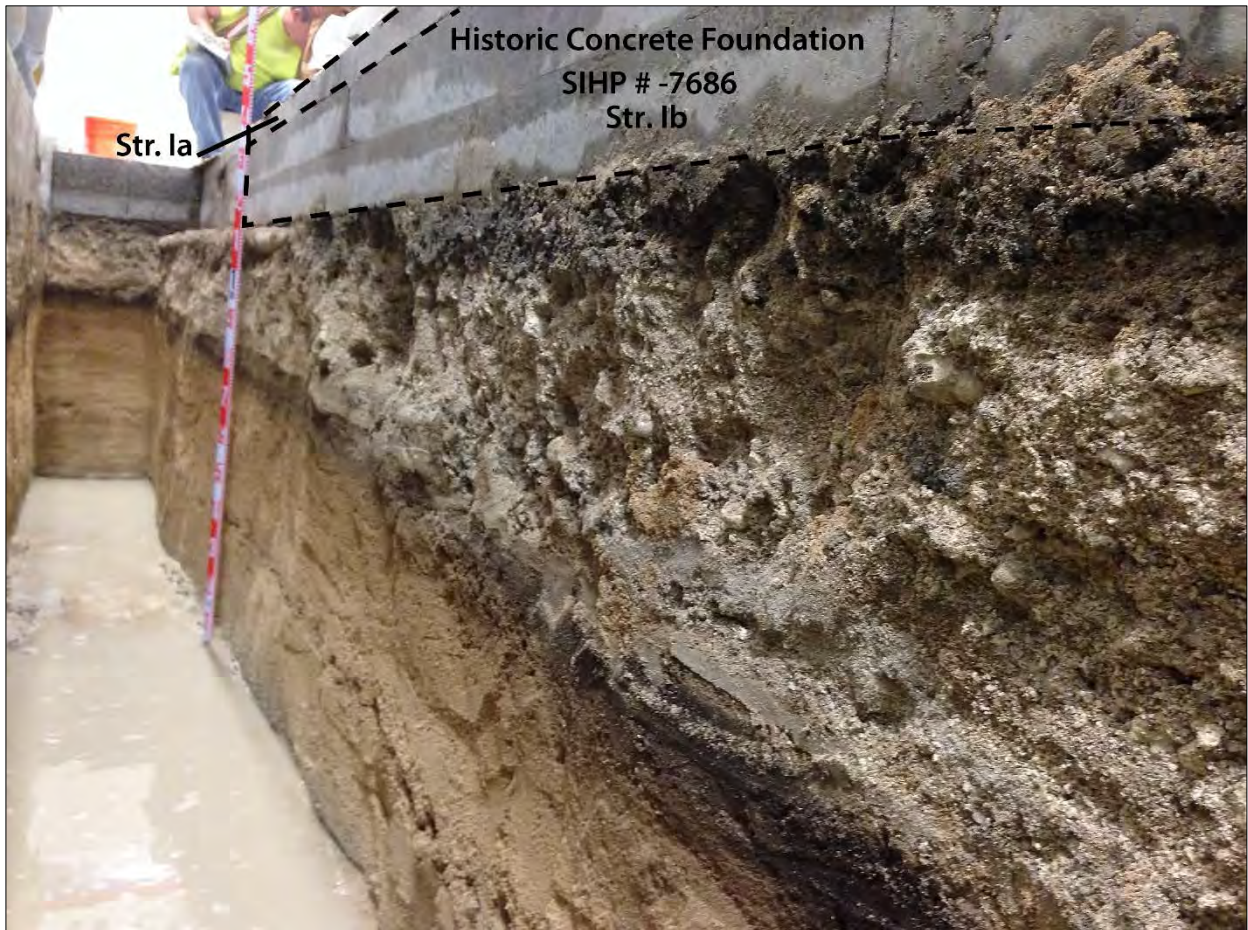
Figure 118. Photograph of T-17, showing a historic concrete foundation (SIHP # -7686) underlying the Stratum Ia modern surface, view to northeast

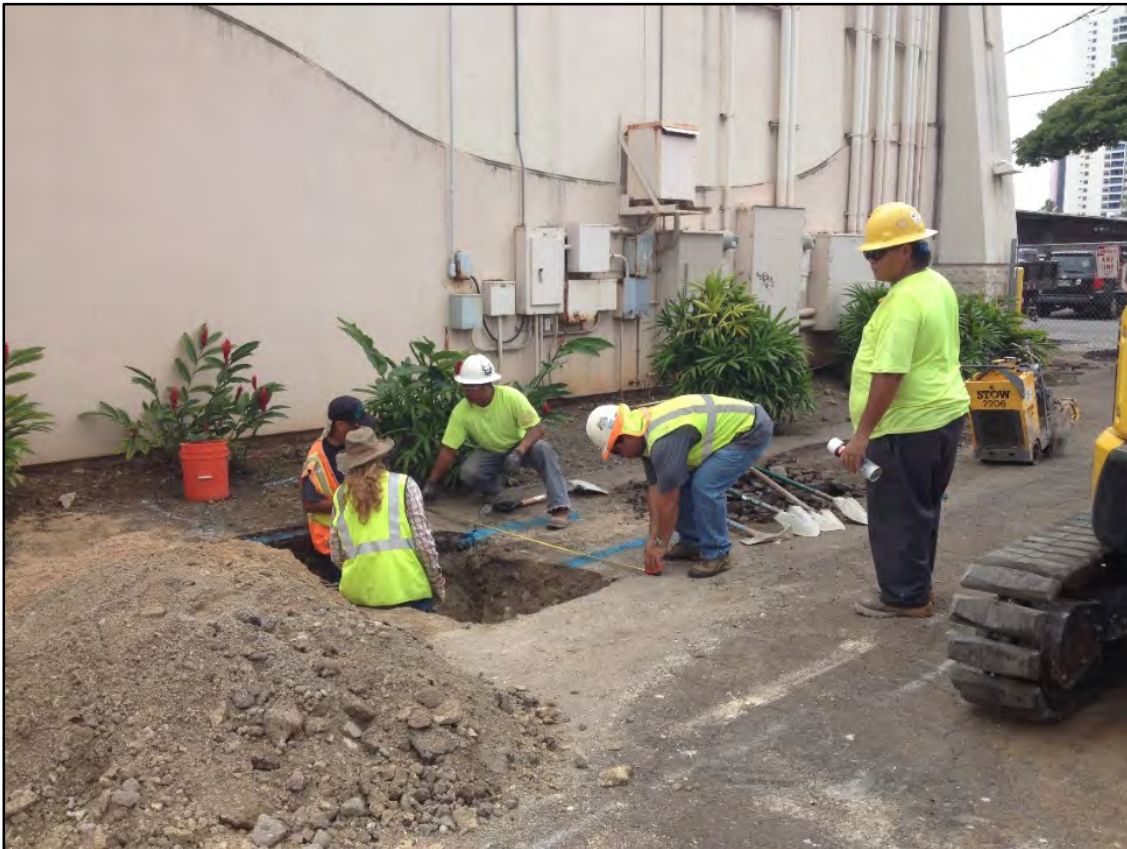
Figure 120. Location of T-18 in relation to the spatial limitations, view to west

Test Excavation 18 (T-18), an exterior excavation located northeast (*mauka*) of the Office Depot building along Queen Street, was oriented northeast-southwest, and measured 1.95 m long by 1.0 m wide. The base of excavation was determined by spatial constraints and a seeping sewer pipe at a depth of 1.1 mbs. The size and location of T-18 was limited by the Office Depot building directly southwest (*makai*), utility lines extending parallel to the building, the property boundary, and a utility corridor to the northeast (*mauka*) (Figure 120). The stratigraphy of T-18 consisted of the asphalt surface (Stratum Ia) and associated base course (Stratum Ib) overlying 1919–1927 Kaka'ako reclamation fill deposits consisting of coarse sand (crushed coral) (Stratum IIa) and hydraulic (dredge) clay sand (Stratum IIb) overlying a disturbed natural loamy sand A horizon (Stratum IIIa) and Jaucas sand (Stratum IIIb) (Figure 121 and Figure 122, and Table 21). Two utility lines with associated utility fill were documented running perpendicular through T-18, which resulted in the truncation of both the imported fill and natural deposits (see Figure 121).

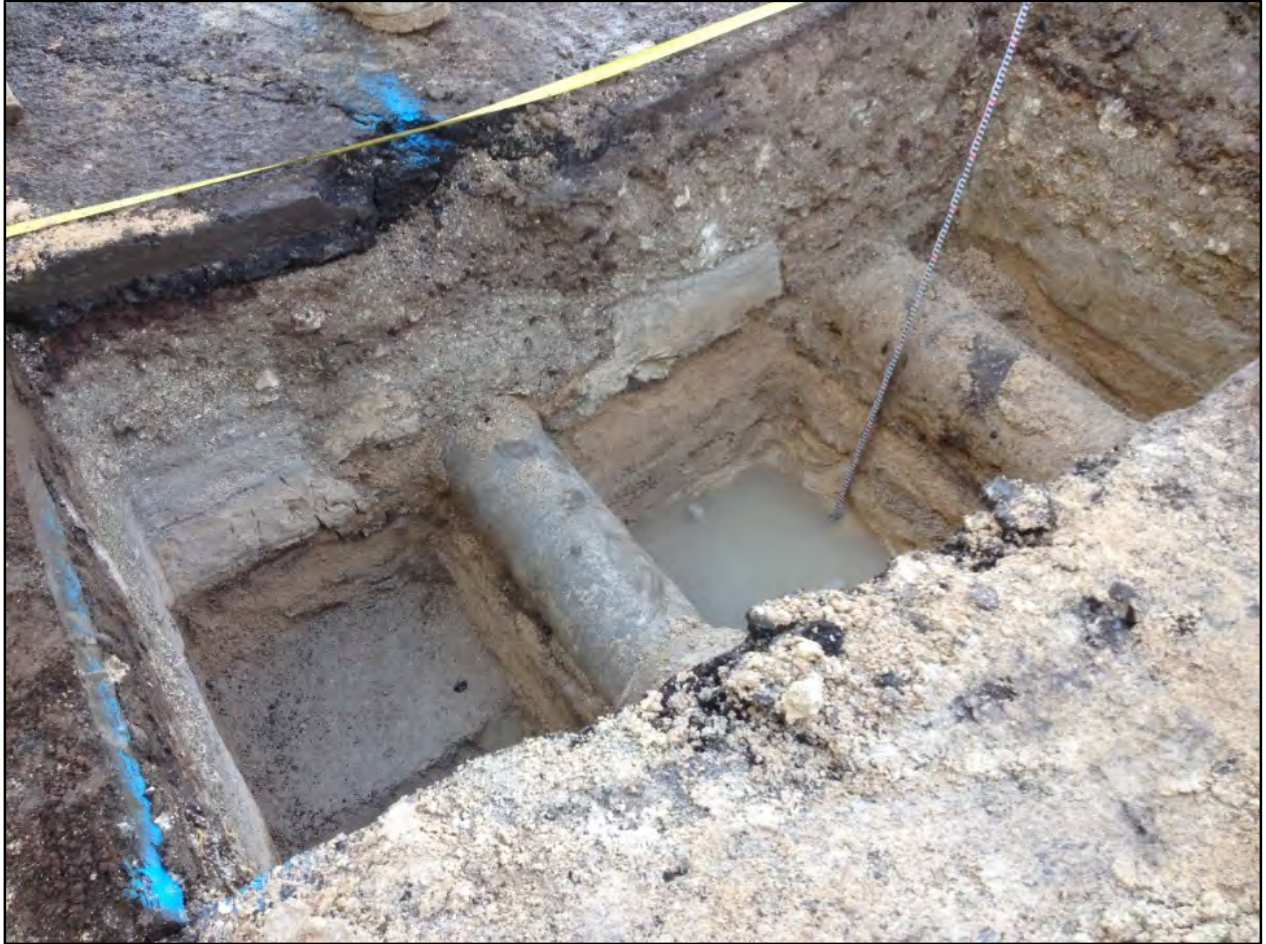
Figure 121. Photograph of T-18 northwest wall, view to north

T-18 documented the remnant of a previously disturbed, culturally sterile A horizon (Stratum IIIa). The A horizon consisted of dark loamy sand which was heavily truncated most likely during the installation of a utility corridor. A 10-gallon screen of the A horizon yielded no cultural material.

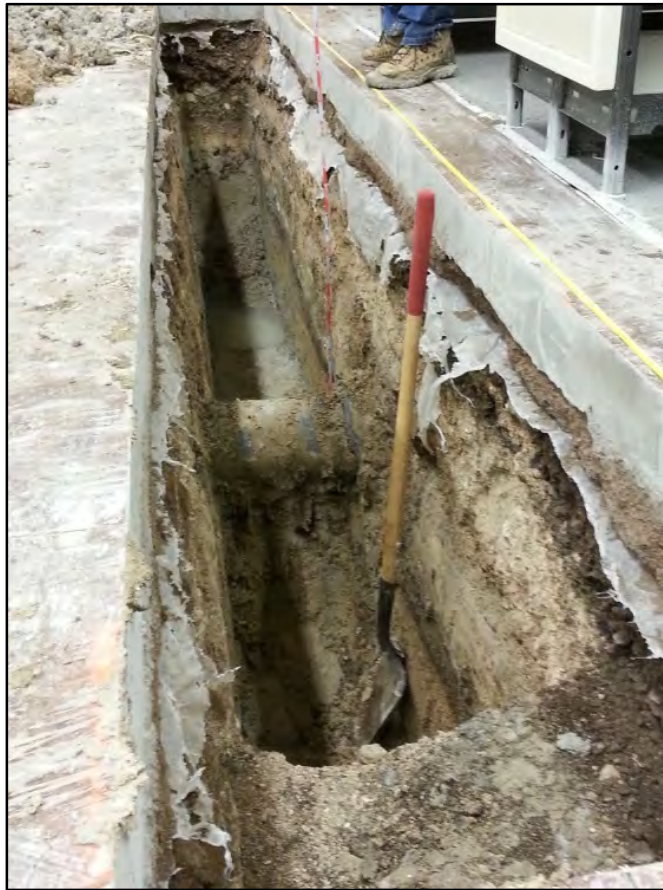
Figure 123. T-19 southwest wall, view to south

Test Excavation 19 (T-19), an interior excavation located within the former Nordstrom Rack building, was oriented southeast-northwest and measured 6.1 m long by 0.6 m wide. The base of excavation was determined by the presence of the hard coral shelf at 1.68 mbs. The stratigraphy of T-19 consisted of the current concrete surface (Stratum Ia) overlying gravelly sand with a visqueen barrier (Stratum Ib), associated base course (Stratum Ic), and sandy loam fill (Stratum Ie), overlying 1919–1927 Kaka'ako reclamation fill deposits consisting of gravelly sand (crushed coral) (Stratum IIa) and hydraulic (dredge) clay (Stratum IIb), overlying a natural clay sand A horizon (Stratum IIIa) and two clay sand wetland deposits (Strata IIIb and IV) (Figure 123 through Figure 125, and Table 22). A concrete utility jacket overlain by extremely gravelly sandy loam utility fill (Stratum Id) was located at the southern end of the test excavation.

T-19 did not contain any buried commercial infrastructure remnants such as those seen in nearby interior test excavations. This is consistent with historic aerial photographs and maps which show a gap between two warehouses in this area. The general stratigraphy documented within T-19 was otherwise similar, consisting of 1919–1927 Kaka'ako reclamation fill deposits (Strata IIa–IIb) overlying a natural, culturally sterile, peaty A horizon (Stratum IIIa) developed within wetland clay sand (Stratum IIIb).

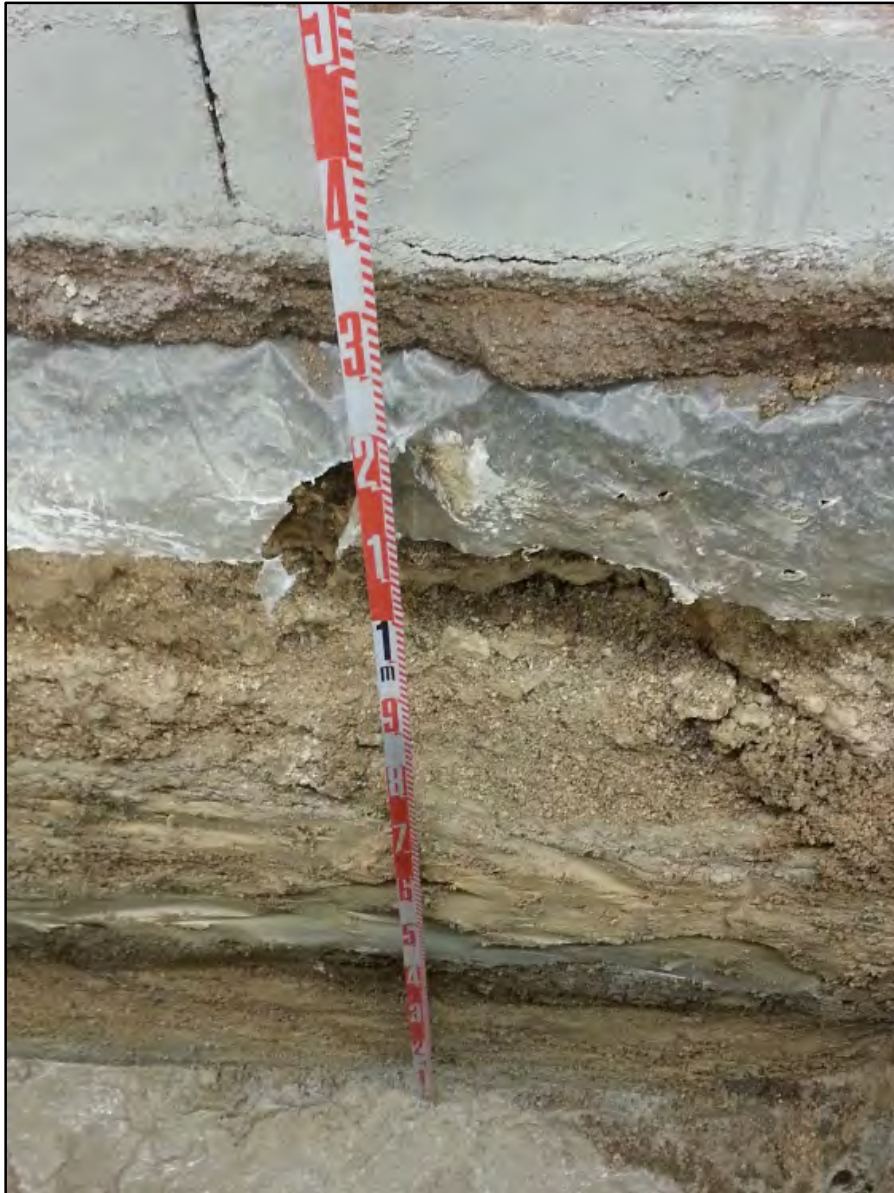
Figure 124. Close-up of T-19 stratigraphy, southwest wall, view to southwest

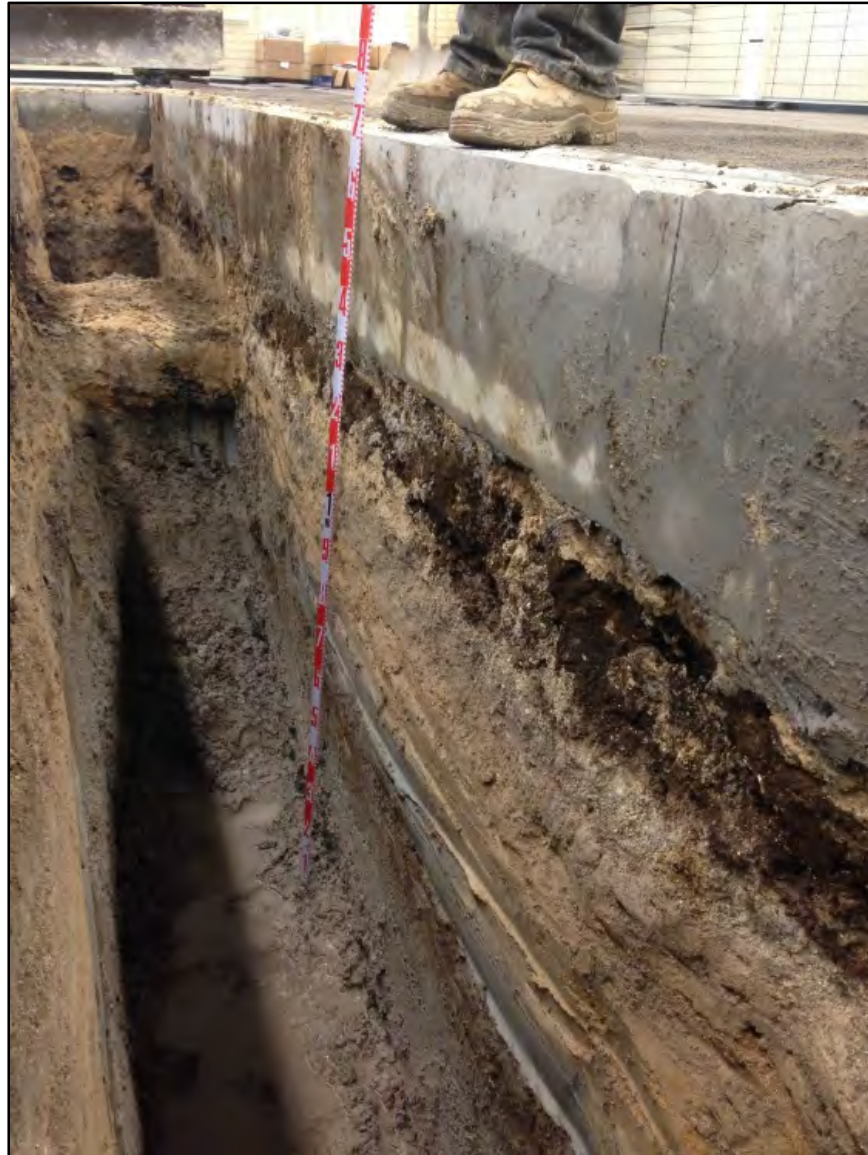
Figure 127. T-20 southwest wall, view to south

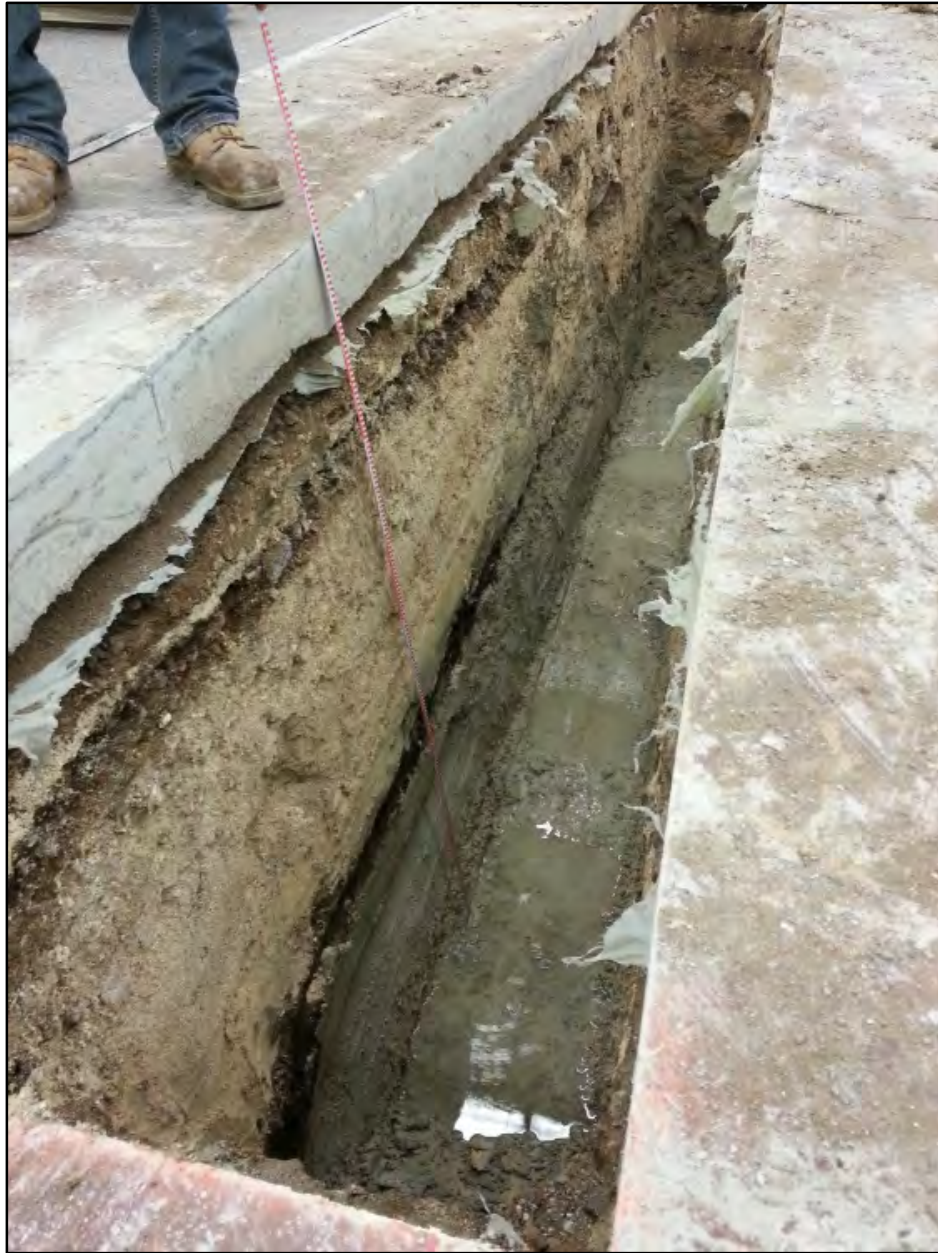
Figure 130. T-21 north wall, view to north

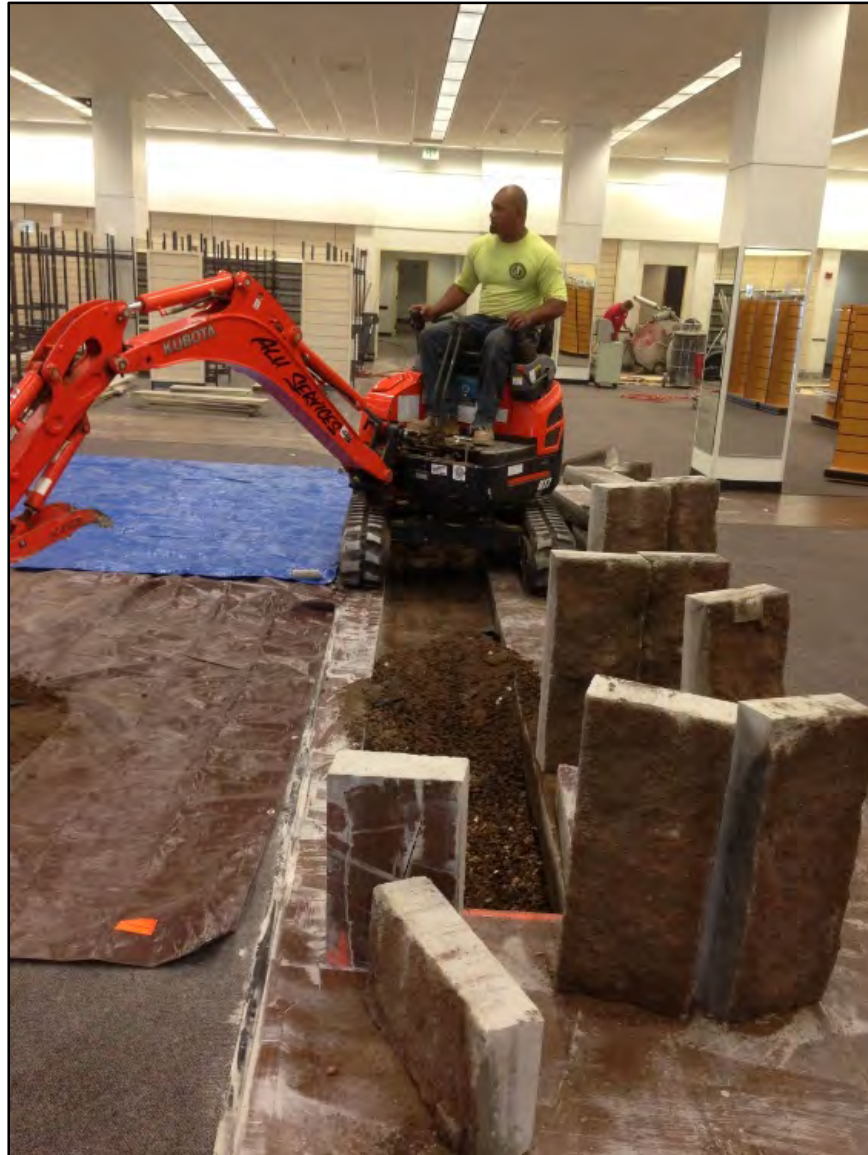
Figure 132. Location of T-22 within interior commercial space, view to northwest

Test Excavation 22 (T-22), an interior excavation located within the former Nordstrom Rack building, was oriented northeast-southwest and measured 6.2 m long by 0.6 m wide (Figure 132). The base of excavation was determined by the presence of the hard coral shelf at 1.63 mbs. The stratigraphy of T-22 consisted of the current concrete surface (Stratum Ia) overlying a visqueen barrier and associated base course fill (Stratum Ib), extremely gravelly silty loam (Stratum Ic), and extremely gravelly silty loam fill (Stratum Id) overlying 1919–1927 Kaka'ako reclamation fill deposits consisting of very gravelly sand (crushed coral) (Stratum IIa) and hydraulic (dredge) clay (Stratum IIb), overlying a redeposited marine sandy clay (Stratum III), overlying a natural sandy clay A horizon (Stratum IVa), an organic rich gravelly sandy clay (Stratum IVb), and a marine sand deposit (Stratum V) (Figure 133 and Figure 134, and Table 25). Two utility pipes were observed in the northern end of the trench and as a result the surrounding material was not excavated.

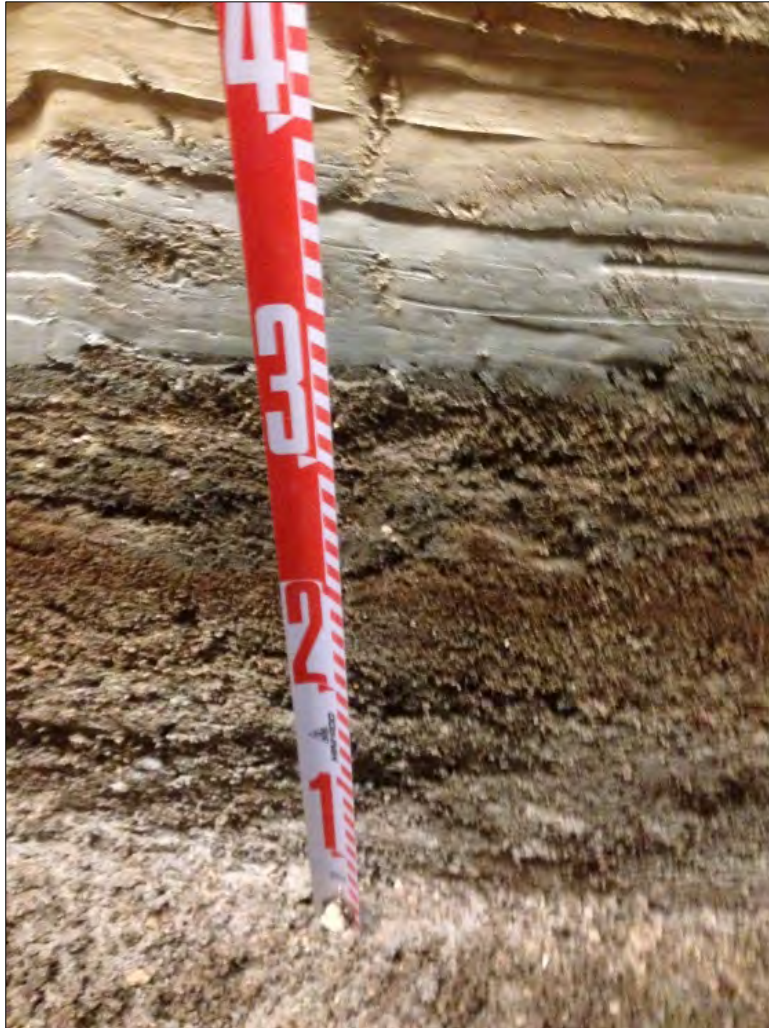
Figure 135. Close-up of Strata IVa and IVb underlying hydraulic dredge clay fill (Stratum IIb)

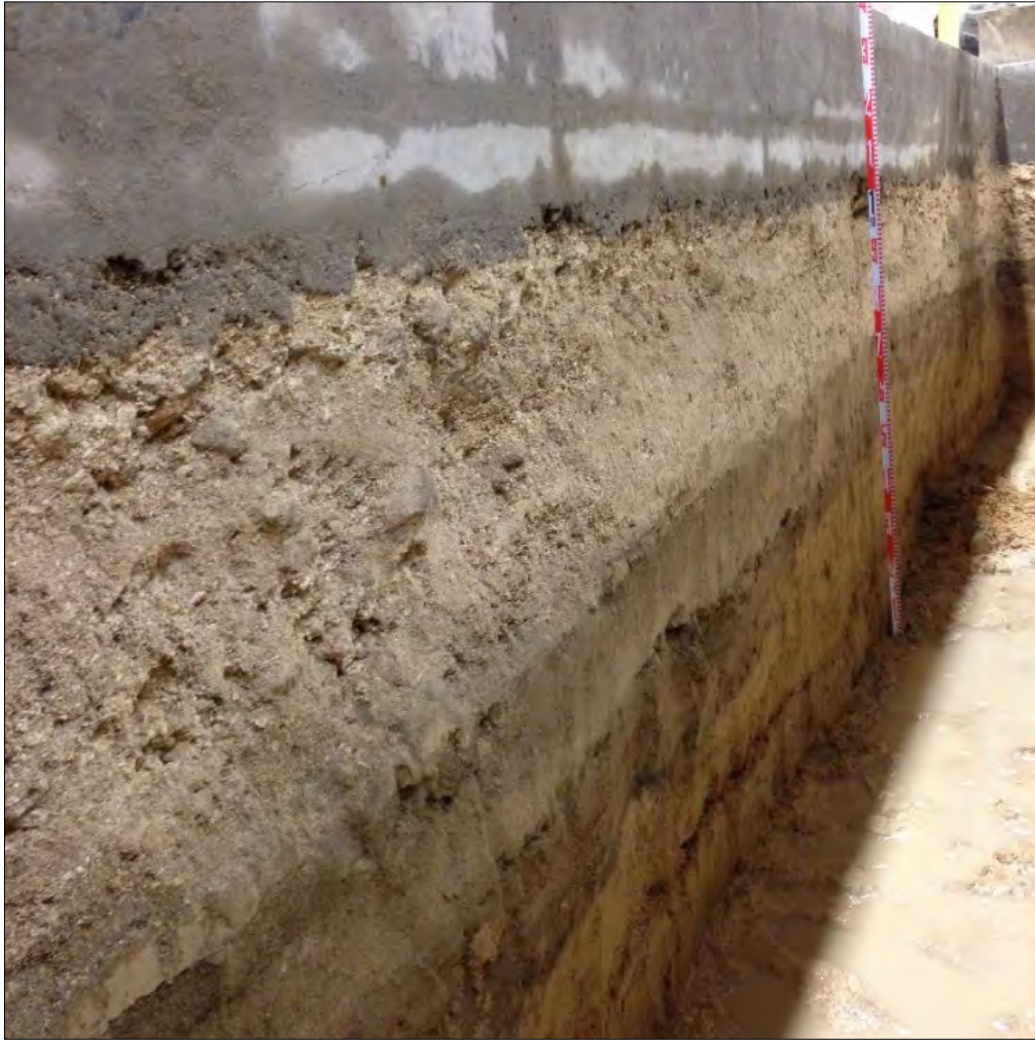
Figure 136. Location of T-23 within interior commercial space, showing removal of the current concrete surface and the thicker buried concrete surface (SIHP # -7686), view to southwest

Test Excavation 23 (T-23), an interior excavation located within the Office Depot building, was oriented northeast-southwest and measured 6.1 m long by 0.6 m wide (Figure 136). The base of excavation was determined by the presence of the water table at 1.41 mbs. The stratigraphy of T-23 consisted of the current concrete with laminate tile surface (Stratum Ia) overlying a buried concrete surface (Stratum Ib), overlying 1919–1927 Kaka‘ako reclamation fill deposits consisting of very gravelly sand (crushed coral) (Stratum IIa) and hydraulic (dredge) silty sand (Stratum IIb) overlying a redeposited, locally procured sand (Stratum III), overlying a natural loamy sand A horizon (Stratum IVa), Jaucas sand (Stratum IVb), indurated sand (Stratum V), sandy clay (Stratum VI), and marine sand clay (Stratum VII) (Figure 137 and Figure 139, and Table 26).

T-23 documented remnants of a commercial warehouse foundation, considered part of SIHP # -7686 (Figure 138). The warehouse remnants consisted of a buried concrete surface (Stratum Ib), which extended across the length of the test excavation. The current commercial building surface (Stratum Ia) was constructed directly over top this earlier commercial surface.

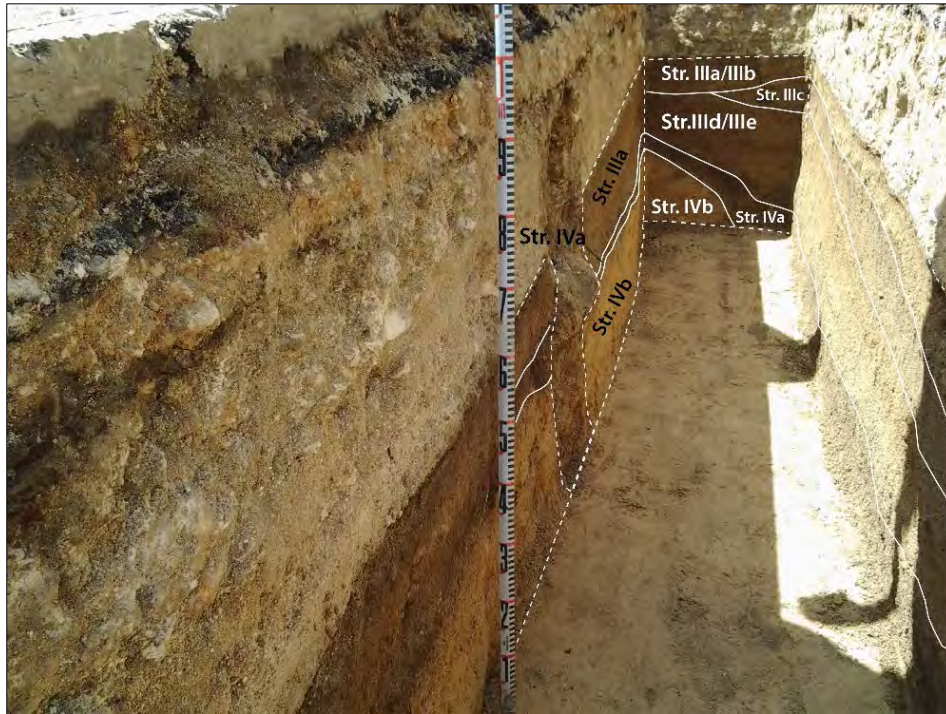
Figure 152. T-26 southeast wall, view to southeast

The stratigraphy of the southeast wall consisted of the asphalt surface (Stratum Ia) and associated base course material (Stratum IIb) overlying a layer of subsurface asphalt (Stratum Id) and sandy loam fill (Stratum Ie), overlying a 1919–1927 Kaka‘ako reclamation fill deposit consisting of gravelly sand grading to sandy clay loam (Stratum II), overlying a redeposited, locally procured sandy loam (Stratum IIIa), overlying a natural loamy sand A horizon (Stratum IVa), Jaucas sand (Stratum IVb), and a gravelly clay sand wetland deposit (Stratum V) (Figure 152 through Figure 154, and Figure 157). This sequence is typical of the surrounding area.

The stratigraphy of the northwest wall differed from the southeast wall due to the natural downward slope of the A horizon and Jaucas sand, which descended approximately 50 cm from the southeast wall to the northwest wall (see Figure 152 and Figure 158). To in-fill this lower lying area, several additional layers of sandy loam fill were deposited below Stratum IIIa (Strata IIIb–IIIe) (Figure 158 and Figure 159, and Table 29).
