Draft
Archaeological Inventory Survey Report for the
Block M Project, Kaka‘ako,
Honolulu Ahupua‘a, Honolulu (Kona) District, O‘ahu
TMK: [1] 2-3-002:001 (portion)

Prepared for
Victoria Ward Limited/Howard Hughes Corporation

Cultural Surveys Hawai‘i, Inc.
Kailua, Hawai‘i
(Job Code: KAKAAKO 122)

September 2014

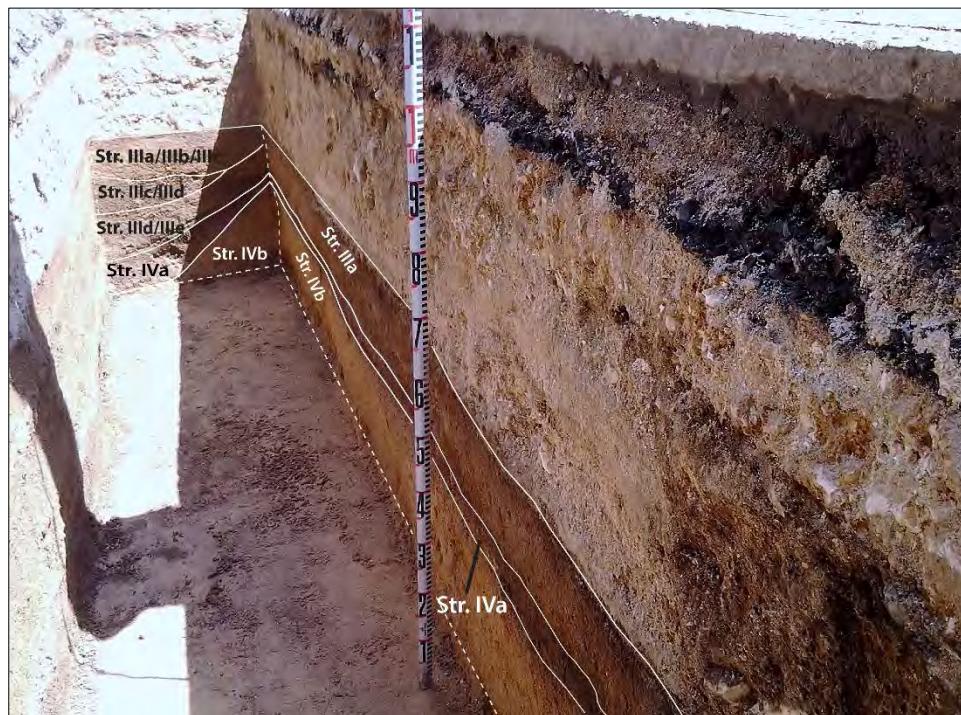
Figure 153. T-26 southeast and southwest walls, strata and disturbance fill on southeast wall, view to south

The stratigraphy of the southeast wall consisted of the asphalt surface (Stratum Ia) and associated base course material (Stratum IIb) overlying a layer of subsurface asphalt (Stratum Id) and sandy loam fill (Stratum Ie), overlying a 1919–1927 Kaka‘ako reclamation fill deposit consisting of gravelly sand grading to sandy clay loam (Stratum II), overlying a redeposited, locally procured sandy loam (Stratum IIIa), overlying a natural loamy sand A horizon (Stratum IVa), Jaucas sand (Stratum IVb), and a gravelly clay sand wetland deposit (Stratum V) (Figure 152 through Figure 154, and Figure 157). This sequence is typical of the surrounding area.

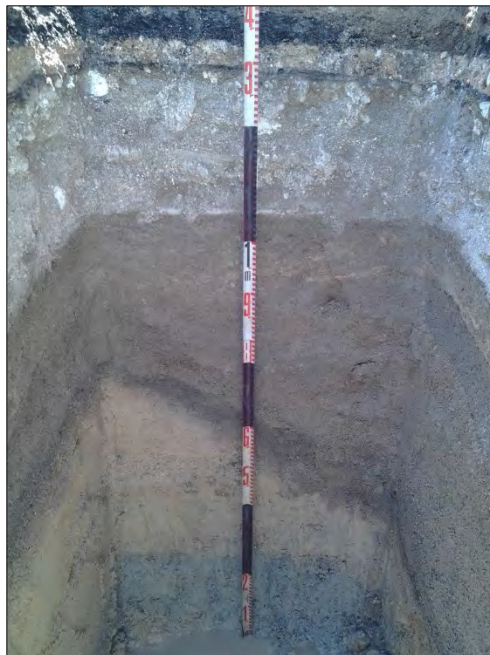
Figure 154. T-26 northeast and southeast walls, view to east

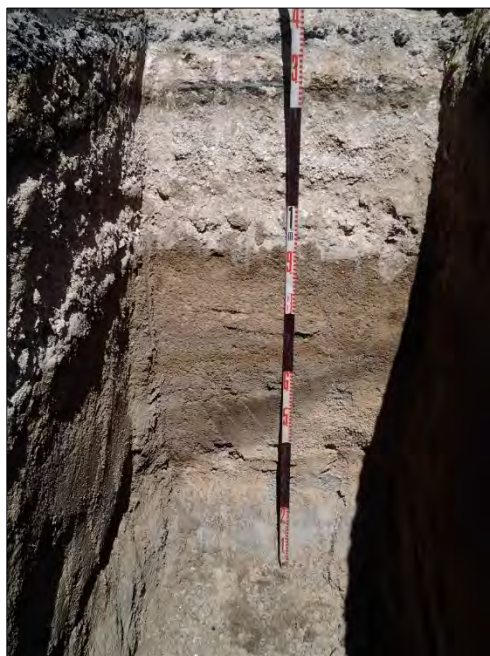
Figure 155. Close-up of southwest wall, showing a sloping sand dune (Stratum IVb) overlain by a dark, in situ A horizon (Stratum IVa) and several layers of lomy sand fill (Strata IIIa–IIIe), view to southwest

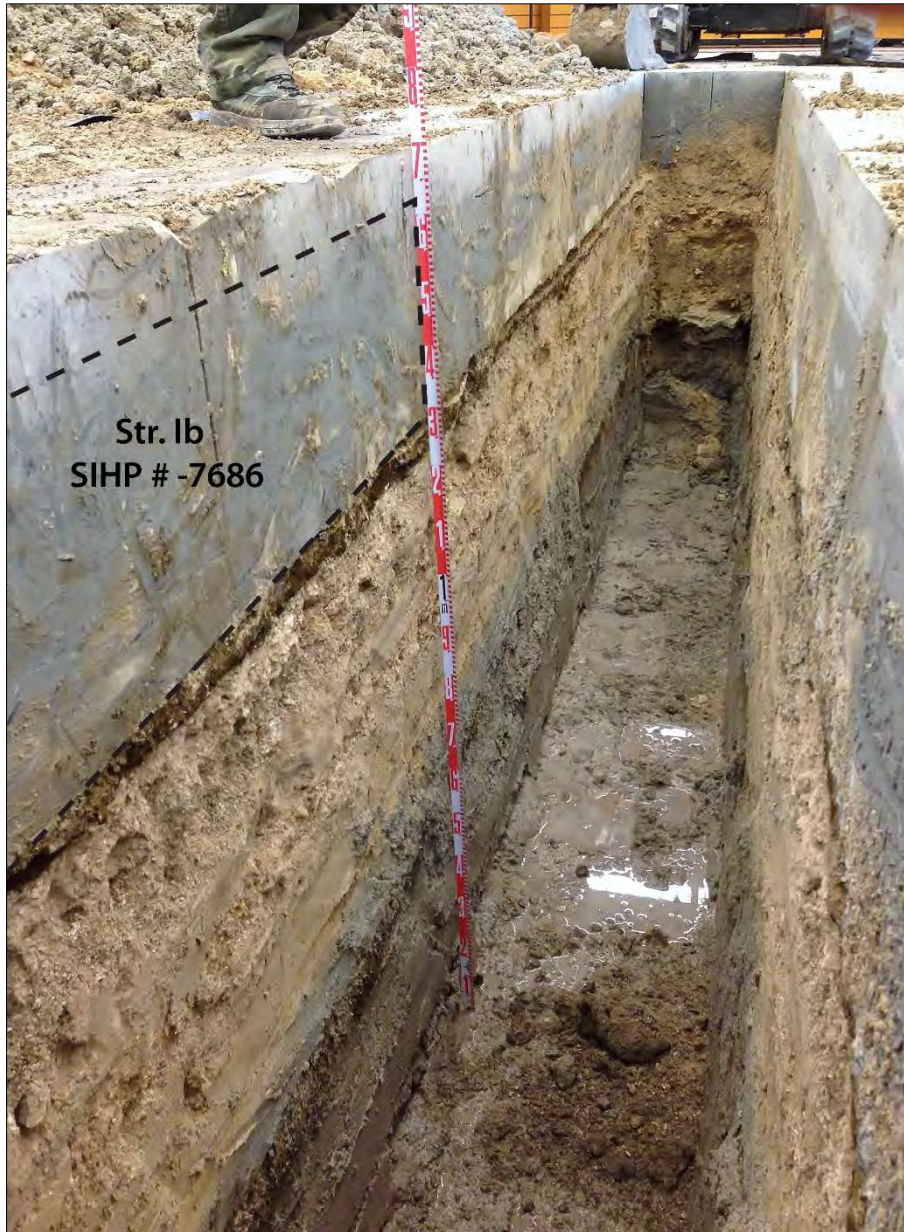
Figure 160. Location of T-27 within interior commercial space, showing removal of the current concrete surface and the thicker buried concrete surface (SIHP # -7686), view to southwest

T-27 had a similar stratigraphic sequence as T-20. Directly beneath the current commercial floor, remnants of a commercial warehouse foundation were identified, considered part of SIHP # - 7686. The warehouse remnants consisted of a buried concrete surface (Stratum Ib) and associated base course (Stratum Ic). Located beneath the commercial warehouse remnants were 1917–1926 Kaka‘ako land reclamation fill deposits. The underlying natural stratigraphic deposits consisted of a culturally sterile, peaty A horizon (Stratum IIIa) developed within a wetland environment (Stratum IIIb) (Figure 163). The upper boundary of Stratum IIIa was truncated by previous ground disturbance activities; however, no other disturbances were observed.

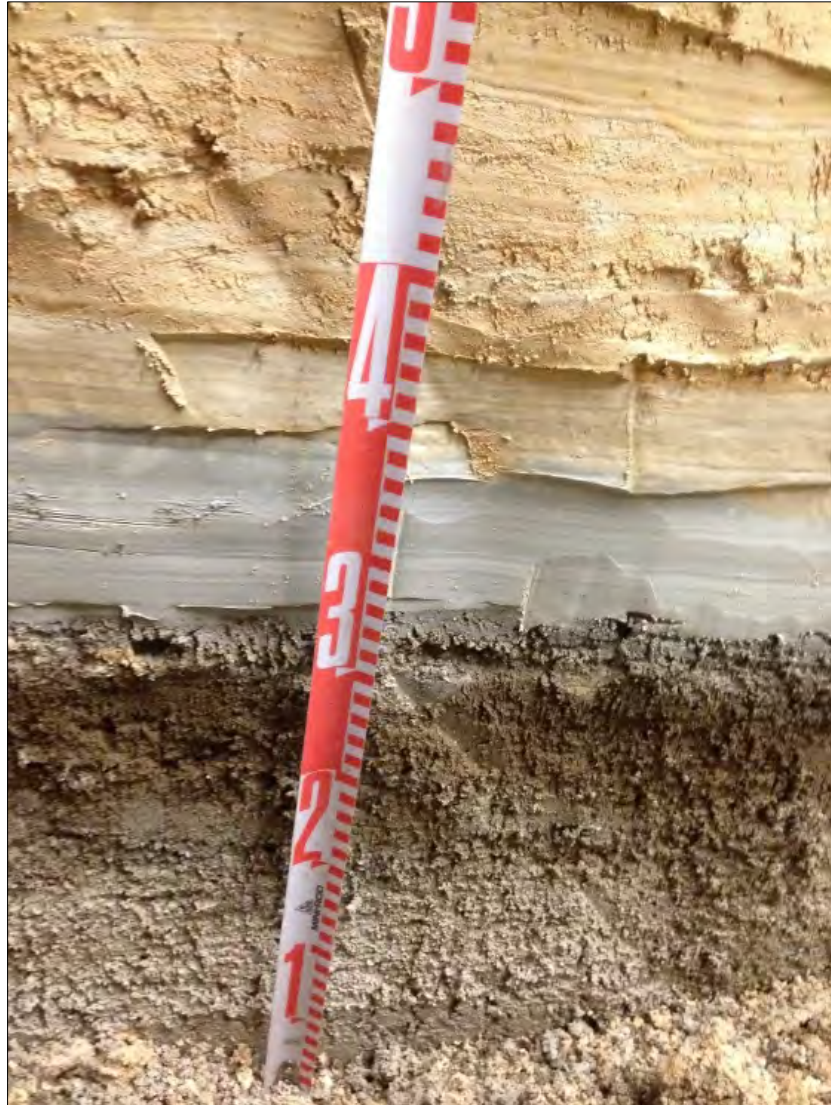
Figure 163. Close-up showing Stratum IIIa wetland A horizon developed within Stratum IIIb wetland sandy clay

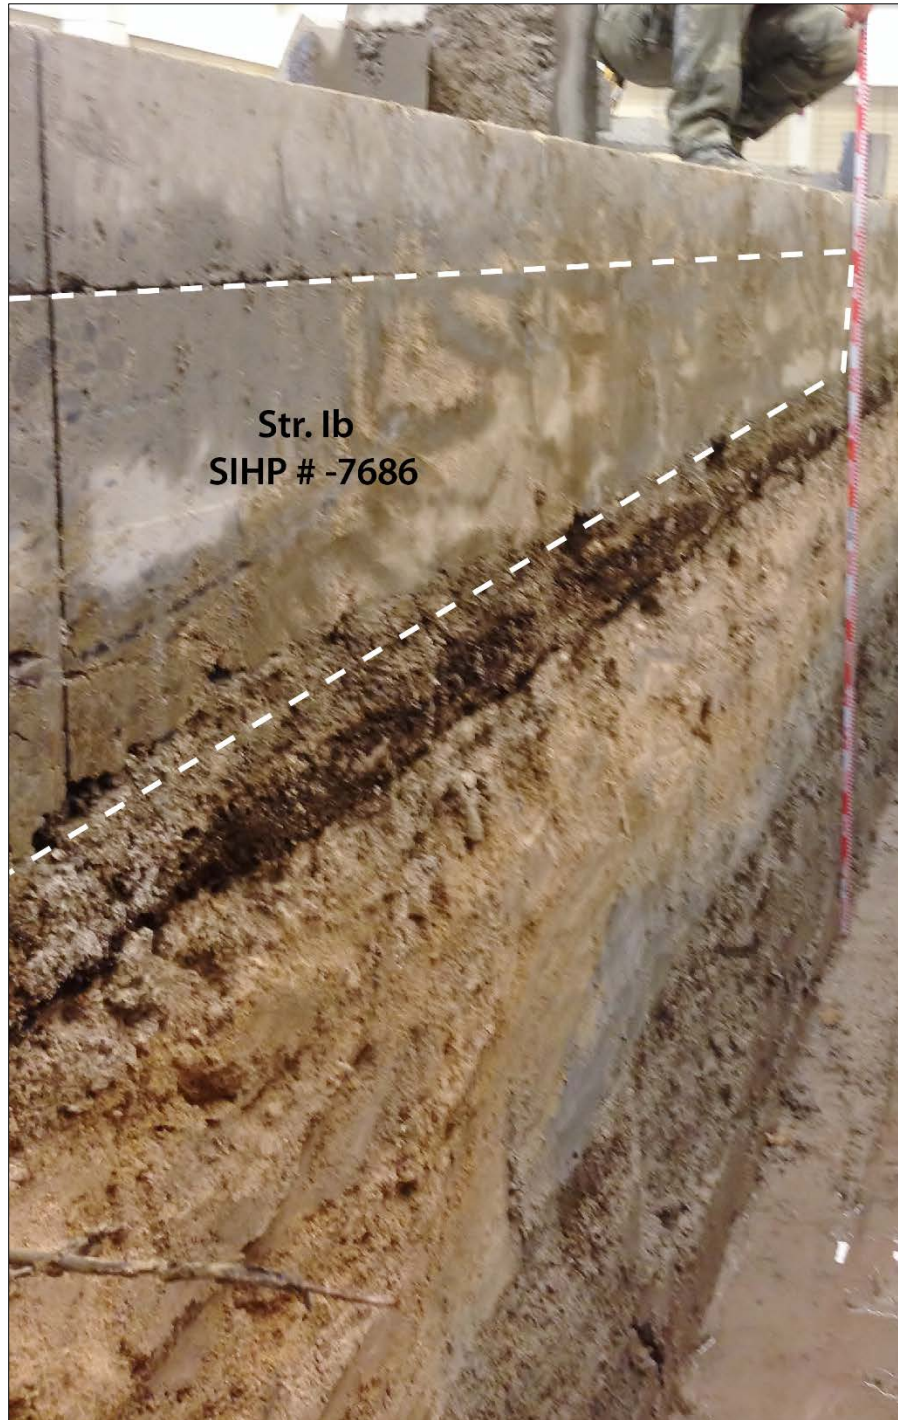
Figure 165. T-28 southeast wall, view to south

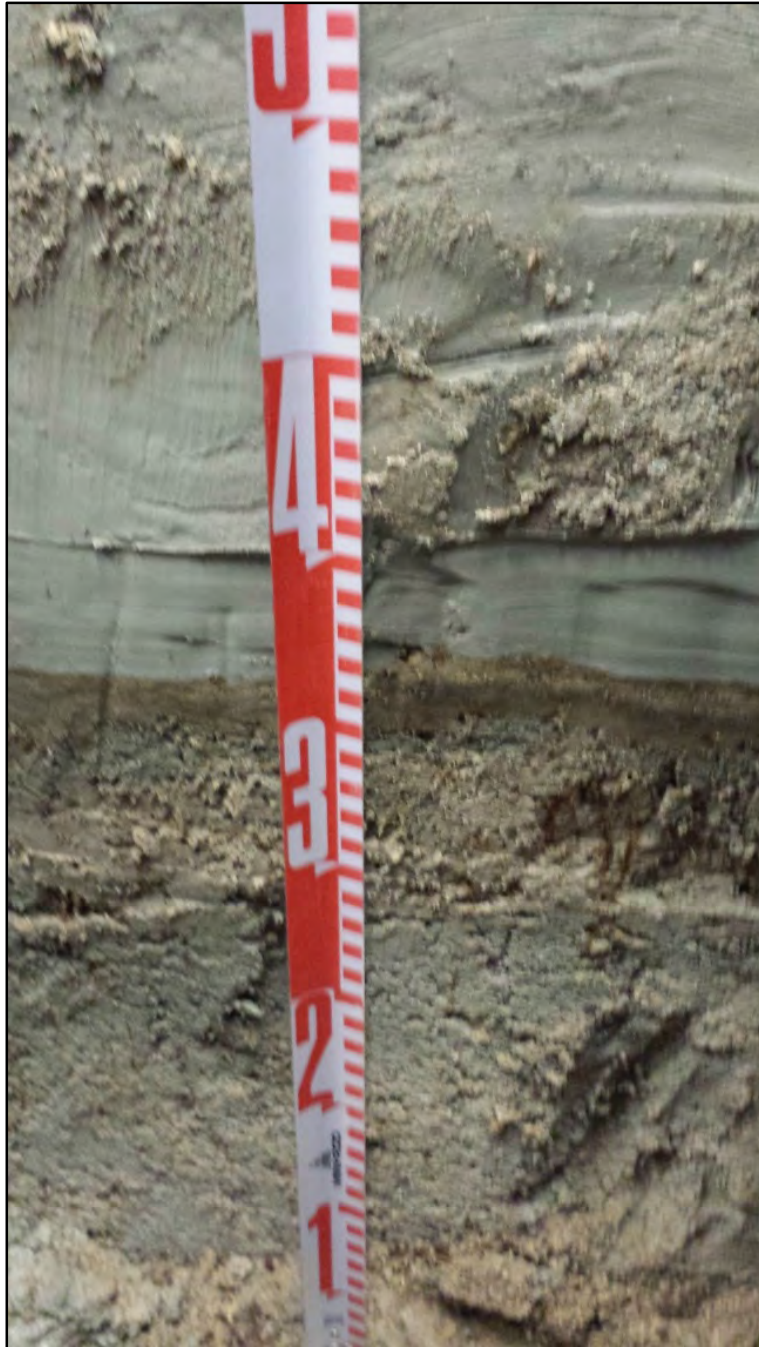
Figure 186. T-33 southeast sidewall, view to east

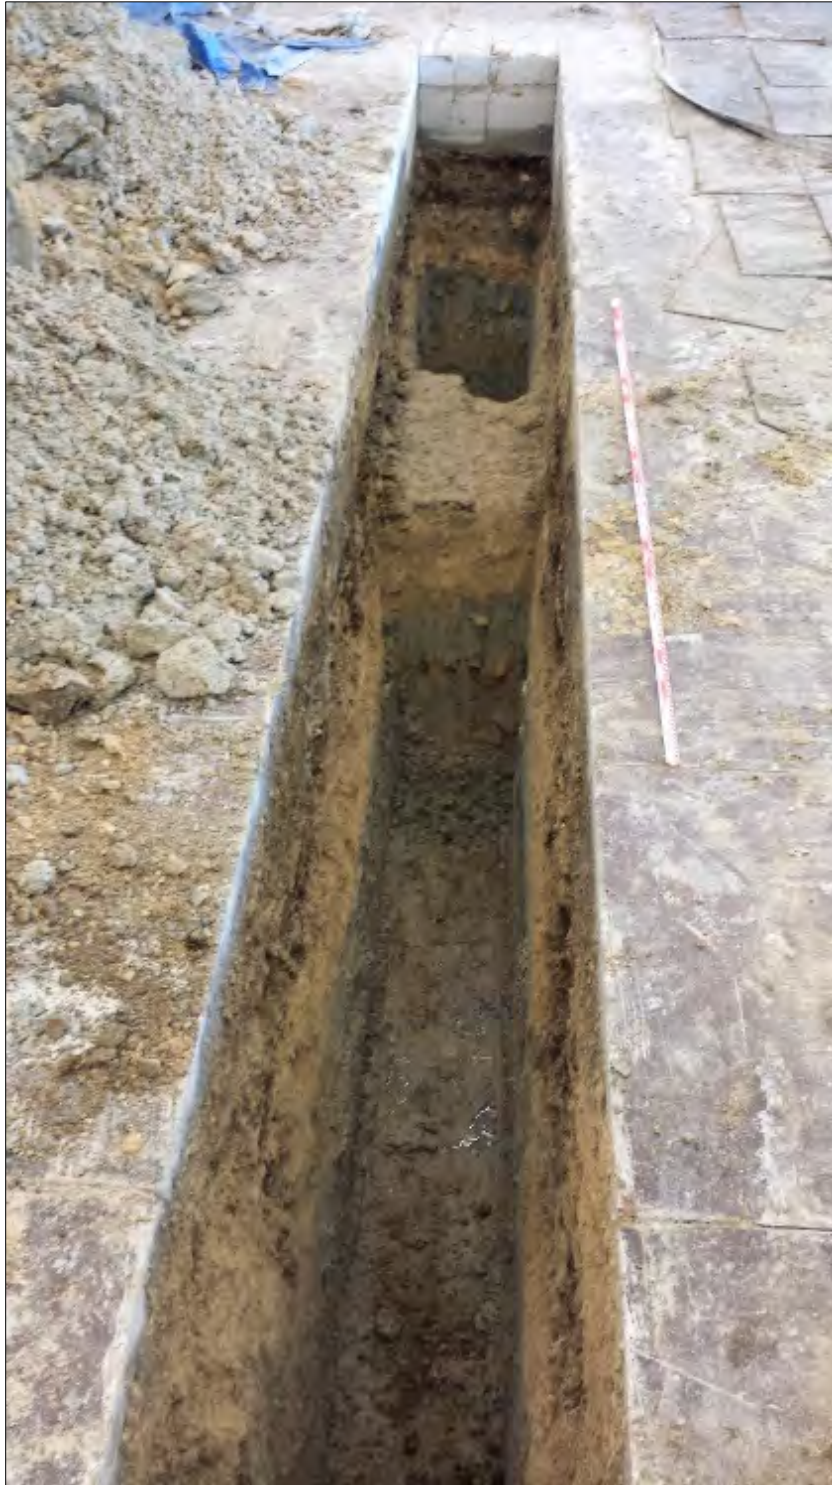
Figure 187. Close-up of gray pump dredge fill (Stratum IIb) overlying a dark organic-rich A horizon (Stratum IIIa) and marine sand (Stratum IIIb)

Similar to T-32, T-33 documented remnants of a commercial warehouse foundation, considered part of SIHP # -7686. The warehouse remnants consisted of a buried concrete surface (Stratum Ib) and associated base course (Stratum Ic) directly underlying the current commercial floor. Located beneath the commercial warehouse remnants were a 1917–1926 Kaka'ako land reclamation fill deposits (Strata IIa–IIb). The underlying natural stratigraphic deposits consisted of a culturally sterile, peaty A horizon (Stratum IIIa) developed within the upper boundary of a sandy wetland environment (Stratum IIIb) (see Figure 187).

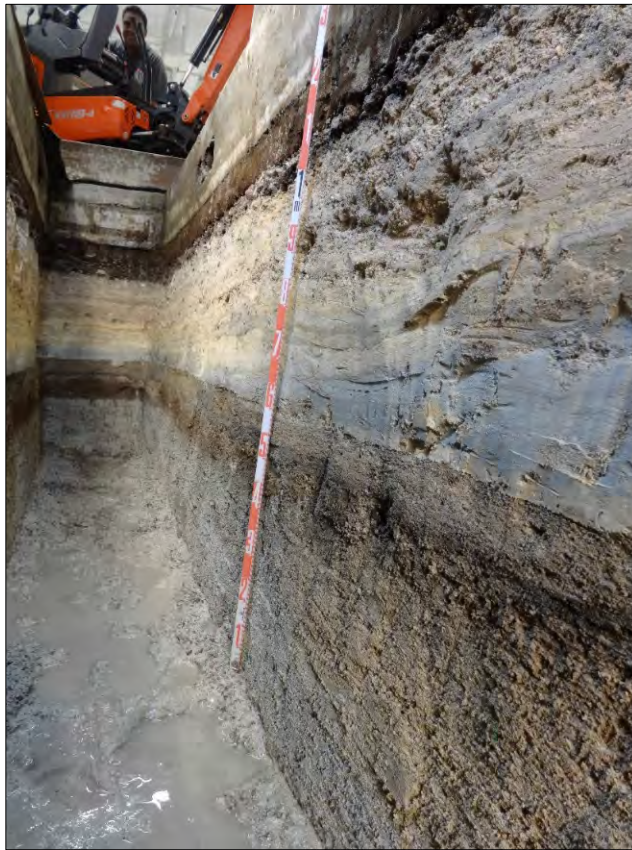
Figure 190. Location of T-34 within interior commercial space, view to west

Test Excavation 34 (T-34), an interior excavation located within the Office Depot building was oriented northeast-southwest and measured 6.1 m long by 0.6 m wide (Figure 190). The base of excavation was determined by the presence of the water table at 1.63 mbs. The stratigraphy of T-34 consisted of concrete with laminated tile surface (Stratum Ia) overlying a buried concrete surface (Stratum Ib), mixed loam and cinder (Stratum Ic), and base course fill (Stratum Id), overlying 1919–1927 Kaka'ako reclamation fill deposits consisting of very gravelly sand (crushed coral) with pockets of clay (Stratum IIa) and hydraulic (dredge) clay (Stratum IIb), overlying a redeposited, locally procured loamy sand (Stratum III), overlying an organic rich sandy clay A horizon (Stratum IVa) developed within a wetland sandy clay (Stratum IVb) (Figure 191 and Figure 192, and Table 37).

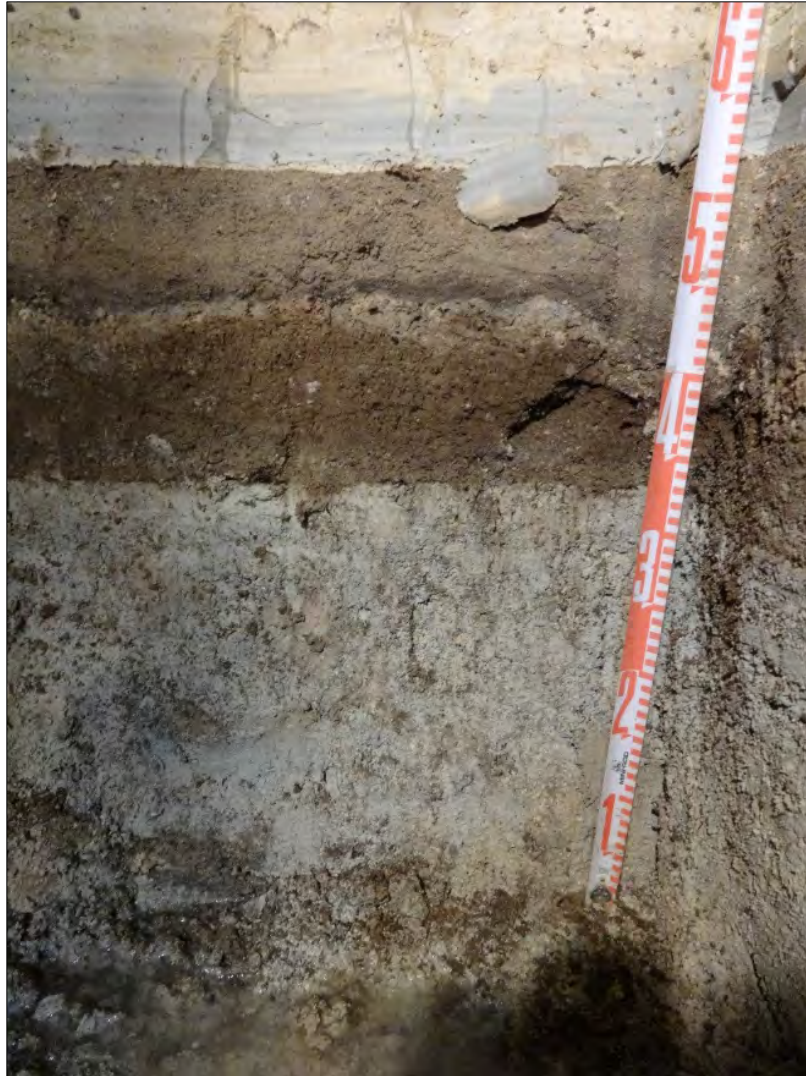
Figure 193. T-34 northeast wall, close-up of hydraulic clay (Stratum IIb) overlying fill sand (Stratum III) and an organic wetland A horizon (Stratum IVa) with a very abrupt contact with the underlying wetland clay sand (Stratum IVb), view to northeast

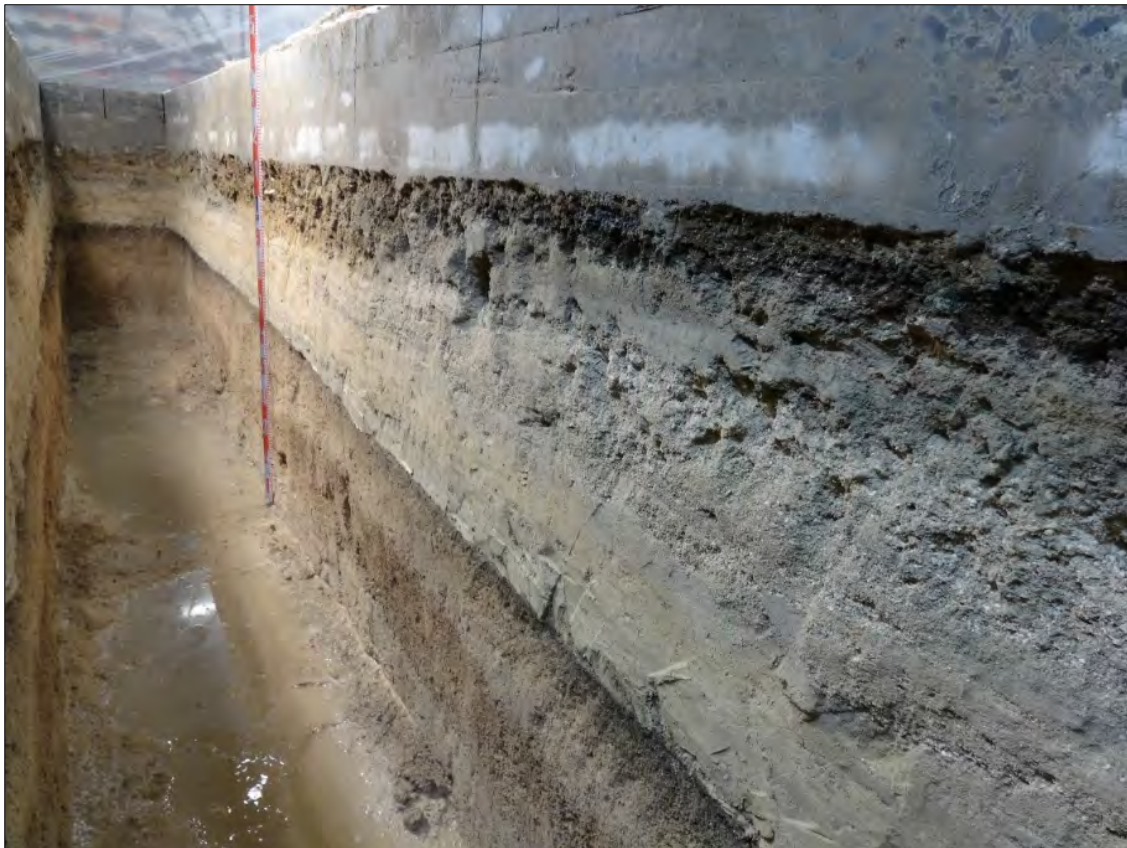
Figure 194. T-35 southeast wall, view to north

Test Excavation 35 (T-35), an interior excavation located within the Office Depot building, was oriented northeast-southwest and measured 6.1 m long by 0.7 m wide. The base of excavation was determined by the presence of the water table at 1.44 mbs. The stratigraphy of T-35 consisted of concrete with laminated tile surface (Stratum Ia) overlying a buried concrete surface (Stratum Ib) and gravelly loamy sand fill (Stratum Ic), overlying 1917–1927 Kaka'ako reclamation fill consisting of hydraulic very fine sand (Stratum II), overlying a natural loamy sand A horizon (Stratum IIIa), Jaucas sand (Stratum IIIb), a marine sand (Stratum IV), and loamy sand (Stratum V) (Figure 194 and Figure 195, and Table 38).

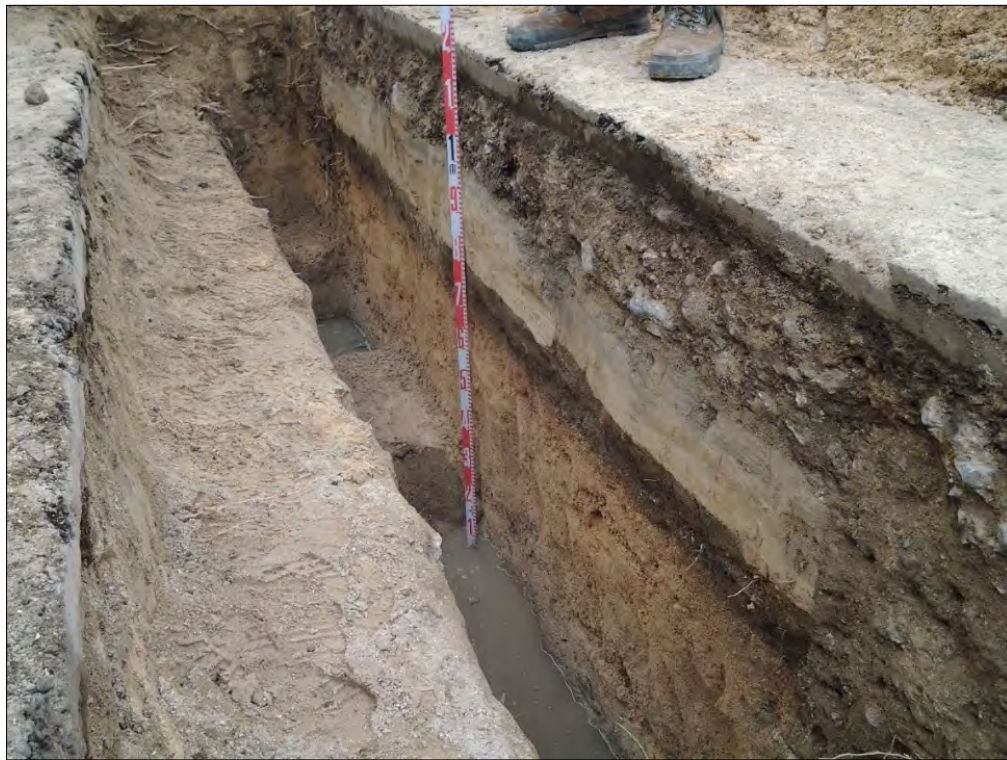
Figure 196. T-36 north wall, view to northwest

Test Excavation 36 (T-36), an exterior excavation located along Queen Street near the entrance to the Office Depot building, was oriented northwest-southeast and measured 6.1 m long by 0.7 m wide. The base of excavation was determined by the presence of the hard coral shelf at 1.30 mbs. The stratigraphy of T-36 consisted of the asphalt surface (Stratum Ia) and associated base course (Stratum Ib), overlying a 1919–1927 Kaka'ako reclamation fill deposit consisting of hydraulic (dredge) very fine sandy clay (Stratum II), overlying a redeposited, locally procured loamy sand (Stratum III), a natural sandy loam A horizon (Stratum IVa), Jaucas sand (Stratum IVb), a clay sandy wetland deposit (Stratum V), and a sand wetland deposit (Stratum VI) (Figure 196, Figure 197, Figure 199, and Table 39). A utility line was encountered at 0.45 mbs running parallel with the south (*makai*) wall; as a result, the south wall was benched and the surrounding material was not excavated (Figure 198). Additionally, two utility pits were observed truncating Strata II–IVb on the northeast wall (see Figure 199).

T-36 documented historic fill deposits (Strata II, III) over a disturbed, natural A horizon developed within Jaucas sand. Stratum III consisted of loamy sand that likely consisted of redeposited, locally procured sediment deposited to level and/or build up the ground surface and which served as a historic land surface for a period of time prior to reclamation activities. The in situ A horizon (Stratum IVa) was a culturally sterile, truncated, sandy loam A horizon. The A horizon was absent within the southwest (*makai*) wall due to the installation of a utility pipe. Fine to medium-sized roots were observed in Stratum IIIa, however, more roots were observed within the utility fill on the north wall, most likely as a result of the nearby palm trees.

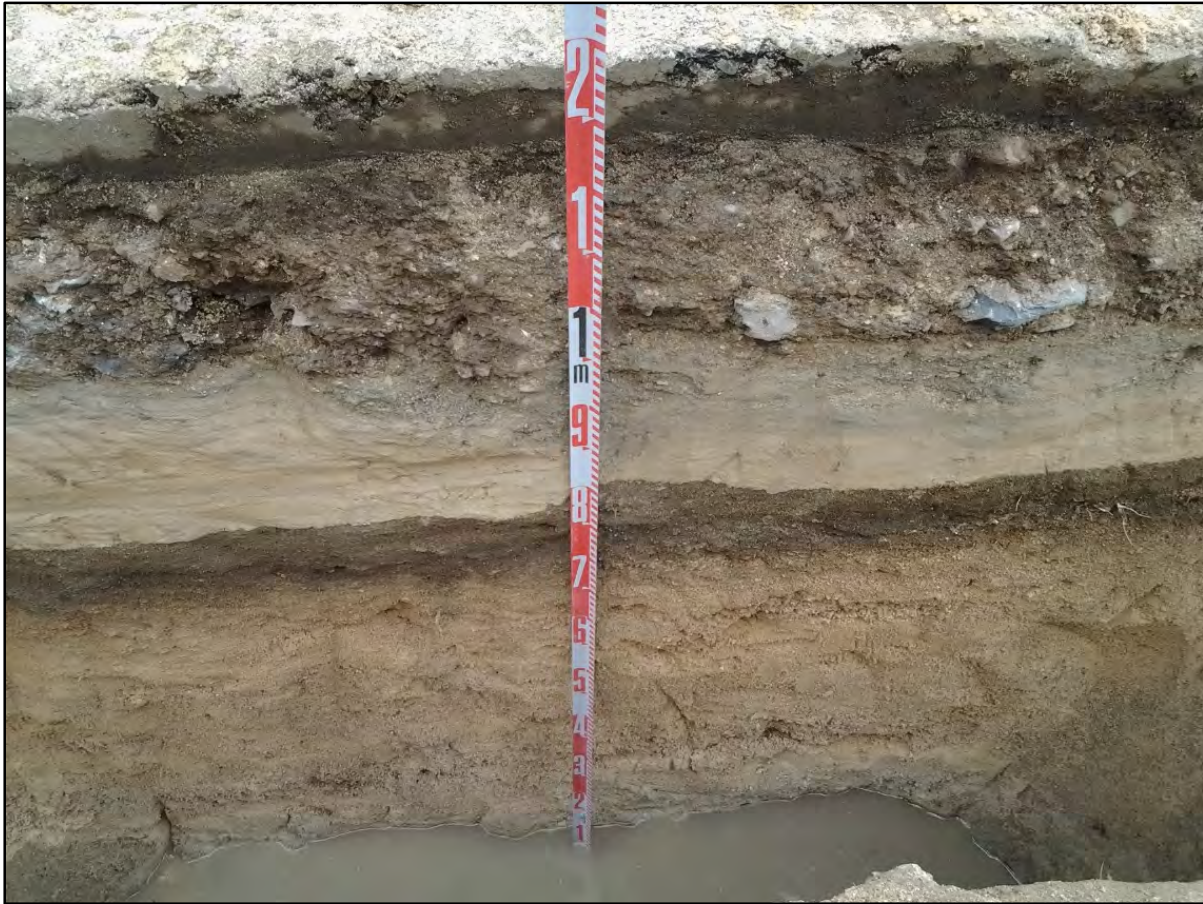
Figure 197. Close-up of T-36 stratigraphy

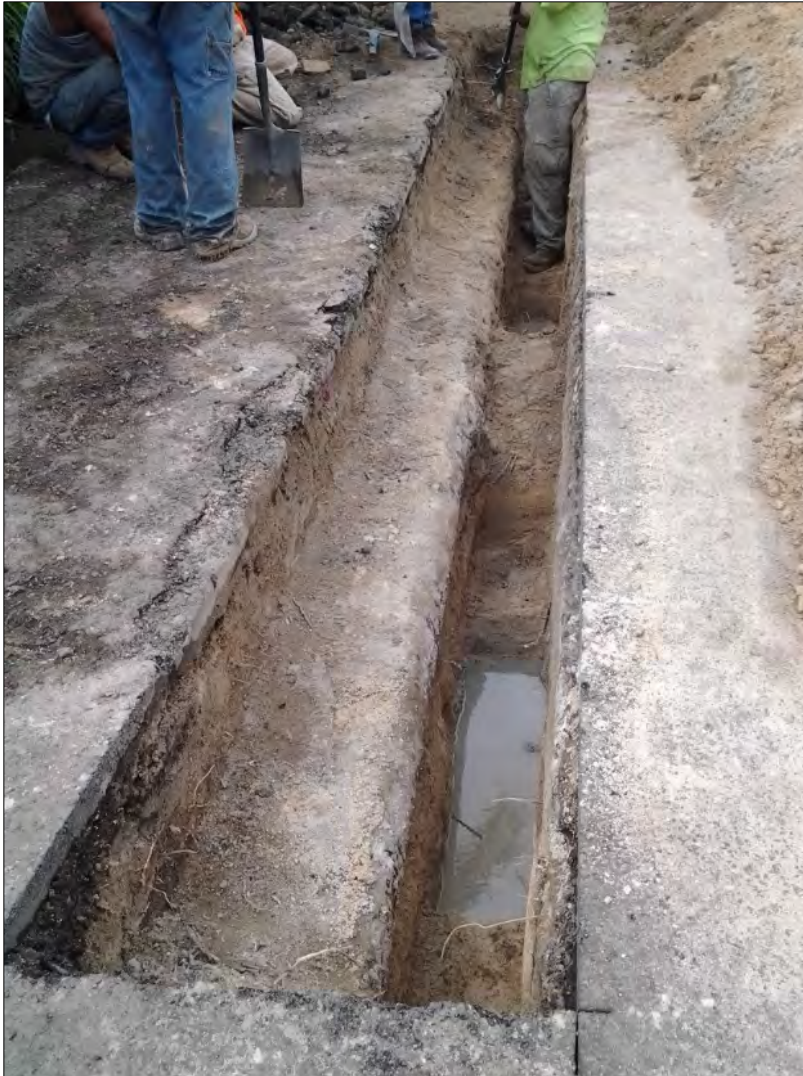
Figure 198. Photograph showing utility running parallel with the south wall, view to northwest

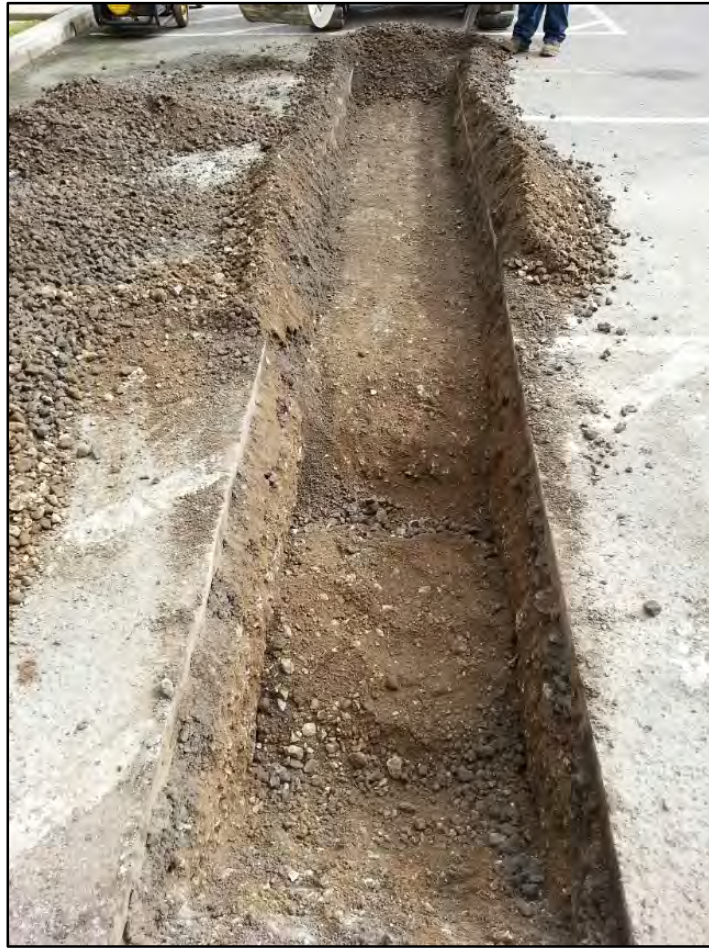
Figure 200. T-37, post excavation, view to northeast

Test Excavation 37 (T-37), an exterior excavation located in the Office Depot parking lot on the corner of Queen and Kamake'e streets, was oriented northeast-southwest and measured 6.0 m long by 0.75 m wide. The base of excavation was determined by the presence of very hard gravel associated with a possible concrete jacket at 0.39 mbs (Figure 200). The gravel layer was encountered at 0.22 mbs and excavations terminated after it was established that the impasse extended across the majority of the test excavation. No stratigraphy was recorded.

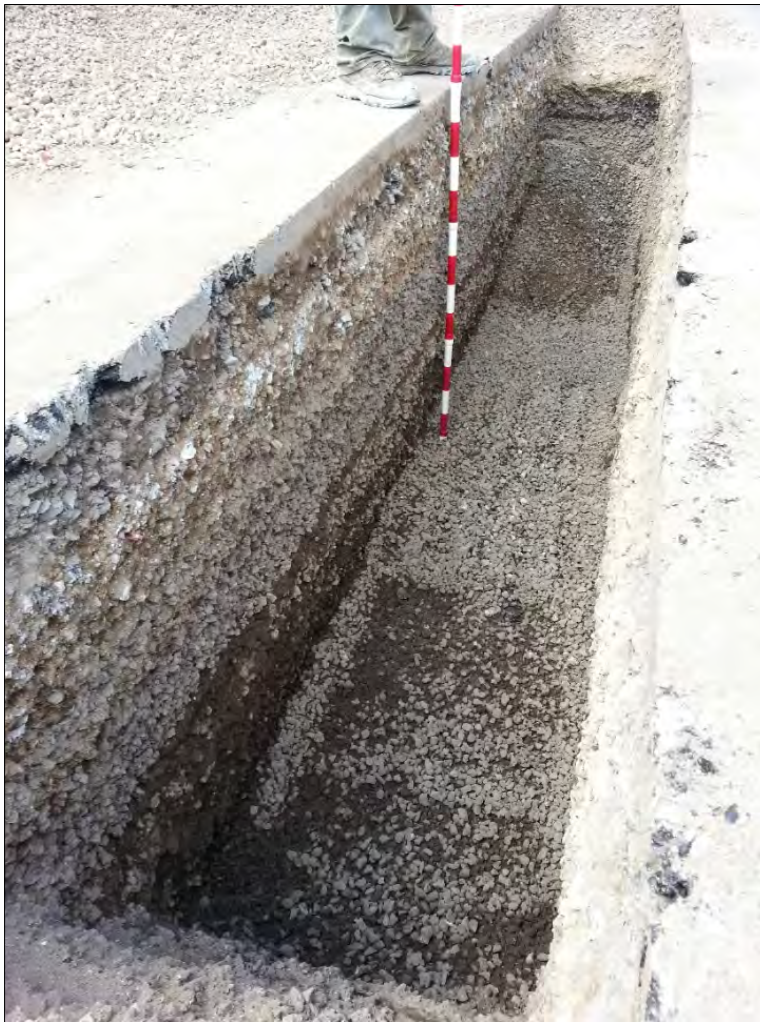
Figure 201. T-38, post excavation, view to northwest

Test Excavation 38 (T-38), an exterior excavation located in the Office Depot parking lot on the corner of Queen and Kamake'e streets, was oriented northwest-southeast and measured 6.0 m long by 0.70 m wide. The base of the excavation was determined by the water table at 1.23 mbs. The stratigraphy of T-38 consisted of the asphalt surface (Stratum Ia), associated base course (Stratum Ib), and very gravelly sandy loam (Stratum Ic), overlying a thick layer of gravel which extended to below the water table (Stratum Id) (Figure 201, Figure 202, and Table 40). No natural stratigraphy was observed; it appeared to have been removed during the deposition of the gravel fill. Based on the surrounding test excavations, however, the natural sediments likely consisted of wetland deposits.

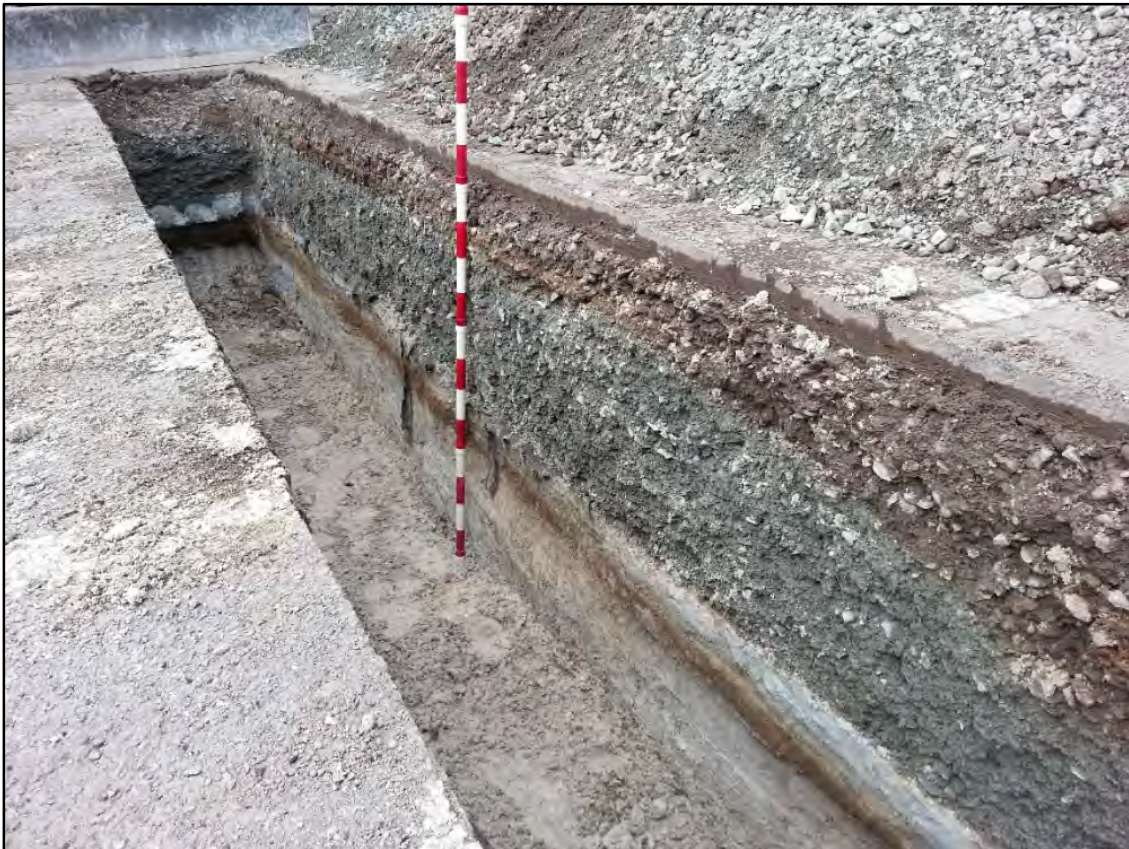
Figure 203. T-39 northwest wall, view to west

Test Excavation 39 (T-39), an exterior excavation located in the Office Depot parking lot on the corner of Queen and Kamake'e streets, was oriented northeast-southwest and measured 6.5 m long by 0.8 m wide. The base of excavation was determined by the presence of the hard coral shelf at 1.30 mbs. The stratigraphy of T-39 consisted of the asphalt surface (Stratum Ia) and two layers of associated base course material (Strata Ib–Ic), overlying a 1919–1927 Kaka'ako reclamation fill deposit consisting of fine sandy clay (Stratum II), overlying natural loamy clay A horizon (Stratum IIIa), over a sandy clay A horizon (Stratum IIIb), developed within a fine sandy wetland deposit (Stratum IIIc) (Figure 203 through Figure 205, and Table 41).

T-39 documented fill deposits from the Kaka'ako land reclamation period (Stratum II) overlying a natural, organically rich, wetland environment (Strata III). It is clear from the gleyed characteristics of the natural strata and the hydraulic dredge material (Stratum II) that this area experienced a prolonged state of reduced oxygen and increased water saturation. Stratum IIIa was a culturally sterile, loamy clay A horizon and former ground surface of a marshy wetland environment. Surface stability is evidenced by the diffused contact between Strata IIIa and IIIb, which suggests the downward translocation of solid particles and soluble constituents in the soil. The wetland deposits in T-39 are consistent with other test excavations within the project area.

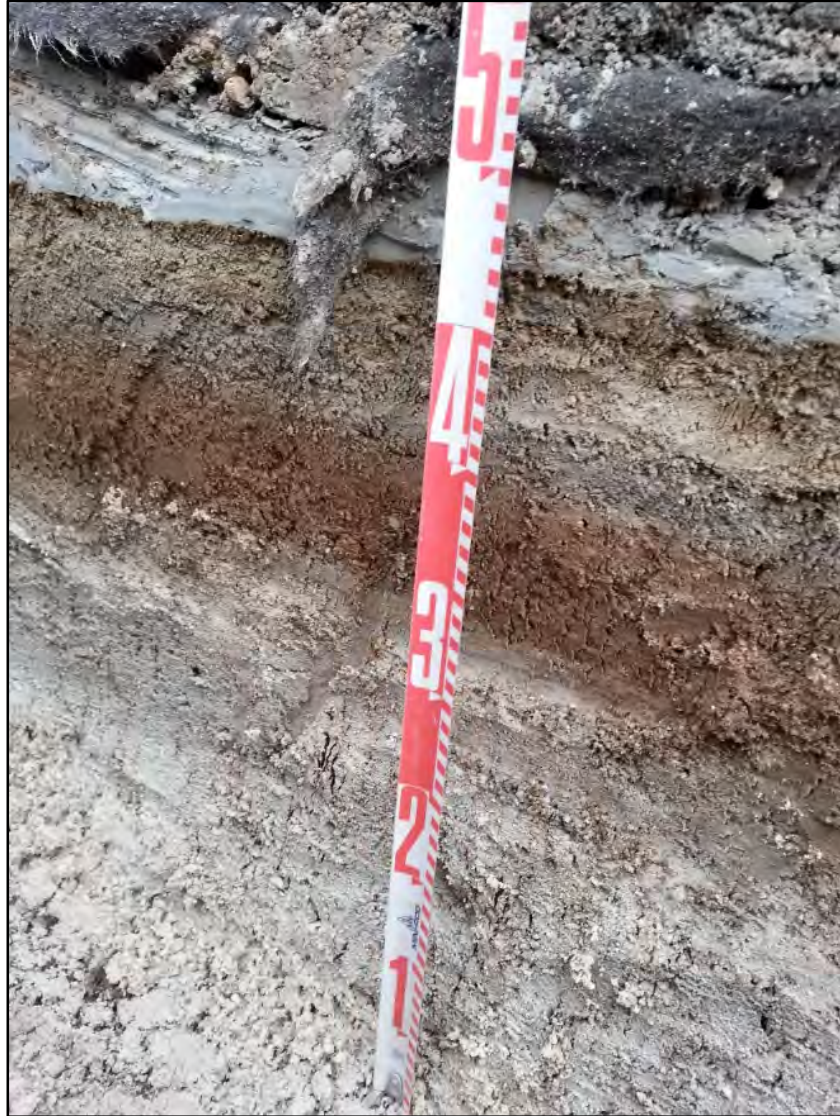
Figure 204. T-39, close-up of Strata II (hydraulic fill) over Strata IIIa–IIIc (natural wetland environment deposits), view to northwest

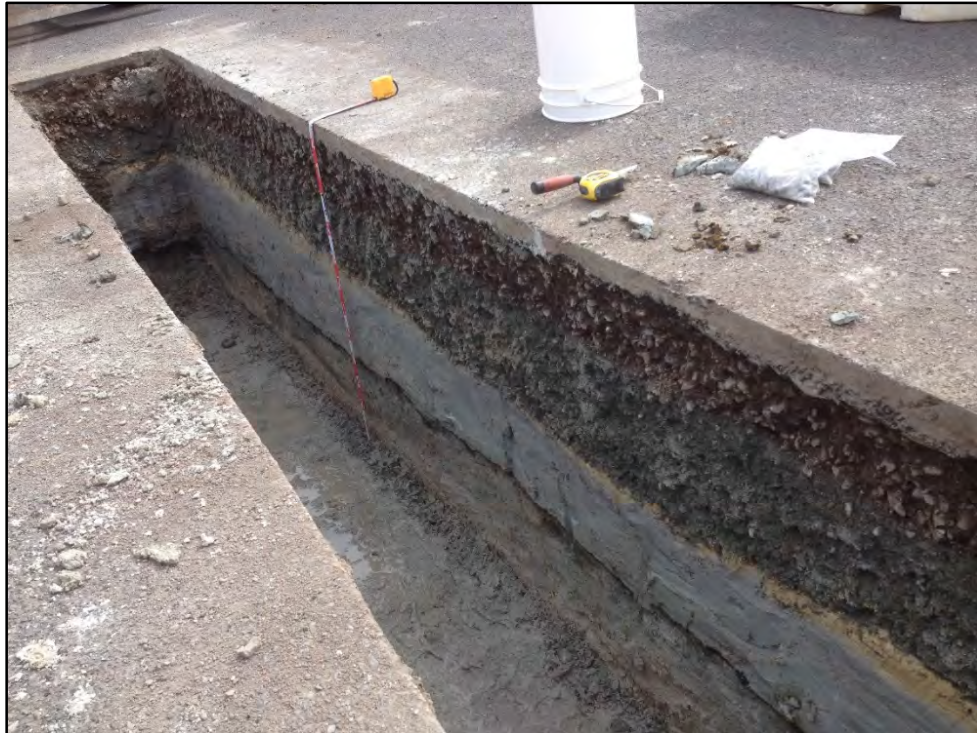
Figure 206. T-40 northeast wall, view to northwest

Test Excavation 40 (T-40), an exterior excavation located in the Office Depot parking lot on the corner of Queen and Kamake'e streets, was oriented northwest-southeast and measured 6.1 m long by 0.7 m wide. The base of excavation was determined by the presence of the hard coral shelf at 1.3 mbs. The stratigraphy of T-40 consisted of the asphalt surface (Stratum Ia) and associated base course material (Stratum Ib) overlying additional base course material with a lower silt liner (Stratum Ic), overlying a 1919–1927 Kaka'ako reclamation fill deposit consisting of hydraulic (dredge) silty clay (Stratum II), overlying a clay loam O horizon (Stratum IIIa), sandy loamy clay (Stratum IIIb), and gravelly loamy sand (Stratum IIIc) (Figure 206 through Figure 209, and Table 42).

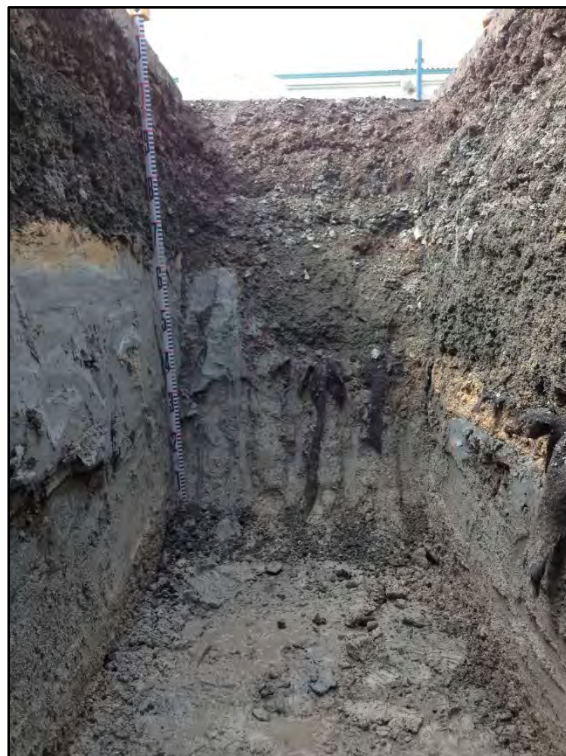
Figure 207. T-40 southeast wall, showing Stratum II (hydraulic fill) truncated by Stratum Ic subsurface base course, view to southeast

T-40 documented recent fill deposits (Strata Ia–Ic) overlying Kaka'ako reclamation fill deposits (Strata IIa–IIb), resting on a natural, organically rich, wetland environment. Recent landscape modifications (Stratum Ic) truncated the Kaka'ako reclamation fill (Stratum II) along the northwest and southeast walls (Figure 207). The interface of the natural wetland environment consisted of a layer of clay loam and the surface accumulation of partially decomposed organic matter (i.e., natural peat) (Stratum IIIa). This stratum has many fine roots, smells of sulfur, and is more characteristic of an O horizon than an A horizon. Strata IIIb and IIIc are grouped with the Stratum IIIa sequence as they appear to represent the same wetland depositional environment.

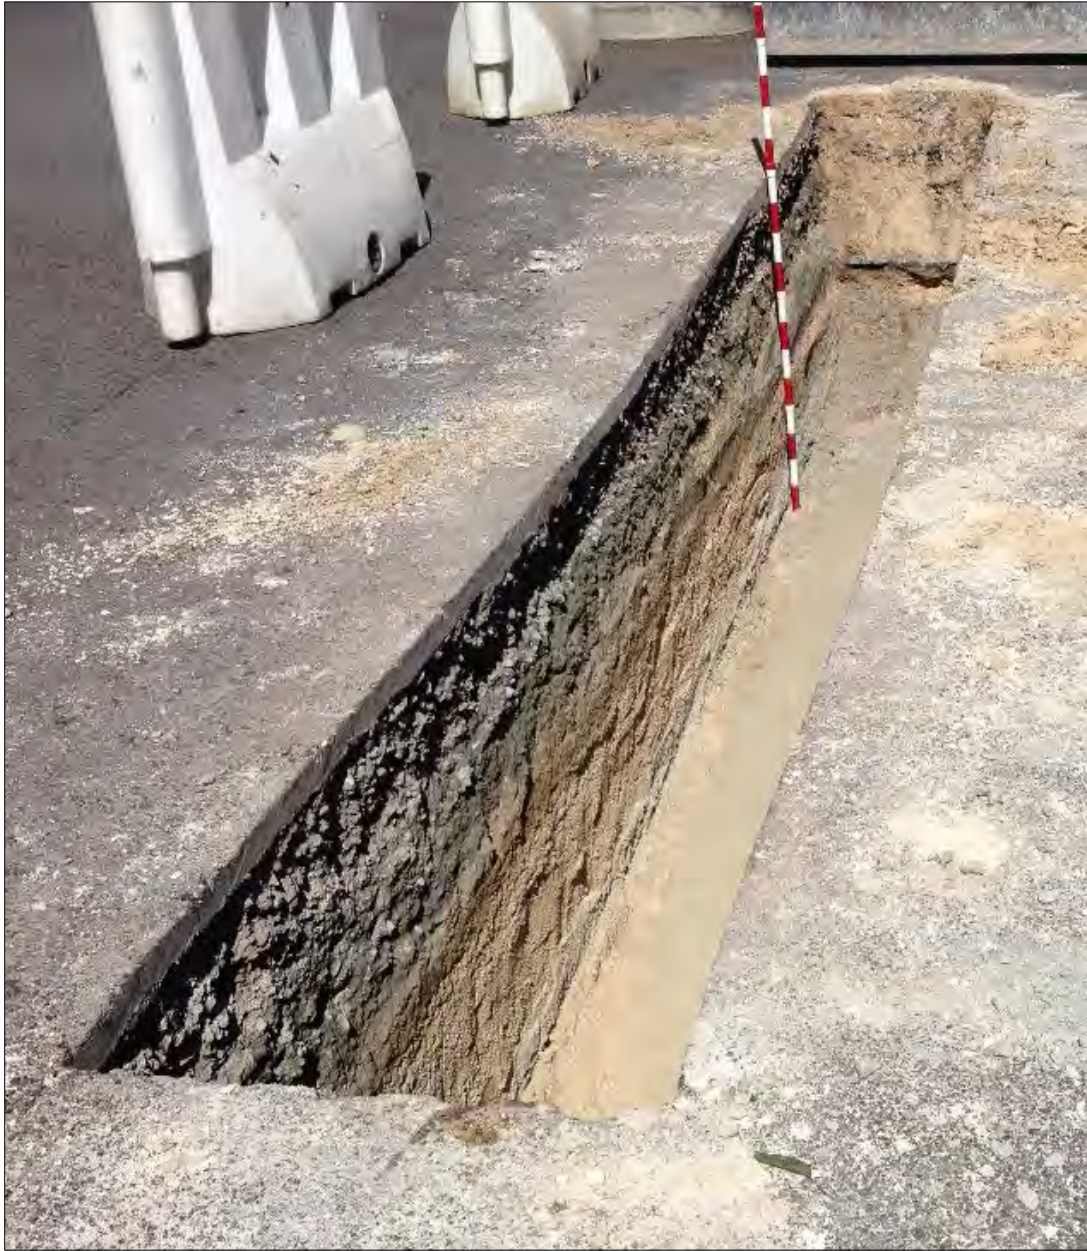
Figure 210. T-41 northwest wall, view to north

Test Excavation 41 (T-41), an exterior excavation located in the Office Depot parking lot on the corner of Queen and Kamake'e streets, was oriented northeast-southwest and measured 6.1 m long by 0.7 m wide. The base of excavation was determined by the presence of the hard coral shelf at 1.2 mbs. The stratigraphy of T-41 consisted of the asphalt surface (Stratum Ia) and two associated base course layers (Strata Ib–Ic) overlying a 1919–1927 Kaka'ako reclamation fill deposit consisting of hydraulic silty clay (Stratum II), overlying a redeposited, locally procured sandy loam (Stratum III), overlying a loamy sand remnant A horizon (Stratum IVa), developed within Jaucas sand (IVb), over a clay sand wetland deposit (Stratum V) (Figure 210, Figure 211, and, Figure 214, and Table 43).

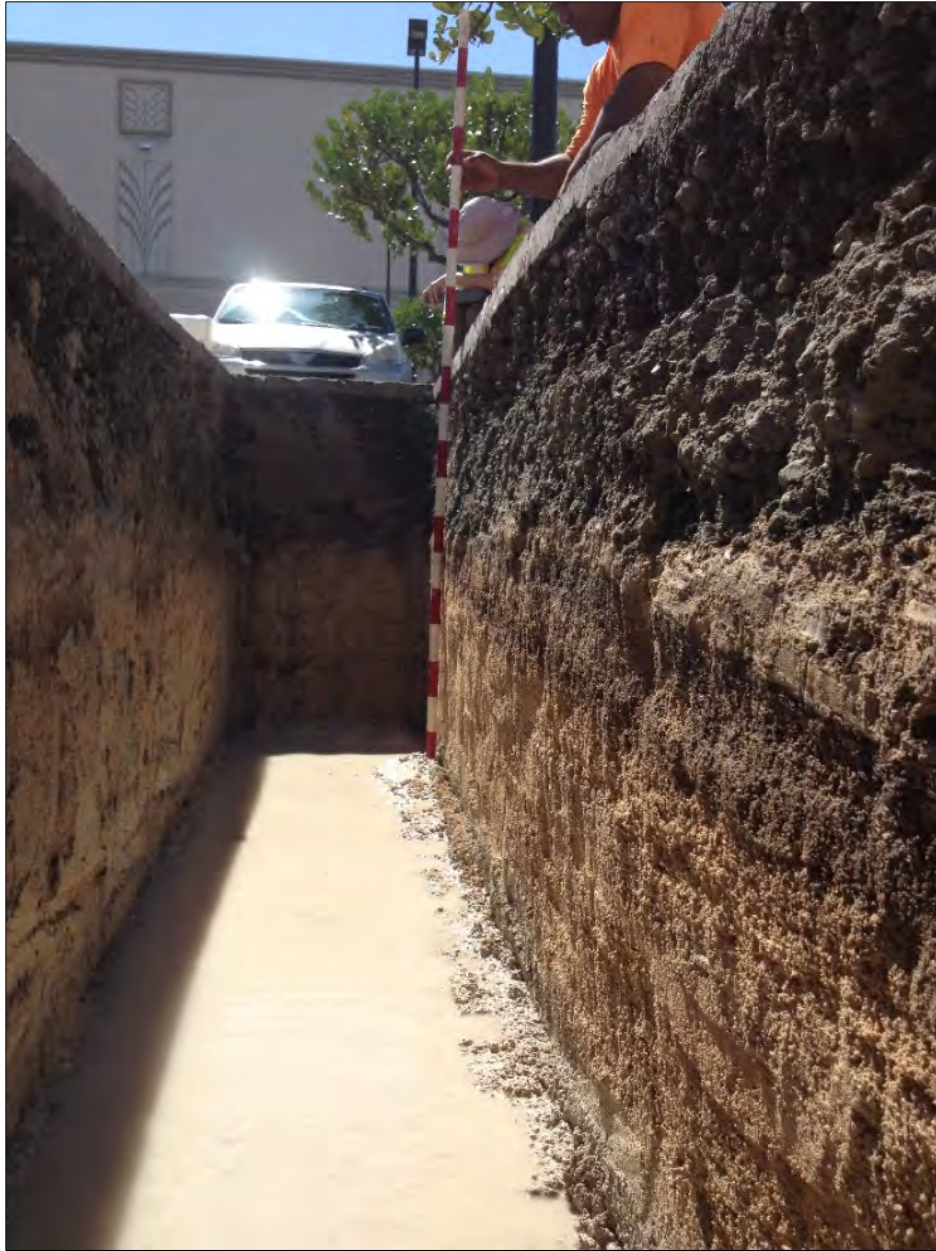
Figure 211. T-41, northwest and southeast walls, view to southwest
