Draft
Archaeological Inventory Survey Report for the
Block M Project, Kaka‘ako,
Honolulu Ahupua‘a, Honolulu (Kona) District, O‘ahu
TMK: [1] 2-3-002:001 (portion)

Prepared for
Victoria Ward Limited/Howard Hughes Corporation

Cultural Surveys Hawai‘i, Inc.
Kailua, Hawai‘i
(Job Code: KAKAAKO 122)

September 2014

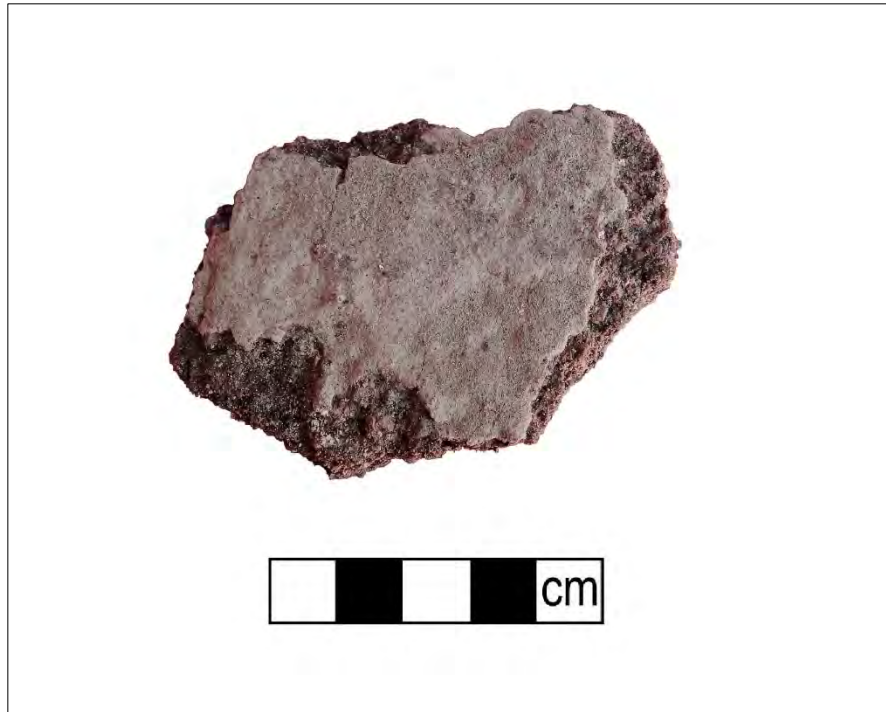
Figure 212. T-41 sediment sample from Stratum II, compacted locally procured fill, top view

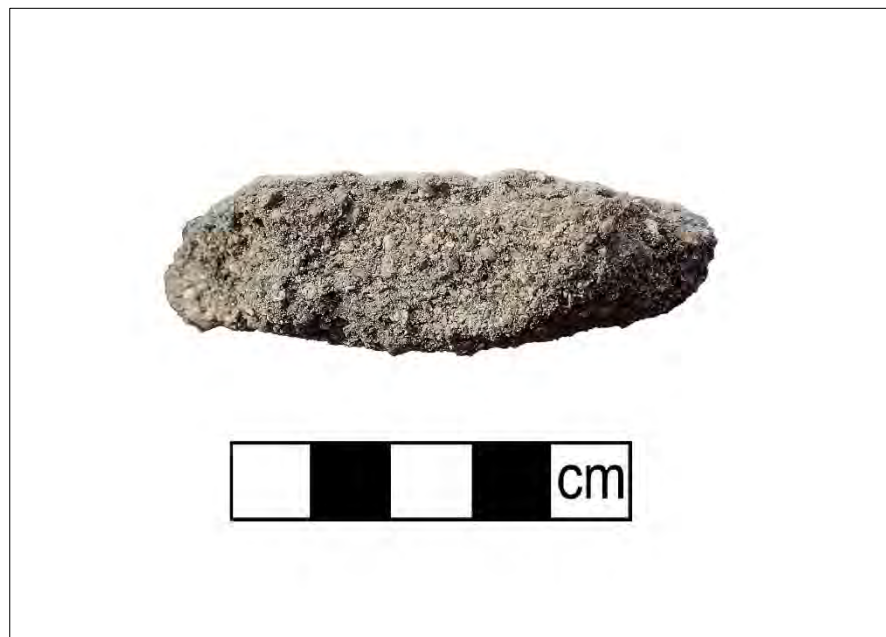
Figure 213. T-41 Stratum II sample, side view

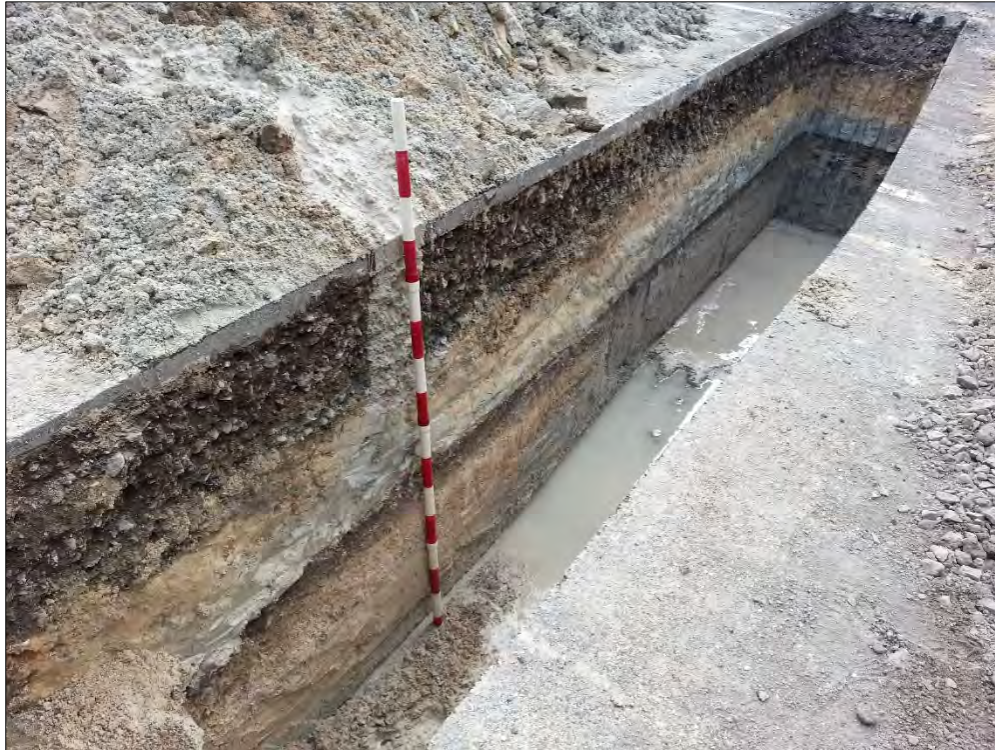
Figure 215. T-42 southeast wall, view to south

Test Excavation 42 (T-42), an exterior excavation located in the Office Depot parking lot on the corner of Queen and Kamake'e streets, was oriented northeast-southwest and measured 6.1 m long by 0.7 m wide. The base of excavation was determined by the presence of the hard coral shelf at 1.3 mbs. The stratigraphy of T-42 consisted of the asphalt surface (Stratum Ia), associated base course material (Stratum Ib), and overlying gravelly sandy loam fill (Stratum Ic), overlying a 1919–1927 Kaka'ako reclamation fill deposit consisting of hydraulic sandy clay (Stratum II), overlying a gravelly sandy loam, remnant A horizon (Stratum IIIa), overlying transitional deposits consisting of wetland sand (Stratum IIIb) and Jaucas sand (Stratum IIIc), a wetland clay sand with roots (Stratum IIIId), and wetland sand with roots (Stratum IV) (Figure 215 through Figure 217, and Table 44).

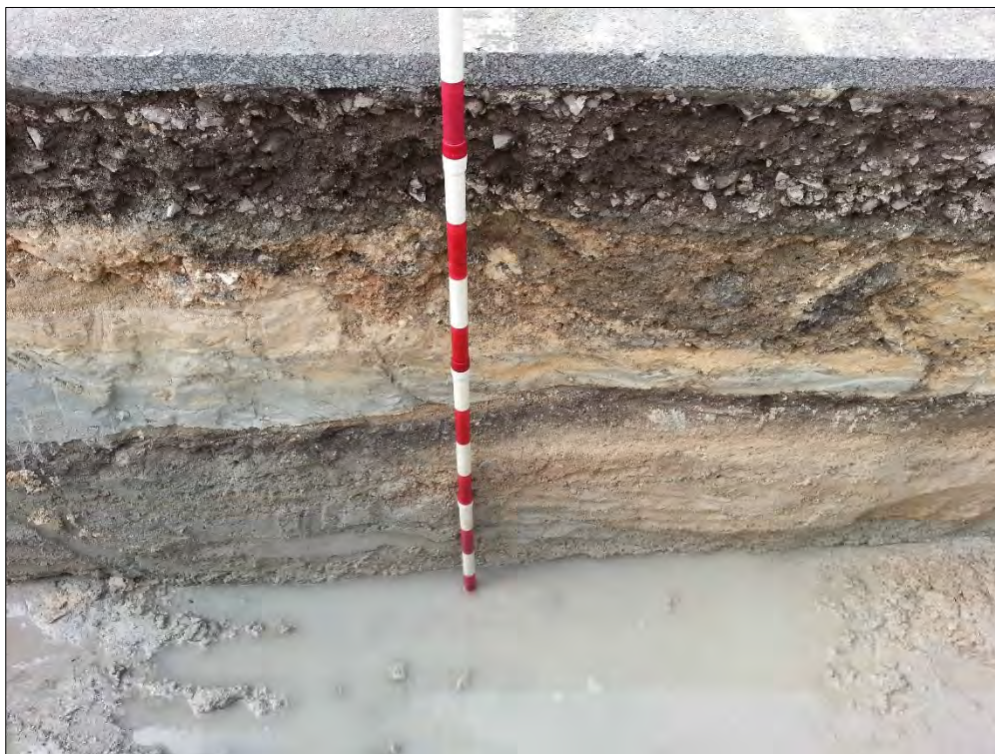
Figure 216. T-42 northwest wall, showing transitional interface, view to northwest

T-42 documented recent fill deposits (Strata Ia–Ic), overlying a 1919–1927 Kaka'ako reclamation fill deposit (Stratum II), resting on a natural transitional zone from terrestrial sand to an organically rich, wetland, marsh-like environment. Stratum IIIa was a highly compacted, remnant A horizon that was culturally sterile and contained brackish water snails, marine shells, and organic material. This horizon had been disturbed and truncated, and a thin black lens was observed at the upper stratum boundary in the southwest (*makai*) end. Stratum IIIa overlies both the wetland and Jaucas sands (Strata IIIb and IIIc), indicating pedogenesis occurred evenly across the upper boundary of these transitional deposits. It is plausible that Strata IIIb and IIIc were truncated, graded, compacted, and then experienced stability resulting in soil formation. The interface between Strata IIIb and IIIc was a lateral-gradational termination of one lithostratigraphic unit against another (see Figure 216). Stratum IIIb was first deposited followed by the lateral aggradation of Stratum IIIc. Stratum IV is an oxygen depleted, water saturated, wetland sand that underlies Stratum III, and rests on top of the coral shelf.

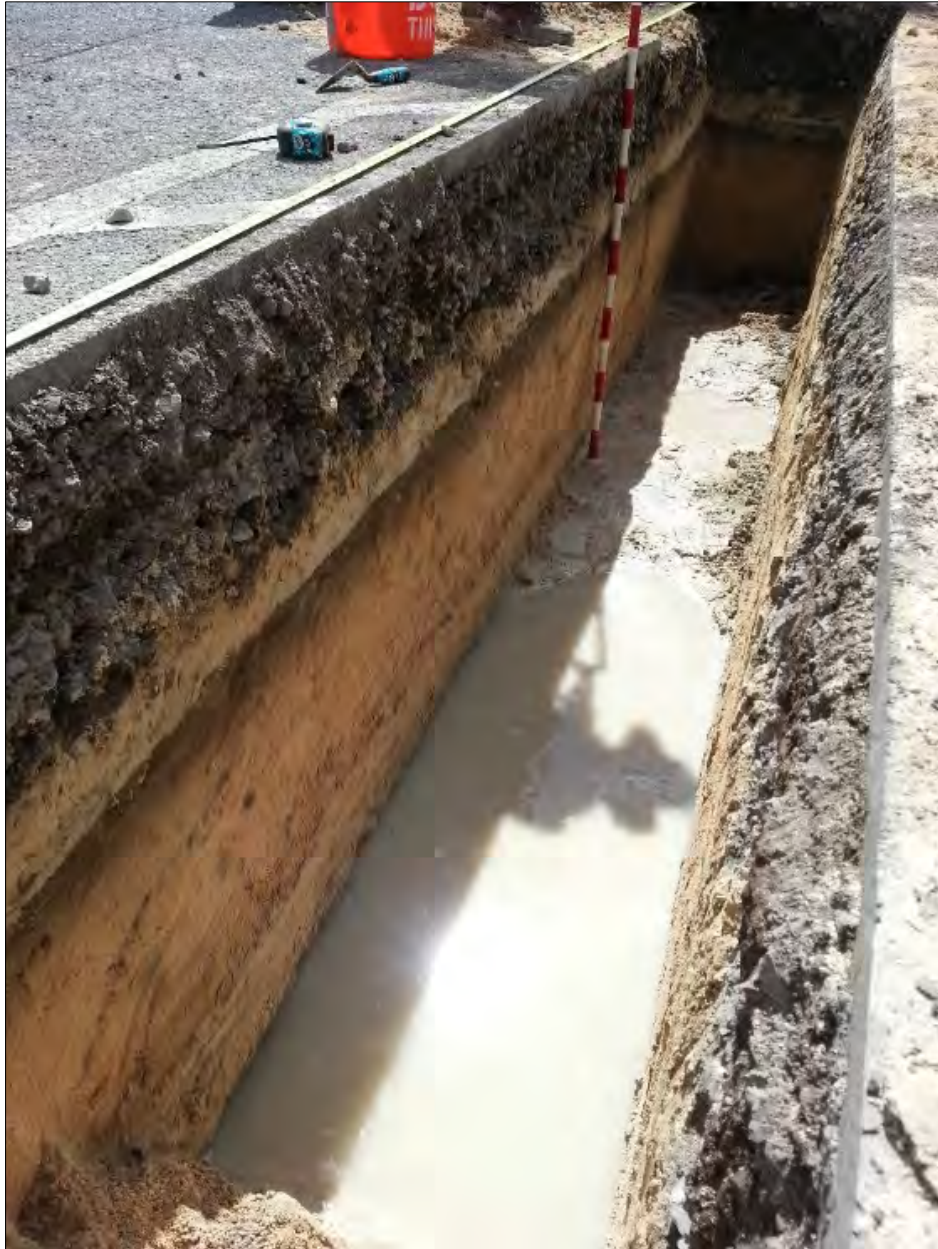
Figure 218. T-43 southeast wall, view to south

Test Excavation 43 (T-43), an exterior excavation located in the Office Depot parking lot on the corner of Queen and Kamake'e streets, approximately 10 m northeast of T-42, was oriented southwest-northeast, and measured 6.1 m long by 0.7 m wide. The base of excavation was determined by the presence of the hard coral shelf at 1.36 mbs. The stratigraphy of T-43 consisted of the asphalt surface (Stratum Ia), associated base course material (Stratum Ib), and 1919–1927 Kaka'ako land reclamation hydraulic sandy clay fill (Stratum II), overlying a sandy loam A horizon (Stratum IIIa), Jaucas sand (Stratum IIIb), a wetland clay sand with organics (Stratum IVa), and coarse wetland sand (Stratum IVb) (Figure 218 through Figure 220, and Table 45).

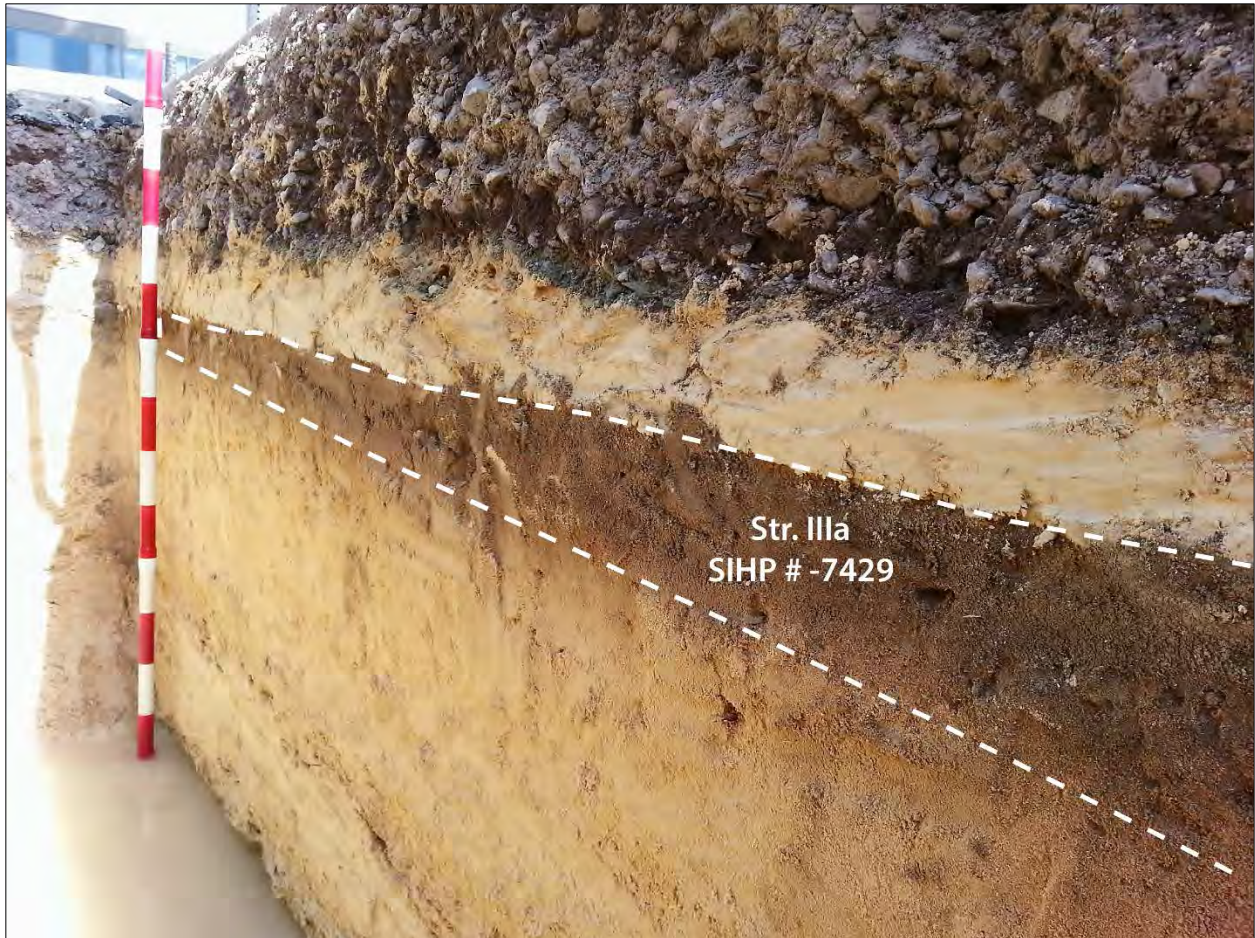
Figure 219. Close-up of Stratum IIIa (A horizon), SIHP # -7429, view to east

T-43 documented recent fill deposits (Strata Ia–Ib) overlying 1919–1927 Kaka'ako reclamation fill (Stratum II), resting on a truncated, natural A horizon (Stratum IIIa) and sand deposits (Strata IIIb–IVb). The A horizon contained a light amount of cultural material and is considered part of SIHP # -7429. Fifteen gallons of Stratum IIIa was screened in the field, yielding charcoal, marine shell midden (*Nerita picea*) (5.6 g), rusted metal pieces (12.9 g), a small ceramic fragment (1.0 g), two small glass fragments (1.8 g), slag (1.3 g), a faunal bone fragment (0.2 g), and natural water-worn marine shell. Stratum IIIa displayed a gradual yet clear lower boundary that indicates in situ pedogenesis within the upper boundary of the Jaucas sand (Stratum IIIb) (see Figure 219). The lower boundary of Stratum IIIb becomes coarse and displayed evidence of bioturbation from roots extending up from the underling wetland clay sand (Stratum IVa).

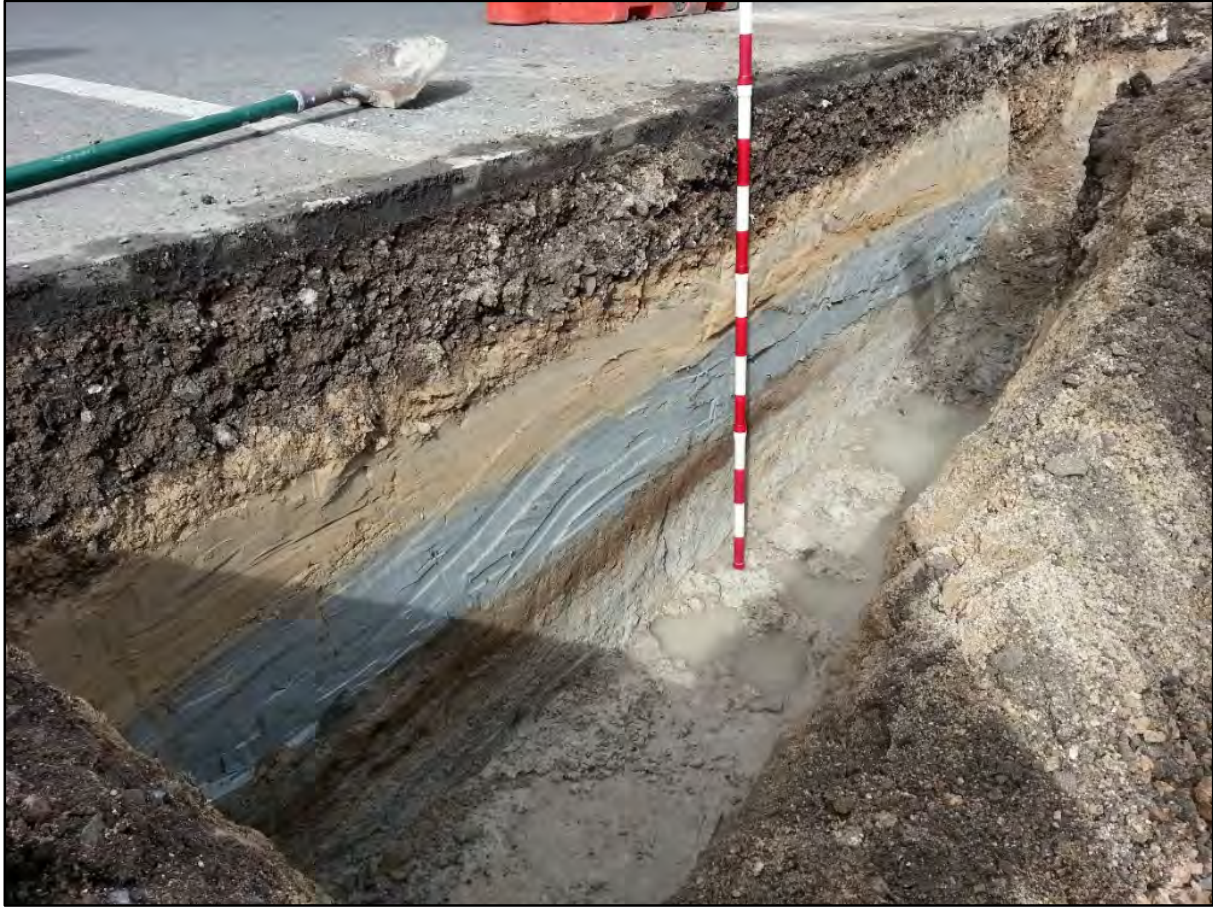
Figure 221. T-44 southwest wall, view to west

Test Excavation 44 (T-44), an exterior excavation located in the Office Depot parking lot on the corner of Queen and Kamake'e streets, was oriented northwest-southeast and measured 6.1 m long by 0.7 m wide. The base of excavation was determined by the presence of the hard coral shelf at 1.3 mbs. The stratigraphy of T-44 consisted of the asphalt surface (Stratum Ia), associated base course (Stratum Ib), utility fill (Stratum Ic), and a 1919–1927 Kaka'ako reclamation fill deposit consisting of hydraulic (dredge) sandy clay to clay (Stratum II) overlying a natural wetland silty clay containing organics (Stratum IIIa), a wetland sandy clay A horizon (Stratum IIIb), silty clay (Stratum IIIc), silty sand with decomposing organics (Stratum IIId), and clay sand with decomposing organics (Stratum IV) (Figure 221 through Figure 223, and Table 46). T-44 was extended approximately 0.7 m southwest of the original layout due to encountering a telecom utility line (0.9 mbs). The telecom utility line cut diagonally through the western end of T-44, and as a result, the surrounding material was not removed.

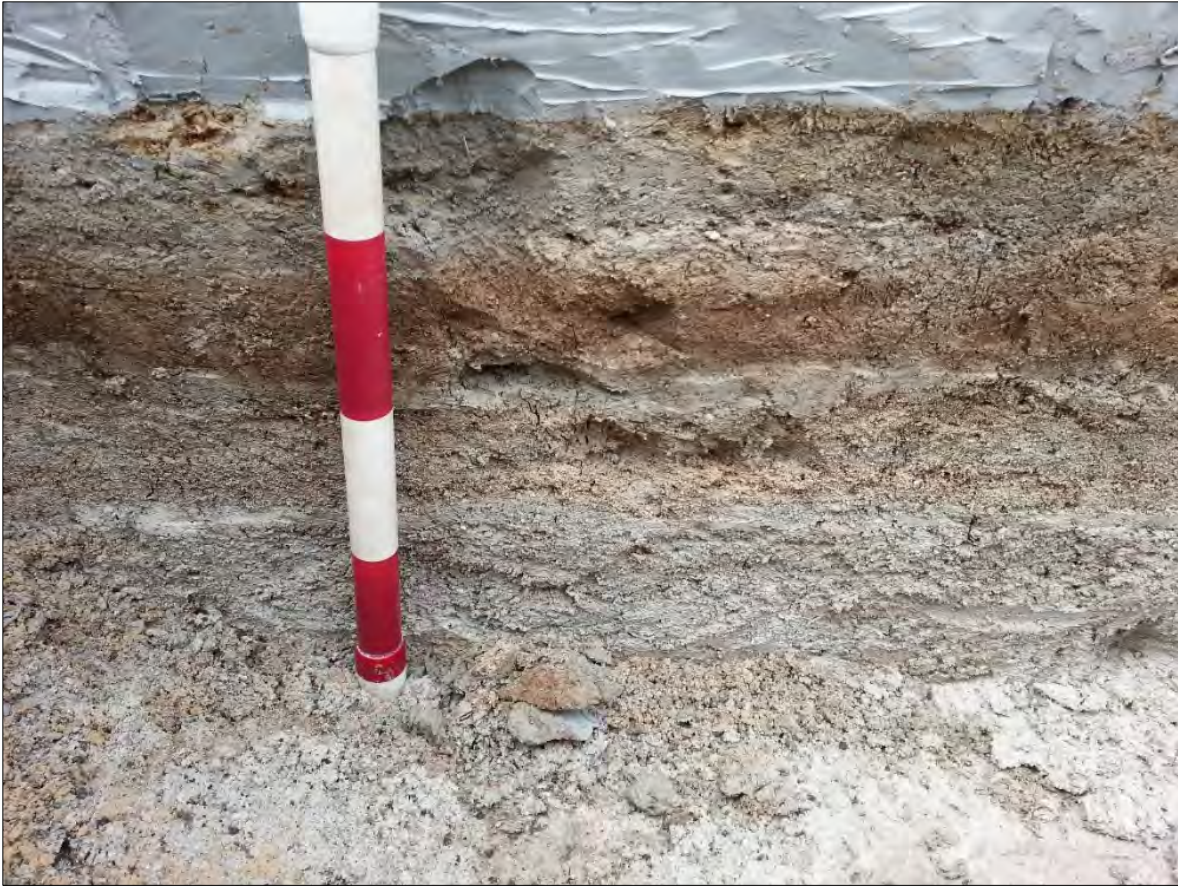
Figure 222. T-44, view of natural deposits (Strata IIIa–IV) underlying gleyed hydraulic clay fill (Stratum II), view to southwest

T-44 documented recent fill deposits (Strata Ia–Ic) overlying a Kaka'ako reclamation fill deposit (Stratum II), overlying a natural former ground surface and several strata of organically rich, wetland sands (Strata IIIa–IV). Stratum IIIa was a culturally sterile, organically rich silty clay, which may have been either locally procured, wetland A horizon material that was deposited as surface leveling fill, or may be part of the natural wetland depositional sequence. It appeared to have been truncated prior to the deposition of Stratum II. Stratum IIIb was a culturally sterile, buried wetland A horizon that consisted of an organically rich sandy clay and contained brackish water snails (e.g., *Melampus* sp.). Below is a culturally sterile, organically rich, silty clay wetland deposit with roots (Stratum IIIc). Collectively, Stratum III appeared to represent alternating sequences of deposition, stability, pedogenesis, and accumulation of organics within a wetland environment, similar to a salt marsh or mud flat (see Figure 222). Stratum IV was wetland clayey sand located above the slowly decomposing coral shelf.

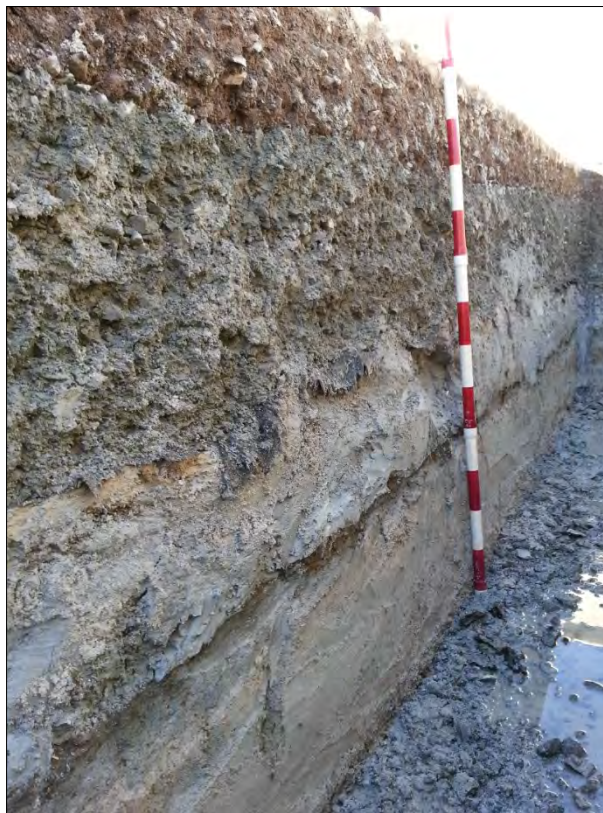
Figure 225. T-46 southeast wall, view to south

Test Excavation 46 (T-46), an exterior excavation located in the Office Depot parking lot on the corner of Queen and Kamake'e streets, was oriented southwest-northeast, and measured 6.0 m long by 0.7 m wide. The base of excavation was determined by the presence of the hard coral shelf at 1.3 mbs. The stratigraphy of T-46 consisted of the asphalt surface (Stratum Ia) and associated base course material (Stratum Ib) over additional base course material with a lower silt lining (Stratum Ic), overlying a 1919–1927 Kaka'ako reclamation fill deposit consisting of hydraulic silty clay (Stratum II), overlying a humicy clay O horizon (Stratum IIIa), an organically rich, loamy clay (Stratum IIIb), and sand (Stratum IV) (Figure 225 and Figure 226, and Table 48).

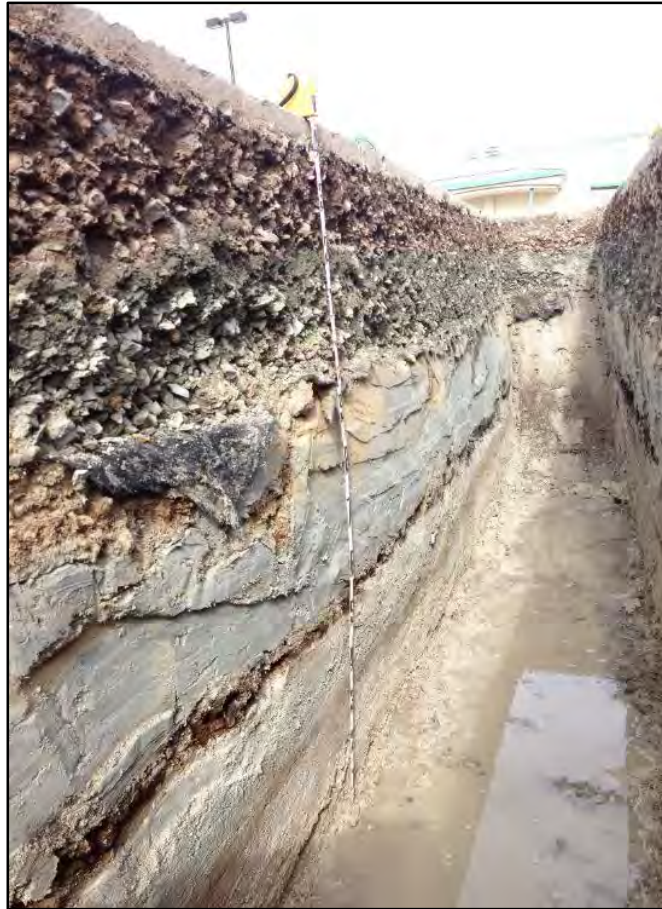
Figure 227. T-47 southwest wall, view to northwest

Test Excavation 47 (T-47), an exterior excavation located in the Office Depot parking lot on the corner of Queen and Kamake'e streets, was oriented northwest-southeast and measured 6.2 m long by 0.7 m wide. The base of excavation was determined by the presence of the hard coral shelf at 1.43 mbs. The stratigraphy of T-47 consisted of the asphalt surface (Stratum Ia), associated base course material (Stratum Ib), an additional base course with a lower silt liner (Stratum Ic), and silty clay mixed with base course material (Stratum Id) overlying a 1919–1927 Kaka'ako reclamation fill deposit consisting of hydraulic (dredge) silty clay (Stratum II), overlying a very gravelly sandy loam containing slag and thermally altered metal (Stratum III), overlying natural loamy sand (Stratum IVa), sandy clay (Stratum IVb), a silty clay A horizon (Stratum IVc), and a loamy sand with roots (Stratum IVd) (Figure 227 through Figure 230, and Table 49).

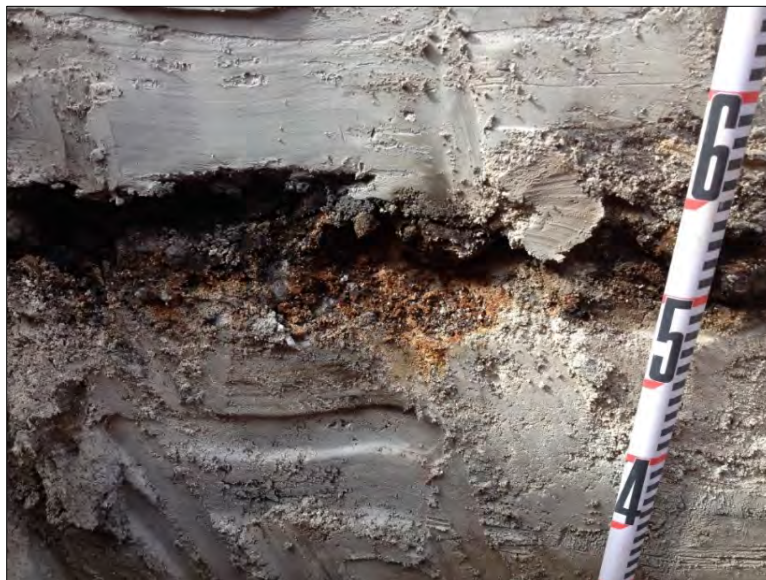
Figure 228. T-47 southwest wall, close-up of incinerated material within Stratum III, view to southwest

T-47 documented recent fill deposits (Strata Ia–Id) overlying a 1919–1927 Kaka'ako reclamation fill deposit (Stratum II), overlying a localized fill deposit, resting on a series of natural wetland deposits (Strata Iva–IVd). Stratum III was a compact layer of slag and thermally altered and oxidized metal fragments (Figure 228). It appeared to be a thin layer of incinerator fill material from early the 1900s method of garbage disposal in Kaka'ako. Below Stratum III was a truncated, culturally sterile wetland-marsh environment (Stratum IV) that displayed two sequences of deposition, stability, and pedogenesis, similar to that of T-44. Strata IVa and IVb appear to have been a wetland sub-stratum that likely supported an A horizon prior to the removal of the upper boundary of Stratum IVa. Strata IVa and IVb most likely represent the second, more recent, observed depositional sequence. Stratum IVb displayed some mineral leaching, most likely due to the translocation of ions and oxides from the subsurface matrix into the dissolved ground water. Stratum IVc was an A horizon that developed within the loamy sand above the coral shelf (Stratum IVd). Stratum IVc represents a period of stability that was eventually buried under Strata IVa and IVb due to a change in the depositional conditions, resulting in an increase in sediment load and aggradation.

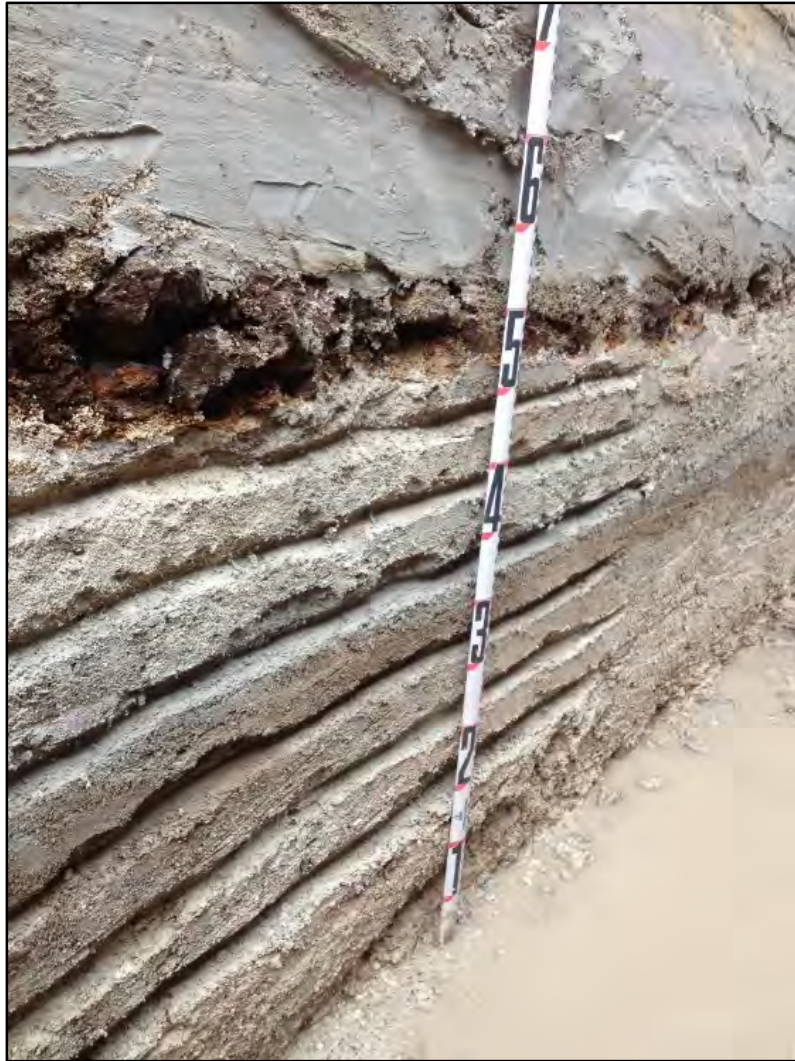
Figure 229. T-47 southwest wall column sample location, view to west

Four column samples were taken from T-47: Strata IVa (97–98 cmbs), IVb (108–109 cmbs), IVc (114–115 cmbs), and IVd (126–127 cmbs) (Figure 229). Results from the four sampled strata indicate that T-47 was consistently a natural wetland. Cyperaceae pollen percentages were high through the sequence indicating a Wet Coastal Sedgeland vegetation dominated the site. Strata IVc and IVd column samples had higher percentages of aquatic Foraminifera shells, suggesting the wetland may have been more frequently or deeply inundated during the earlier depositional periods. Charcoal concentrations increased from the lower to the upper samples (Strata IVd–IVa), demonstrating an increase in burning activities in the surrounding uplands in the more recent sediments.

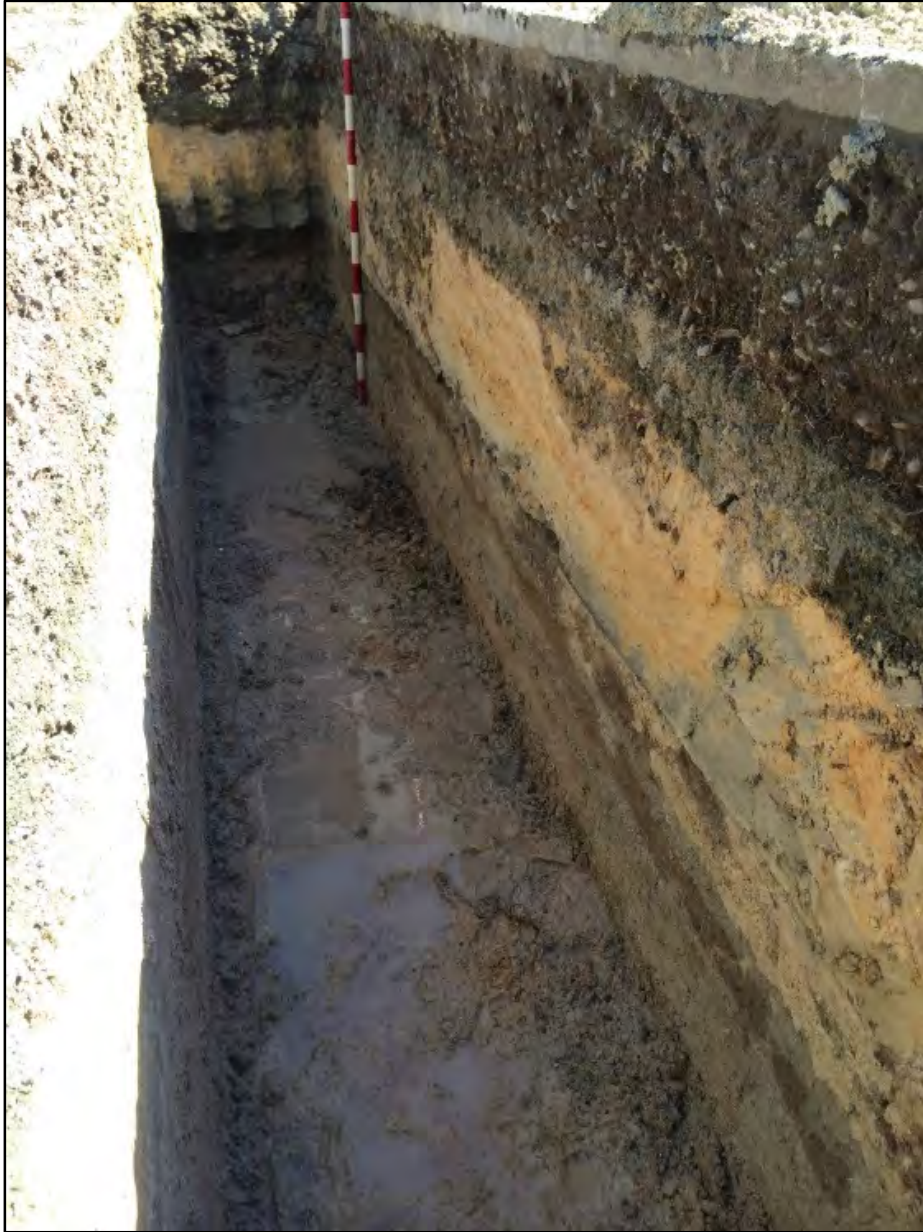
Figure 231. T-48 southeast wall, view to northeast

Test Excavation 48 (T-48), an exterior excavation located in the Office Depot parking lot on the corner of Queen and Kamake'e streets, was oriented southwest-northeast and measured 6.1 m long by 0.7 m. The base of excavation was determined by the presence of the hard coral shelf at 1.33 mbs. The stratigraphy of T-48 consisted of the asphalt surface (Stratum Ia) and two associated base course deposits (Strata Ib–Ic), overlying 1919–1927 Kaka'ako reclamation hydraulic silty clay fill (Stratum II), overlying a locally procured wetland loamy sand (Stratum III), overlying a natural sandy loam wetland A horizon (Stratum IVa), developed within a sand deposit (Stratum IVb) (Figure 231 and Figure 233, and Table 50).

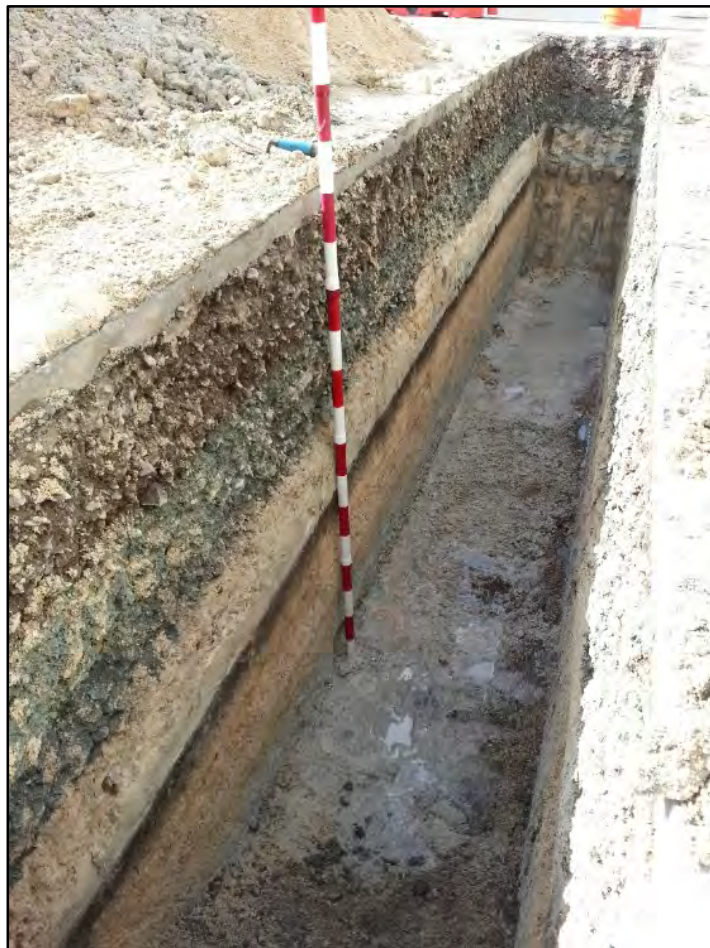
Figure 234. T-49 southwest wall, view to west

Test Excavation 49 (T-49), an exterior excavation located in the Office Depot parking lot on the corner of Queen and Kamake'e streets, was oriented northwest-southeast and measured 6.1 m long by 0.7 m wide. The base of excavation was determined by the presence of the hard coral shelf at 1.4 mbs. The stratigraphy of T-49 consisted of the asphalt surface (Stratum Ia) and two layers of associated base course material (Strata Ib–Ic) overlying a 1919–1927 Kaka'ako reclamation fill deposit consisting of hydraulic silty clay (Stratum II), overlying a natural loamy sand A horizon (Stratum IIIa), developed within Jaucas sand (Stratum IIIb), over a wetland sandy clay (Stratum IVa), and wetland sand (Stratum IVb) (Figure 234 through Figure 236, and Table 51).

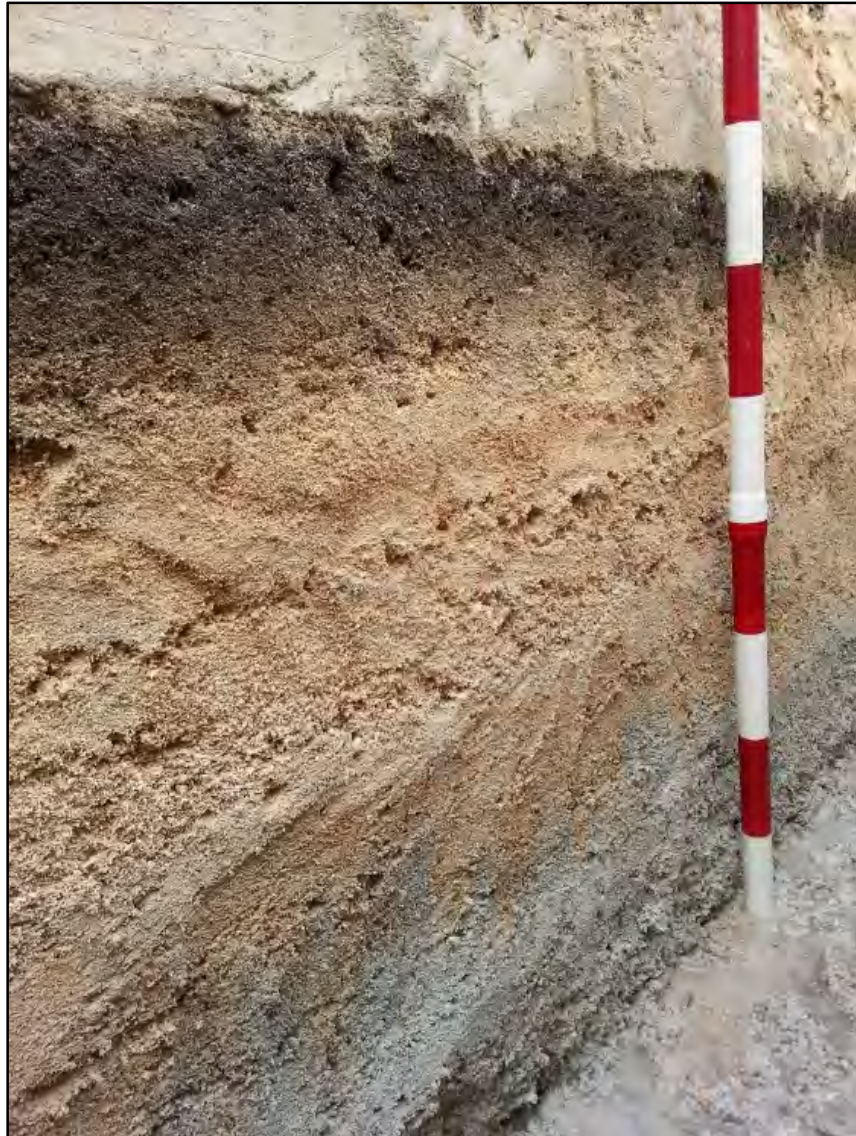
Figure 235. T-49 southwest wall, close-up of natural deposits (Strata III–IV), view to west

T-49 documented recent fill deposits (Strata Ia–Ic) overlying a 1919–1927 Kaka'ako reclamation fill deposit (Stratum II), overlying a natural soil horizon developed within beach sand, and two wetland deposits, resting on top of the coral shelf. Stratum IIIa was a culturally sterile, truncated, and buried A horizon. Stratum IIIb consisted of Jaucas sand and had a highly undulated and diffuse lower boundary that transitioned into a gleyed, wetland clay sand (Stratum IVa), which was most likely the result of post depositional processes in an anaerobic environment (see Figure 235).

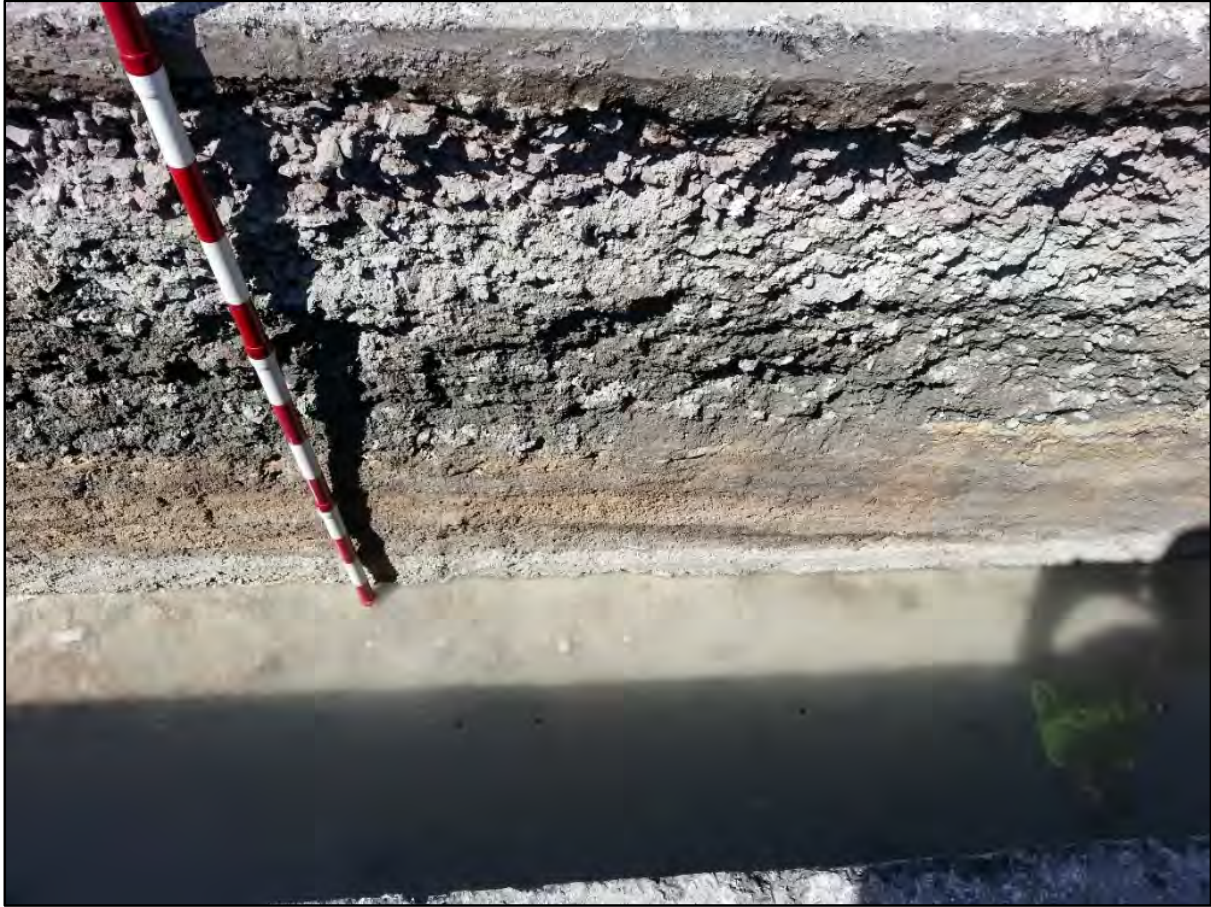
Figure 238. T-50 close-up of northwest wall, showing locally procured sand fill (Stratum III) over a wetland A horizon (Stratum IVa), view to northwest

T-50 documented recent fill deposits (Strata Ia–Ic) overlying a 1919–1927 Kaka'ako reclamation fill deposit (Stratum II) and a historic sand fill deposit (Stratum III), overlying a disturbed, natural wetland deposit resting on top of the coral shelf. Stratum III most likely consists of locally procured sand deposited to level and/or build up the ground surface and that served as a historic land surface for a period of time prior to reclamation activities. Below the mixed local sand was a culturally sterile, buried wetland A horizon (Stratum IVa) that developed within a natural wetland clay that inclined to the southwest (*makai*) (Stratum IVb) (see Figure 238). The Stratum IVa matrix contained minimal organics and appeared to be disturbed, with a truncated upper boundary; portions of the stratum were removed in the southwest end, possibly as a result of the deposition of Stratum III.

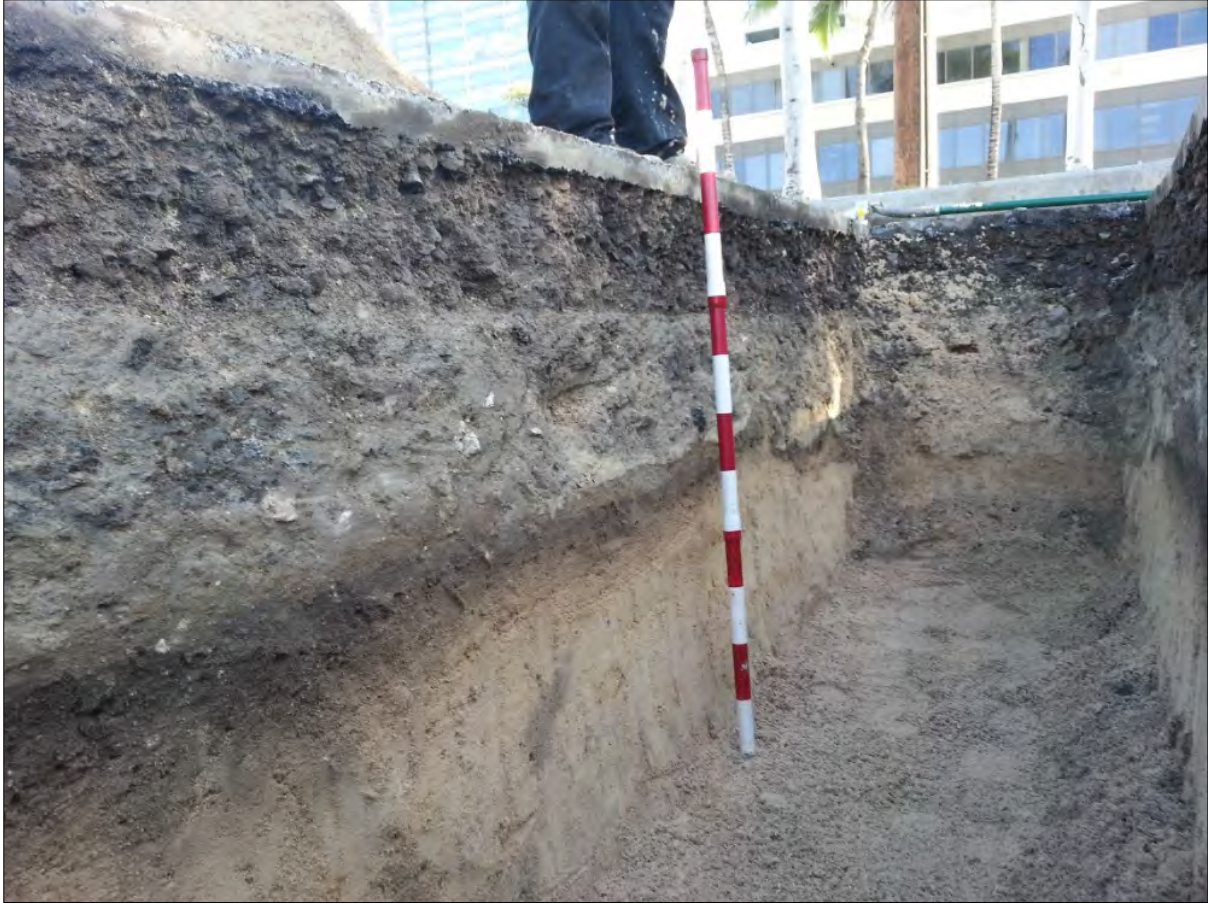
Figure 241. T-51 southwest wall, close-up of disturbed A horizon (Stratum IVa), view to north

T-51 documented recent fill deposits (Strata Ia–II) overlying a historic sand fill (Stratum III), overlying a disturbed, natural A horizon developed within Jaucas sand. Stratum II was a heavily mixed layer that consisted of hydraulic pump dredge material and crushed coralline sand from the Kaka'ako land reclamation period incorporated with asphalt inclusions. Below this was a broken and discontinuous layer of early twentieth century fill, likely composed of locally procured sand and soil (Stratum III). This local fill material may have been deposited to level and/or build up the ground surface and may have served as a historic land surface for a period of time prior to reclamation activities. Stratum III was deposited over an in situ, culturally sterile, silty sand A horizon (Stratum IVa) (Figure 241).

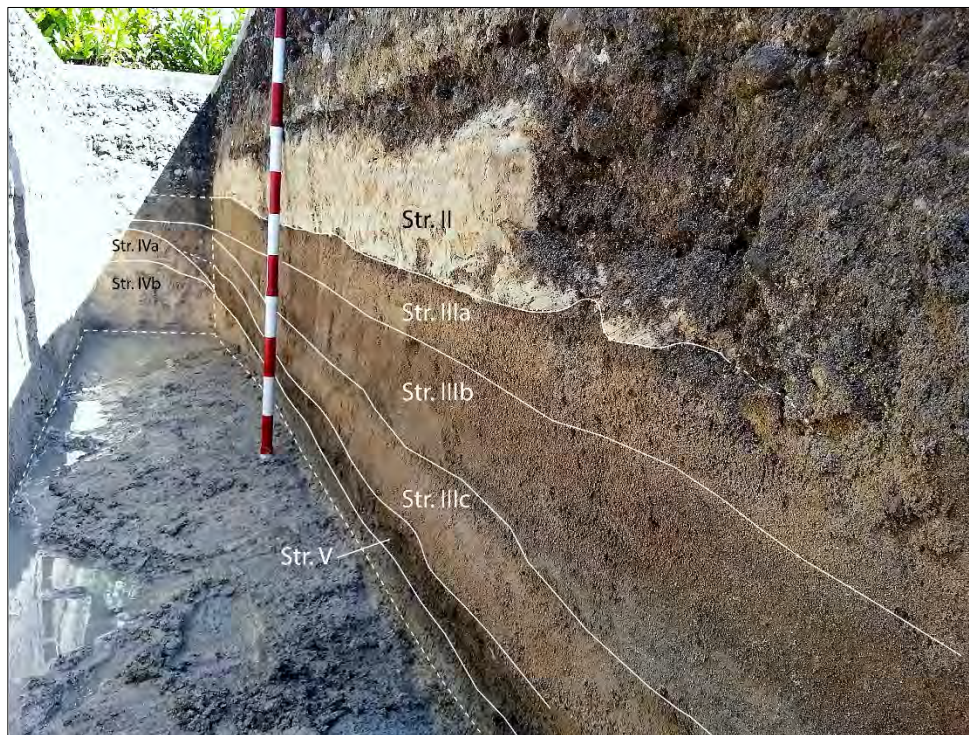
Figure 244. T-52 southeast side wall, close-up of Stratum III (multiple layers of A horizon fill) overlying Stratum V (A horizon), view to east

T-52 documented recent fill deposits (Strata Ia–Ie) overlying a 1919–1927 Kaka'ako reclamation fill deposit (Stratum II), overlying several strata of redeposited, locally procured sand (Strata IIIa–IIIc), overlying a natural transition from a wetland marsh-like setting to a sandy dune setting. Strata IIIa–IIIc were most likely deposited as local grading fill, possibly in an effort to level out the natural wetland prior to the large-scale land reclamation efforts in the early 1900s, and may have served as a former land surface. Stratum III slopes from the northeast to the southwest, congruent with the lower-lying strata, and was thinner on the *mauka* end than on the *makai* end (see Figure 244). Below Stratum III on the northeast (*mauka*) end was a sand berm (Strata IVa–IVc) that sloped down to the southwest (*makai*) (see Figure 245). The upper boundary of Stratum IVa was mottled with pockets of Stratum IIIb, indicating some truncation or disturbance had impacted the sand dune berm. Stratum V was a culturally sterile, natural wetland A horizon with humus and brackish water snails (i.e., *Melampus*). At the lateral interface of Stratum IV and Stratum V, faces converged in a “washed zone” of intermixed brackish water-wetland sediments that contained humus and other organics, with various sand dune deposits. Previous AIS investigations within Queen Street, immediately adjacent to T-52 (Hammatt 2013), documented sand overlaid by an A horizon with very slight cultural content. Stratum V was discontinuous, laterally associated with Strata IVa on the southwest (*makai*) side, and was buried below Stratum II. Below both Strata III and V was wetland sand with organic material (Strata VI and VII), resting over the coral shelf.

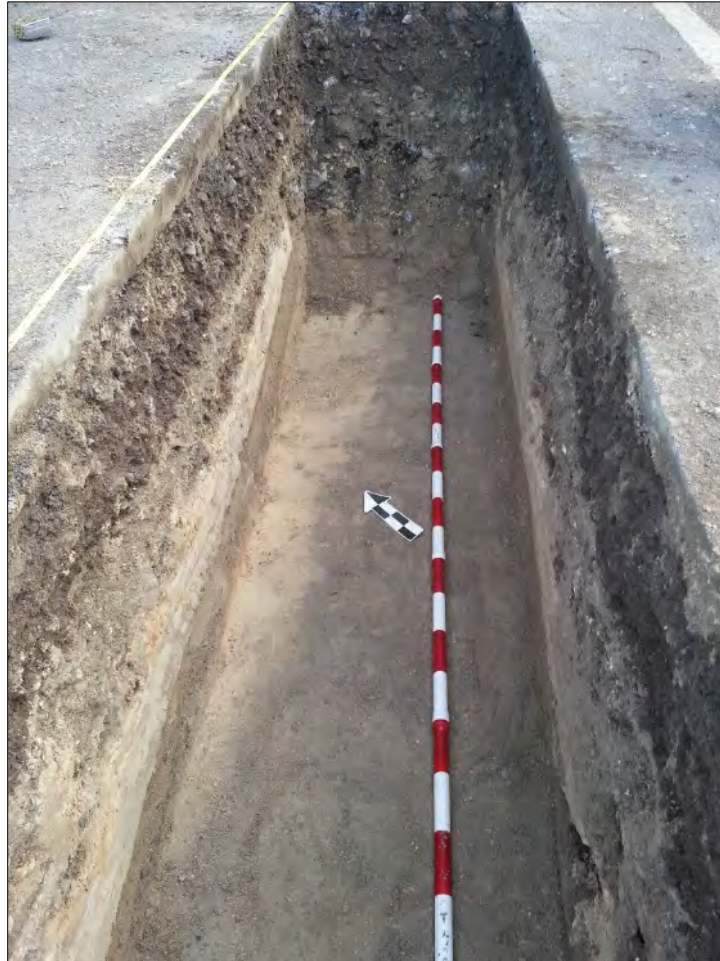
Figure 245. T-52 plan view of Stratum IVa (sand berm) and Stratum III (local A horizon fill) upper boundaries, view to northeast

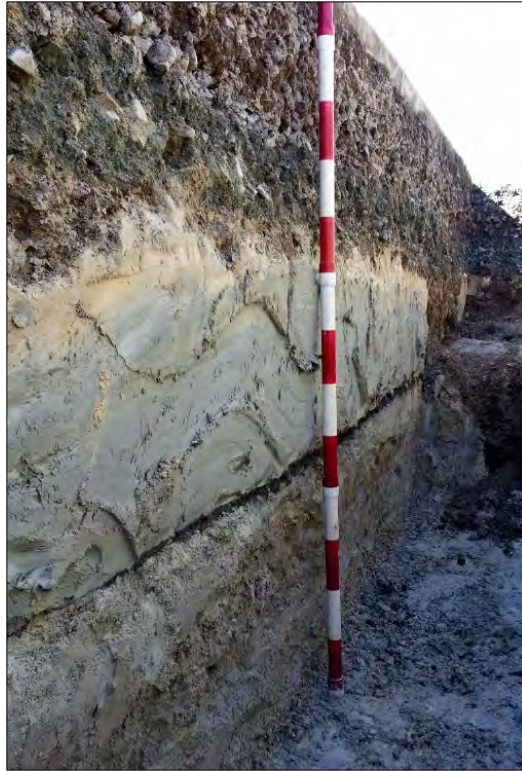
Figure 249. T-54 southeast wall, view to south

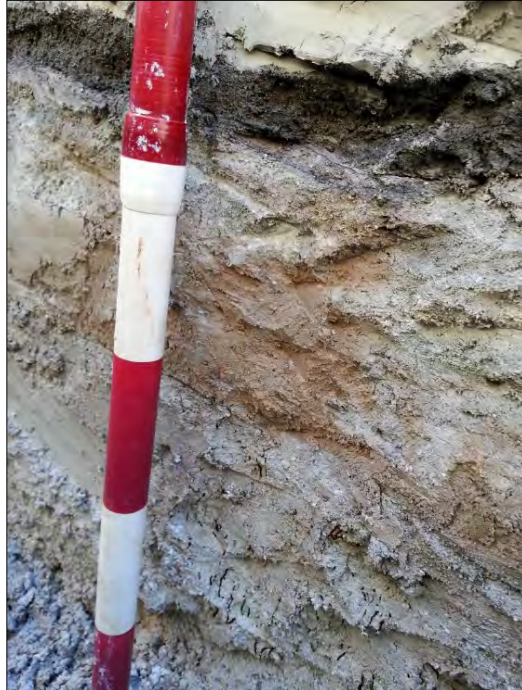
Figure 250. T-54 southeast wall, close-up of possible A horizon fill (Stratum III) over a natural wetland environment (Stratum IV), view to east

T-54 documented recent fill deposits (Strata Ia–Ie) overlying a Kaka'ako reclamation fill deposit (Stratum II), overlying wetland sediments resting on the coral shelf. Underlying the Kaka'ako reclamation fill was a culturally sterile, greenish black, silty sand with an abrupt and discontinuous lower boundary (Stratum III). Judging from the nature of the lower boundary, which also displayed minute undulations, it is difficult to determine if Stratum III was an in situ A horizon, or a redeposited A horizon fill material. Stratum III may have developed in place but was later truncated and disturbed, or it may have been leveling fill comprised of mixed local wetland soil. Below Stratum III was a culturally sterile wetland environment consisting of a sandy clay (Stratum IVa) over a wetland A horizon (Stratum IVb), which developed within a slightly clayey sand with roots (Stratum IVc) (Figure 250).

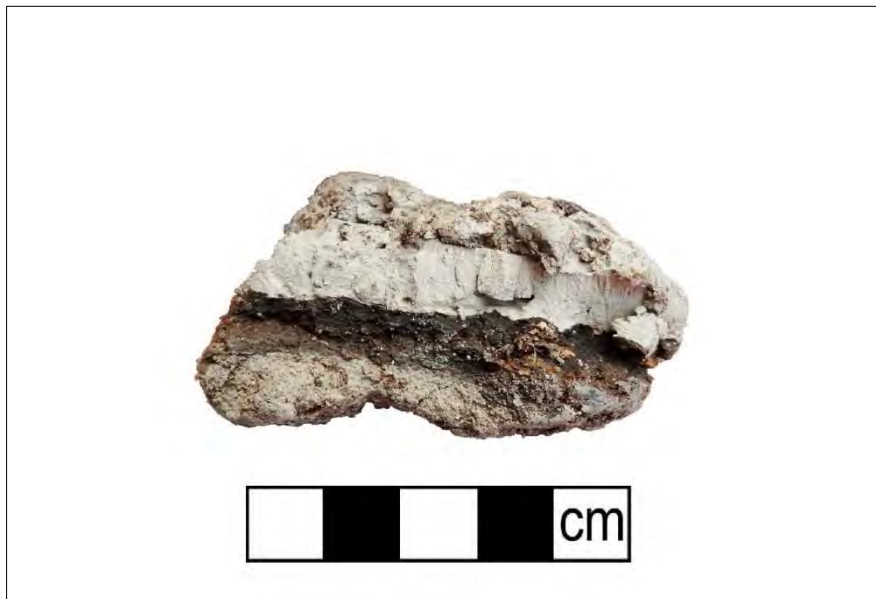
Figure 253. T-55, bulk sample from Stratum IIIa, showing a humus O horizon

T-55 documented recent fill deposits (Strata Ia–Ic), overlying a 1919–1927 Kaka'ako reclamation fill deposit (Stratum II), overlying a natural wetland environment resting on the coral shelf (Strata IIIa–IIIc). Stratum IIIa consisted of a thin layer of very dark grayish brown, clayey loam humus (Stratum IIIa) that developed in an organically rich, loamy-sandy wetland sediment (Strata IIIb and IIIc). Strata IIIb and IIIc exhibited a mixed appearance of brown, organically rich soil constituents, with gleyed sandy clay loam. This mottled presentation may reflect natural intermingling of the wetland deposits, possibly as a result of tidal fluctuations and/or changes in the overall depositional environment.
