Draft
Archaeological Inventory Survey Report for the
Block M Project, Kaka‘ako,
Honolulu Ahupua‘a, Honolulu (Kona) District, O‘ahu
TMK: [1] 2-3-002:001 (portion)

Prepared for
Victoria Ward Limited/Howard Hughes Corporation

Cultural Surveys Hawai‘i, Inc.
Kailua, Hawai‘i
(Job Code: KAKAAKO 122)

September 2014

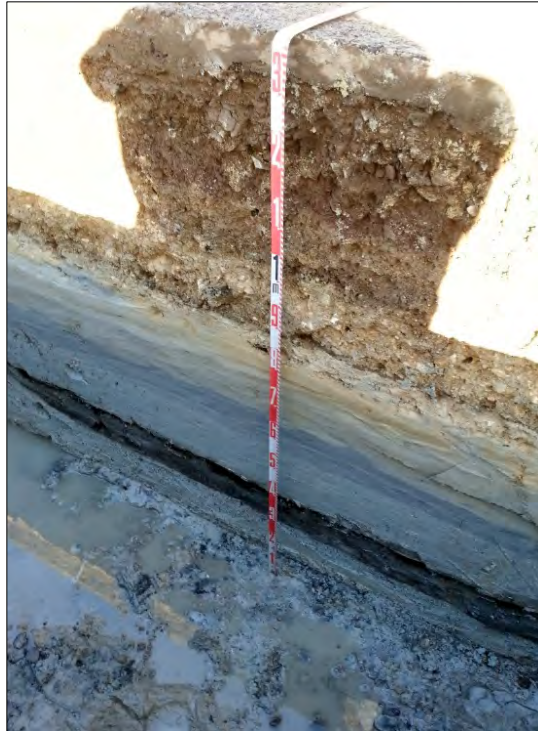
Figure 256. T-56, close-up of northwest wall, view to west

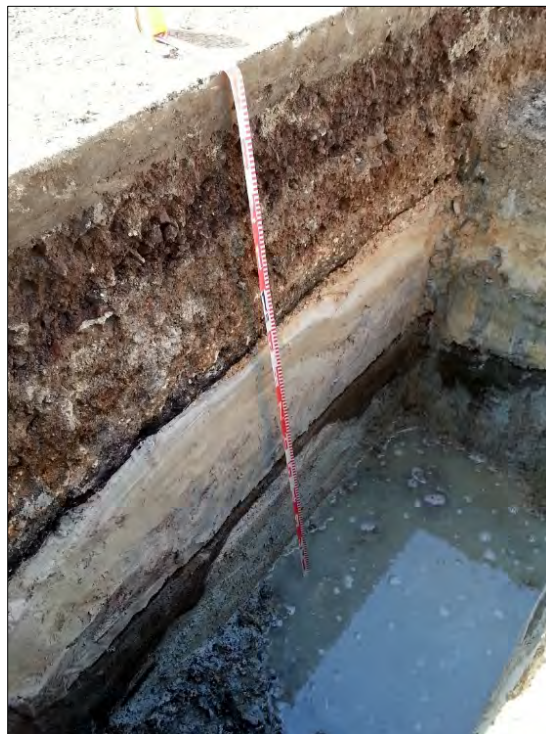
Figure 257. T-56 southeast wall (*makai* end), close-up of the Stratum IIIa abrupt and irregular lower boundary, view to south

T-56 documented recent fill deposits (Strata Ia–Ie) overlying a 1919–1927 Kaka'ako reclamation fill deposit (Stratum II), overlying a wetland environment (Strata IIIa–IIIb) resting on the coral shelf. Stratum IIIa is an undulating layer of dark gray, sandy loam humus (A horizon), developed on the surface of a wetland marsh-like environment. It appears that Stratum IIIa experienced a moderate amount of disturbance, evidenced by the irregular lower boundary that ranged from clear to abrupt (see Figure 257). Some organics were observed within the upper boundary of Stratum IIIb as it most likely underwent at least one of the four general processes of soil formation. Additionally, the gleyed deposits observed within the fill (Stratum II) and natural sediments (Stratum IIIb) are indicative of prolonged saturation in an anaerobic environment.

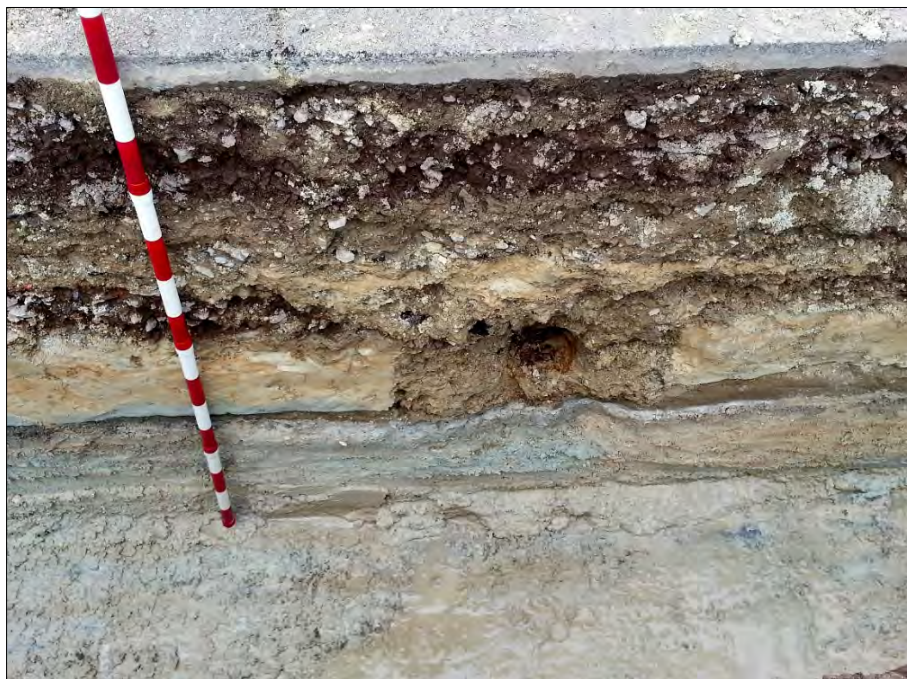
Figure 260. T-57 northwest wall, close-up of natural deposits (Strata III–VI), view to northwest

T-57 documented recent fill deposits (Strata Ia–Ie) overlying a 1919–1927 Kaka'ako reclamation fill deposit (Stratum II), overlying a redeposited, likely locally procured sand and clay utilized for land modification (Strata IIIa–IIIb), resting on a transitional environment from a wetland marsh-like setting to a sandy terrestrial dune setting. Strata IIIa and IIIb may reflect historic endeavors to level the low-lying wetlands prior to Kaka'ako land reclamation efforts and likely served as a former land surface. Below Strata IIIa and IIIb were natural deposits that displayed a shift in the depositional environment (see Figure 260). Collectively, Stratum IV was a culturally sterile soil horizon that gradually transitioned from a dark gray sandy loam, wetland A horizon (Stratum IVa) in the southwest (*makai*) to a light gray, sandy clay loam A horizon (Stratum IVb) in the northeast (*mauka*) (Figure 261). The change in color and texture from Stratum IVa to Stratum IVb was most likely due to both cultural and natural transformations such as intentional intermingling of the soil matrix (i.e., cultural transformation) evidenced by the generally abrupt to diffused lower boundary, and through wind and water (i.e., natural transformations) moving things about. Strata V and VI subsurface deposits also displayed a gradational-lateral shift that corresponded with the Strata IVa-IVb transition above. Stratum VI, located below Stratum IVa, was a culturally sterile sandy clay loam that turned to a culturally sterile clay sand (Stratum V) indicative of a sandier terrestrial environment.

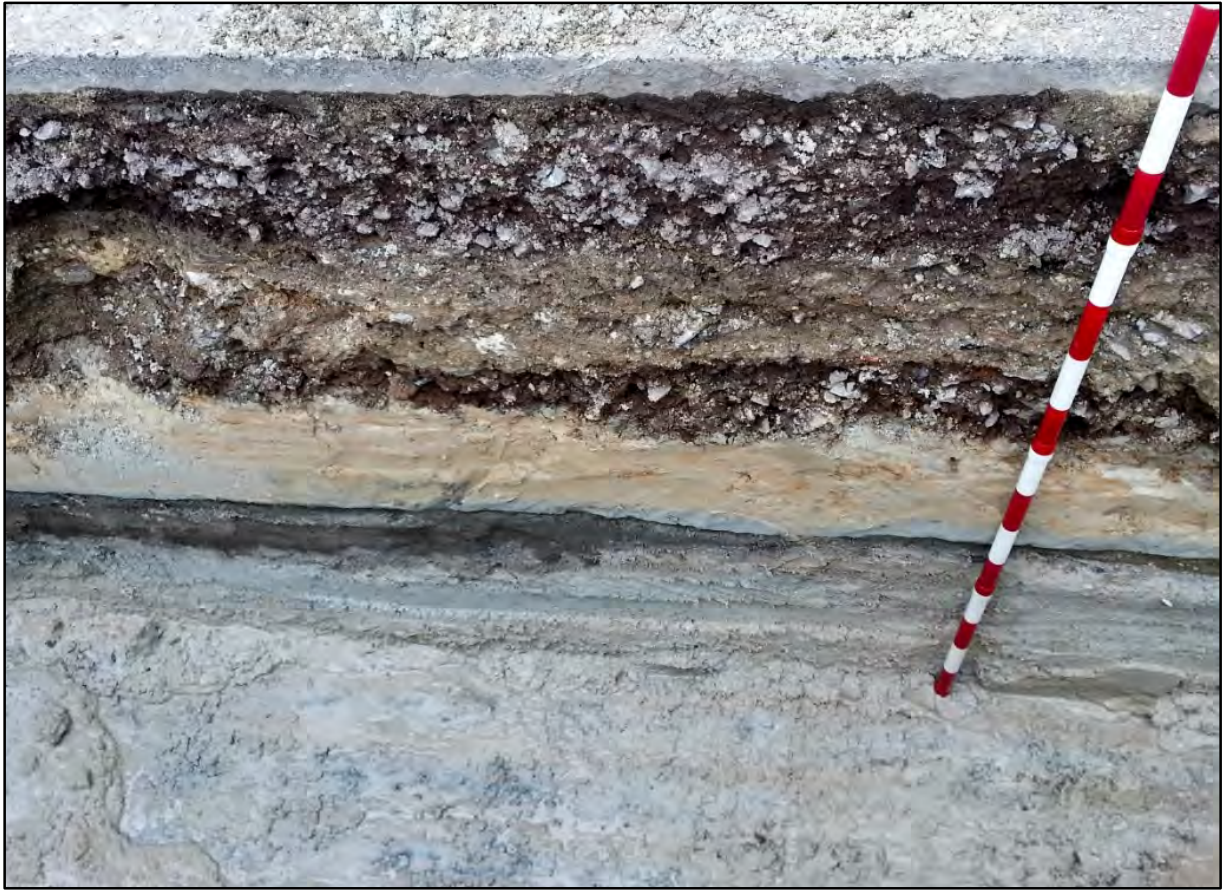
Figure 261. T-57 northwest wall, close-up of Stratum IVa, view to northwest

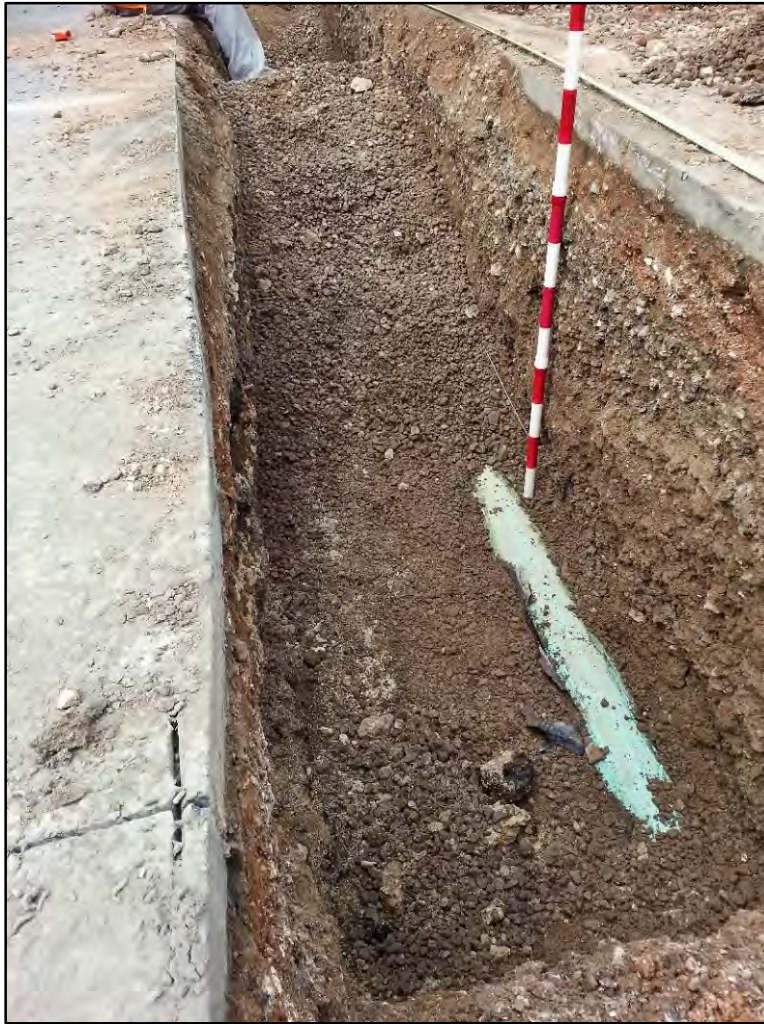
Figure 263. T-58 northeast wall with base course fill material and utility pipes, view to north

Test Excavation 58 (T-58), an exterior excavation located in the Office Depot parking lot on the corner of Queen and Kamake'e streets, was oriented southeast-northwest and measured 6.1 m long by 0.75 m wide. The base of excavation was determined by the presence of a Telecom utility pipe at 1.0 mbs. The stratigraphy of T-58 consisted of the asphalt surface (Stratum Ia) over an extremely gravelly mixed loam with coral and asphalt inclusions (Stratum Ib) and base course material (Stratum Ic) (Figure 263 and Figure 264, and Table 60).

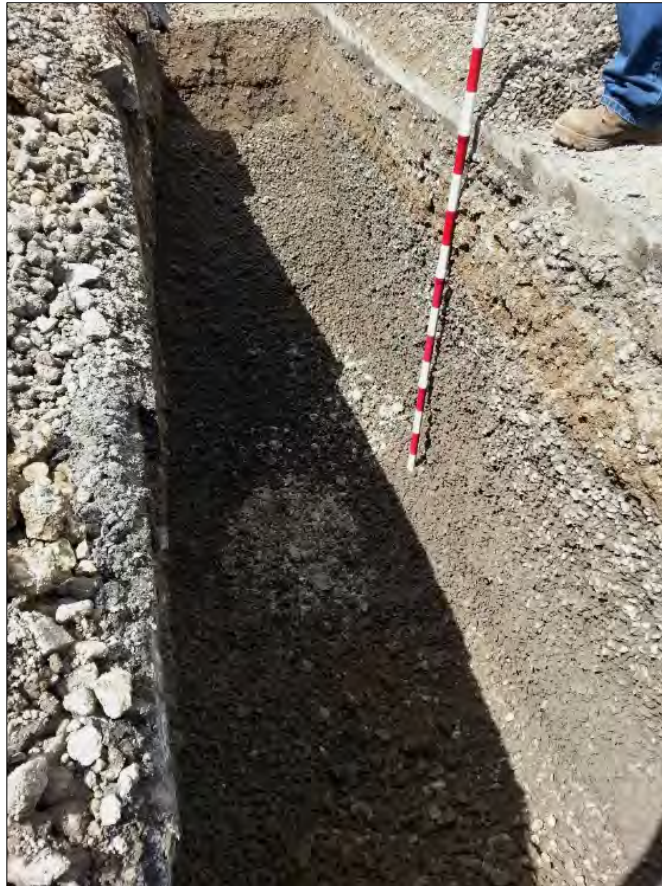
Figure 265. T-59 northeast wall, view to north

T-59 documented extensive modern disturbance as the historic reclamation fill deposits and underlying natural sediment had been removed and replaced with base course material (Strata Ib–Id). The only remaining portion of the natural environment was approximately 6 cm of culturally sterile, clayey wetland sand (Stratum II) resting over the coral shelf.

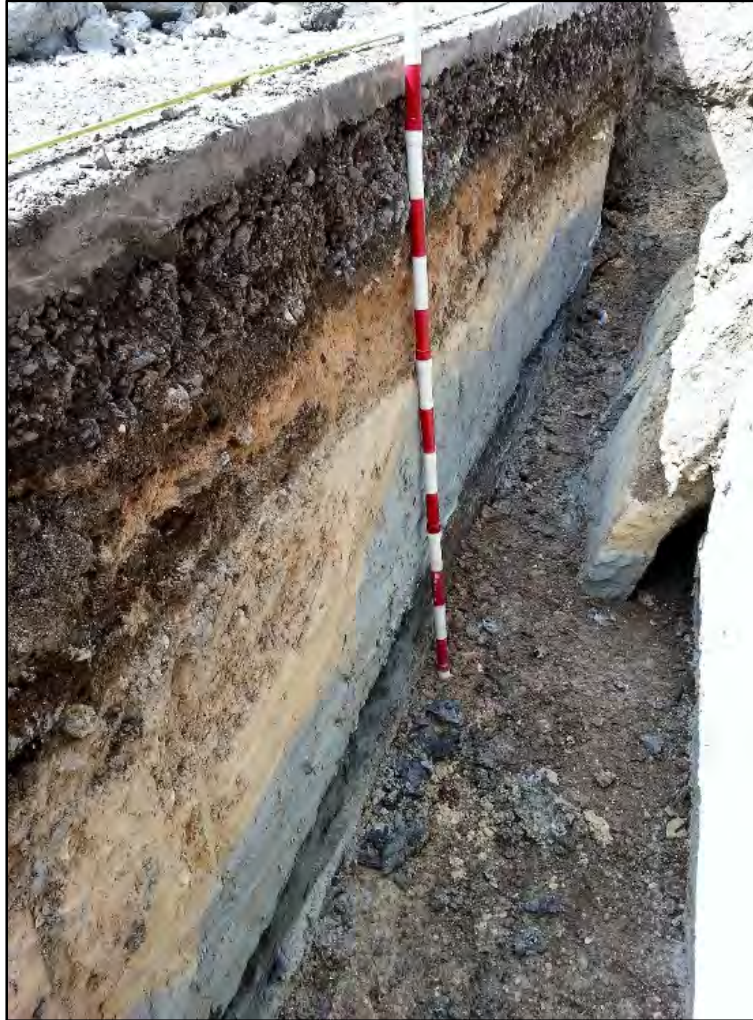
Figure 268. T-60 southwest wall, showing collapse of the northeast wall, view to west

Test Excavation 60 (T-60), an exterior excavation located in the Office Depot parking lot on the corner of Queen and Kamake'e streets, was oriented southeast-northwest and measured 6.0 m long by 1.03 m wide. The base of excavation was determined by the presence of the hard coral shelf at 1.4 mbs. The stratigraphy of T-60 consisted of the asphalt surface (Stratum Ia), associated base course (Stratum Ib), gravelly clay loam (Stratum Ic), and fine sandy clay fill (Stratum Id) overlying a 1919–1927 Kaka'ako reclamation fill deposit consisting of fine sandy clay (Stratum II), overlying a humus and clay wetland O horizon (Stratum IIIa), a wetland clay with organics (Stratum IIIb), and coarse sand (Stratum IV) (Figure 267 through Figure 269, and Table 62). The northeast sidewall was undermined and collapsed due to the combination of a pit disturbance in the north portion of the trench and a PVC line that ran parallel with the northeast wall (see Figure 268).

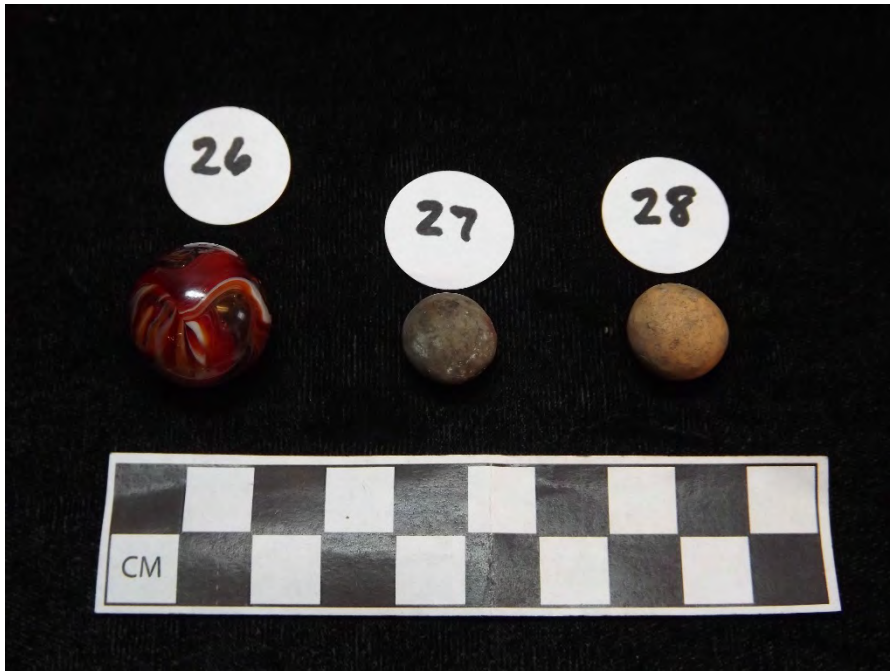
Figure 278. Glass and clay marbles identified within modern mixed fill (Acc. #s 26–28)

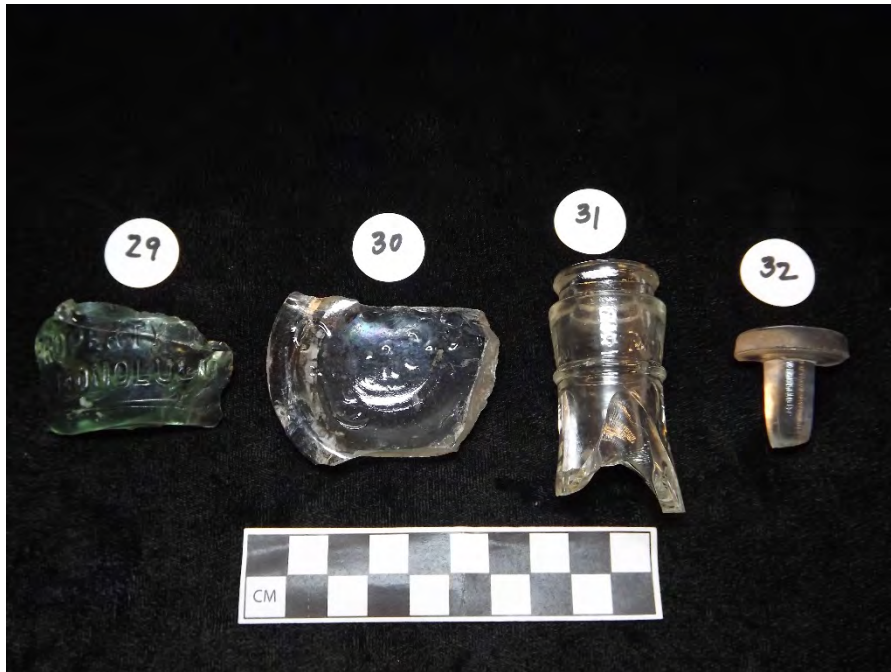
Figure 279. Glass bottle fragments identified within modern mixed fill (Acc. #s 29–32)

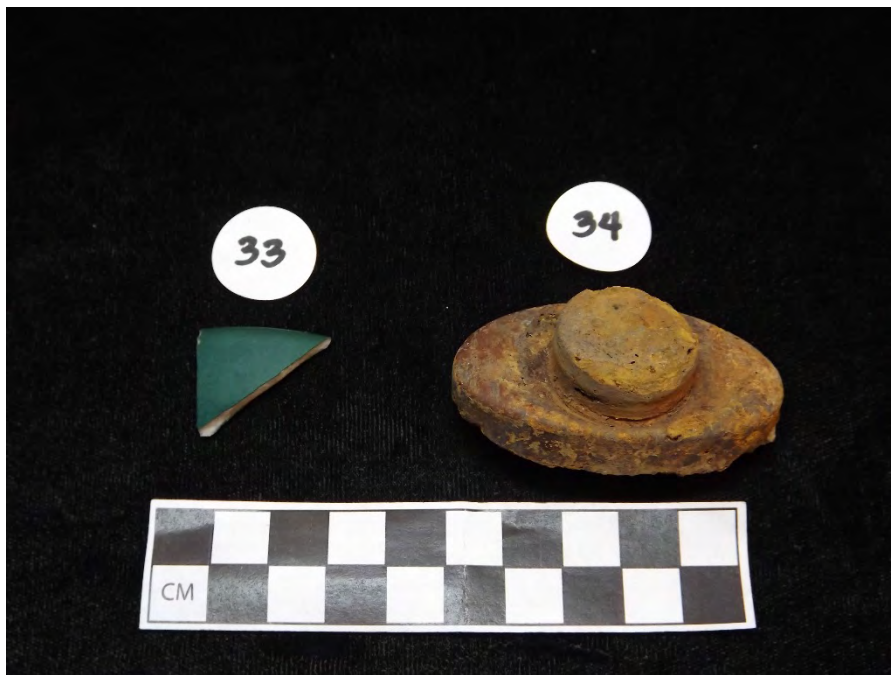
Figure 280. A porcelain bowl fragment and a portion of a screw top metal container identified within modern mixed fill (Acc. #s 33, 34)

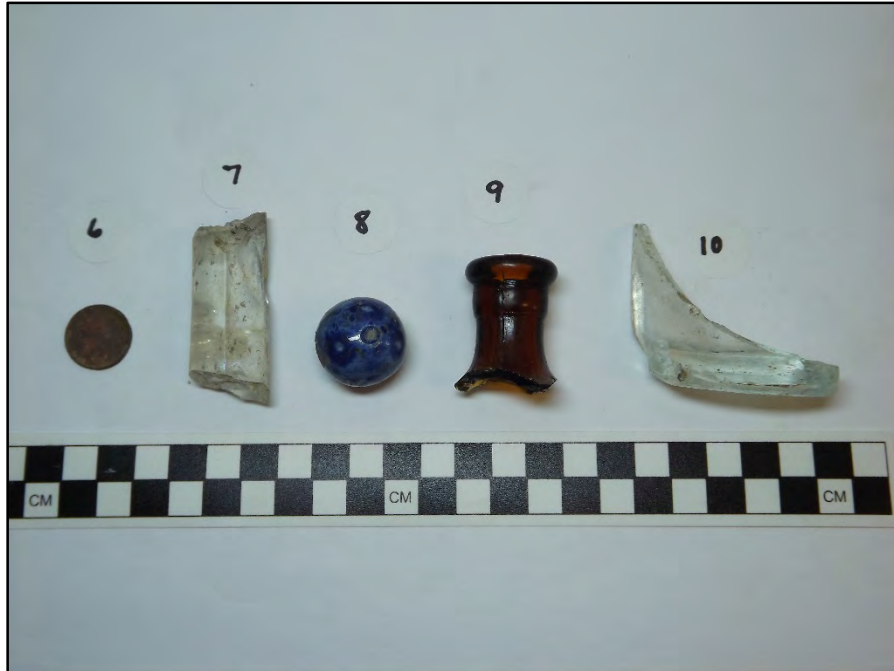
Figure 283. 1918 U.S. penny, a glass handle fragment, a blue-fired clay marble, and glass bottle fragments identified within Stratum Ib (Acc. #s 6–10)

T-64 documented recent fill deposits (Strata Ia–Id), over historic fill deposits (Strata IIa, IIb, III), over a natural, transitional environment from a wetland, marsh-like setting (‘Ewa end) to a sandy terrestrial dune setting (southeast end). Historic trash was found incorporated within Stratum Ib (recent fill), possibly related to the nearby nineteenth and twentieth century residential houses along Queen Street, consisted of fishbone, a clay marble, glass fragments, oxidized metal, broken utility pipe fragments, wood, brick fragments, rusted nails, marine shell, a 1918 U.S. penny, and butchered *Bos taurus* (cow) bone (Figure 283). Additionally, a sandy loam fill containing historic trash (Stratum Ie) was encountered in the northwest (‘Ewa) end that originated from below Stratum Ic and truncated Strata Id and IIa. This deposit consisted of gravelly, coarse sandy loam, with an appreciable amount of historic refuse. Materials included glass bottle fragments, metal fragments, wire, nails, ceramic fragments, wood, tile fragments, decorated shell (non-traditional Hawaiian), ceramic and bone buttons, marine shell (*Nerita picea*), charcoal, fire-altered cobbles, and possible shoe rubber (Figure 284 and Figure 285). A similar concentration was found within T-63, cutting into the upper crushed coralline sand fill. However; the trash concentration within T-64 appeared to have been graded in with the fill, rather than deposited after the crushed coralline sand fill.

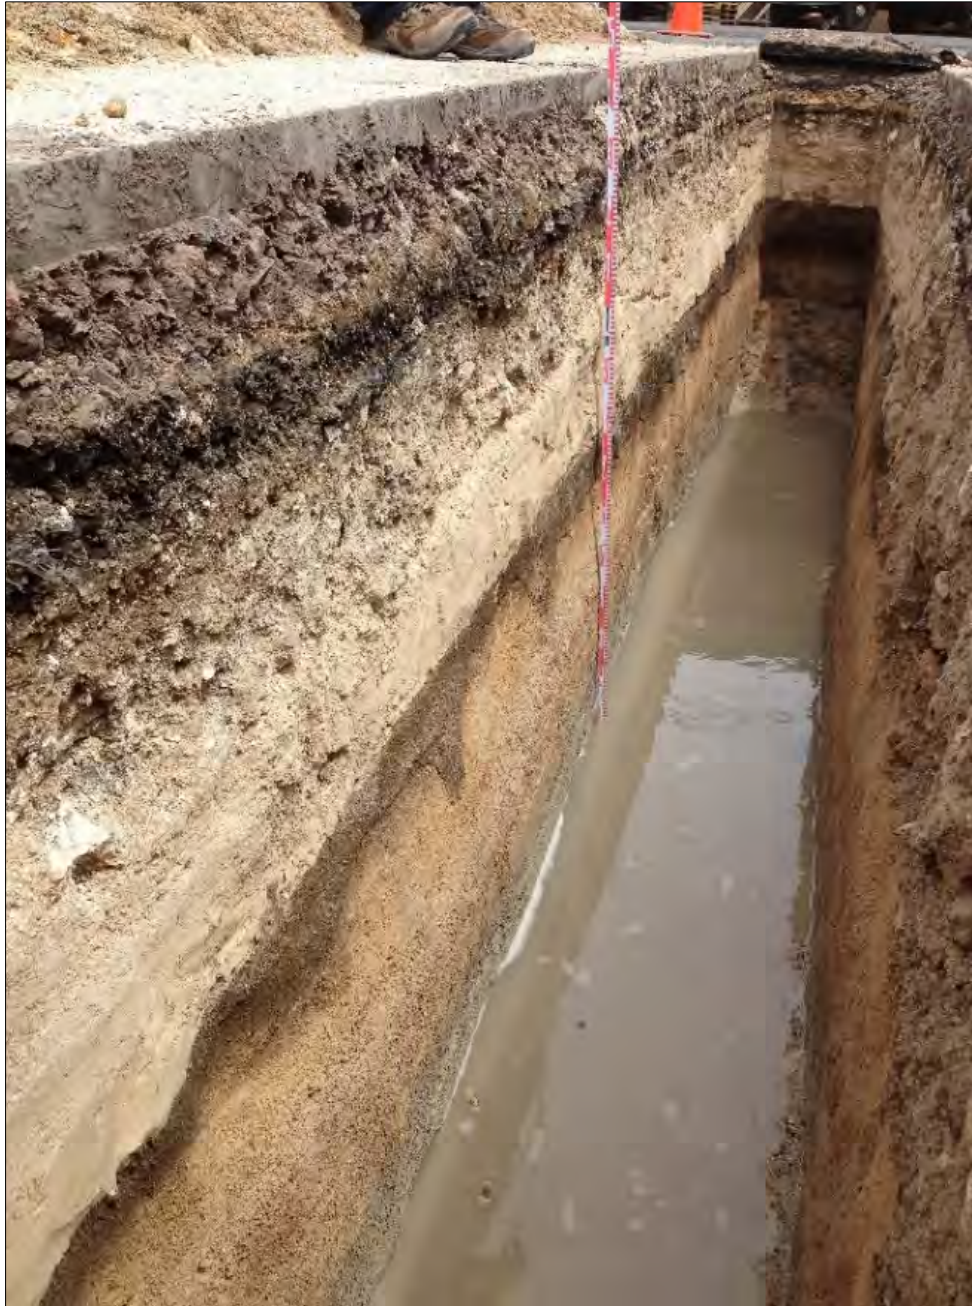
Figure 287. T-65 northeast profile, view to southeast

Test Excavation 65 (T-65), an exterior excavation located in the parking lot northwest (‘Ewa) of the Office Depot building, was oriented northwest-southeast and measured 6.1 m in long and 0.7 m in wide. The base of excavation was determined by the presence of the hard coral shelf at 1.45 m. T-65 consisted of the asphalt surface (Stratum Ia) and associated base course (Stratum Ib), a gravelly asphalt layer (Stratum Ic) and coarse gravelly loam fill (Stratum Id), 1919–1927 Kaka‘ako reclamation fill deposits consisting of very gravelly sand (crushed coral) (Stratum IIa) and hydraulic (dredge) fine clay sand (Stratum IIb), overlying a redeposited, locally procured loamy sand (Stratum III), overlying a natural loamy sand A horizon (Stratum IVa), Jaucas sand (Stratum IVb), and a coarse silty sand wetland deposit (Stratum V) (Figure 287, Figure 288 through Figure 290, and Table 67).

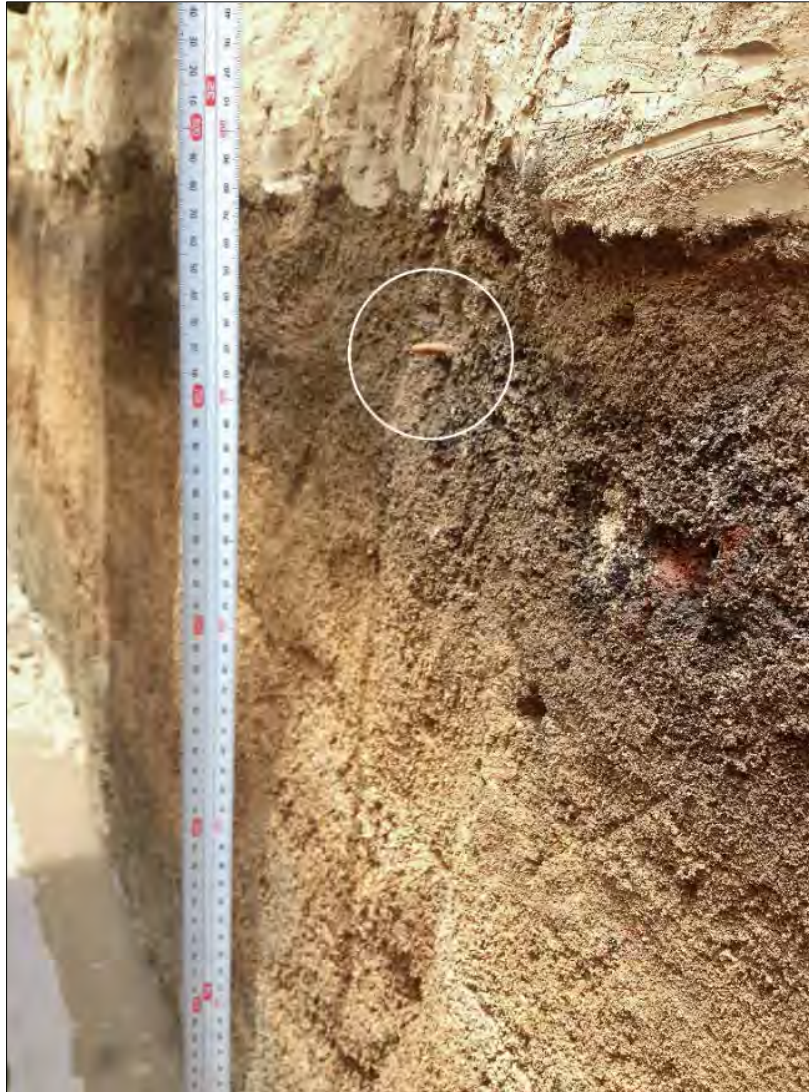
Figure 288. T-65 northeast wall, showing a modified faunal bone located at the interface of Strata III and IVa (SIHP # -7429), view to north

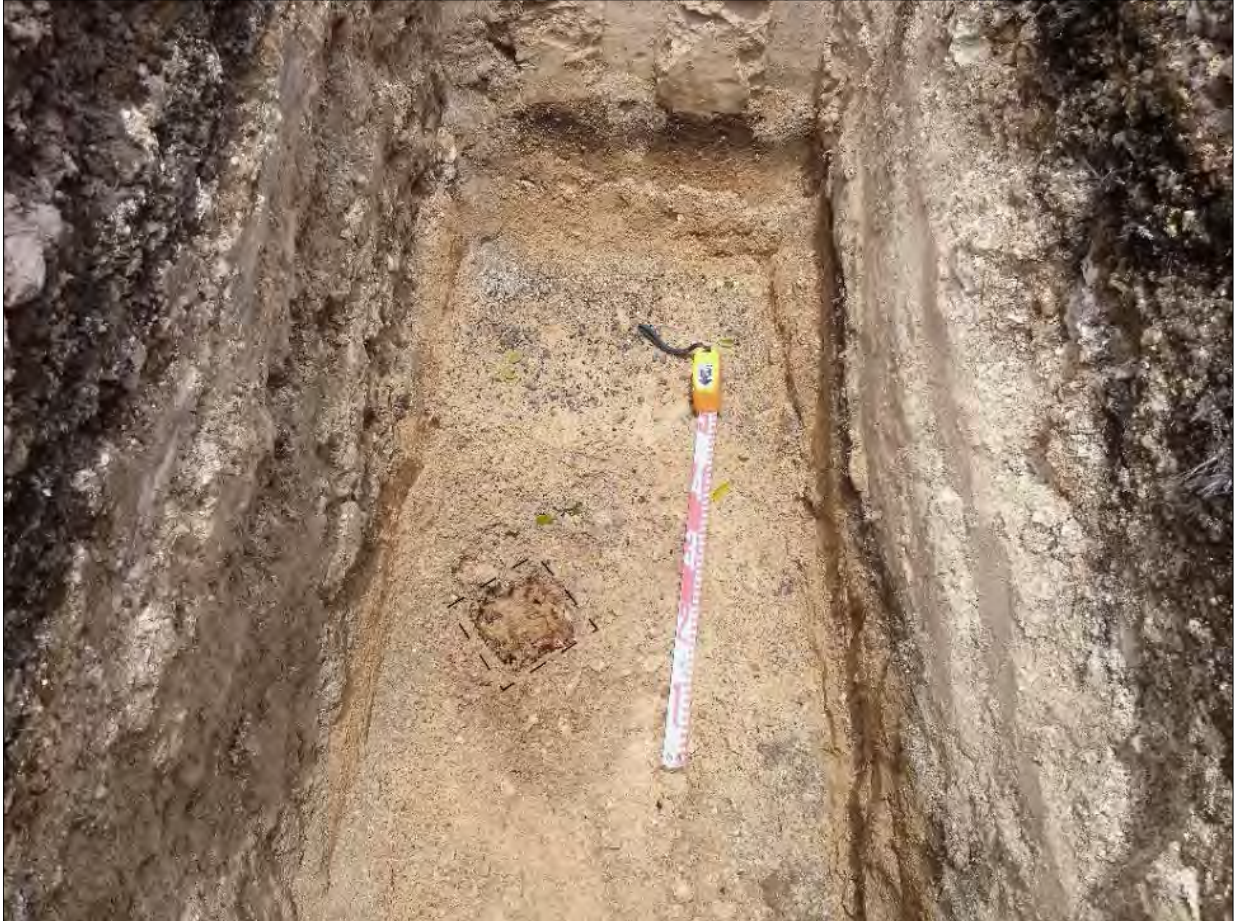
Figure 289. T-65, milled wood terminating in Stratum IVb (Jaucas sand), view to northwest

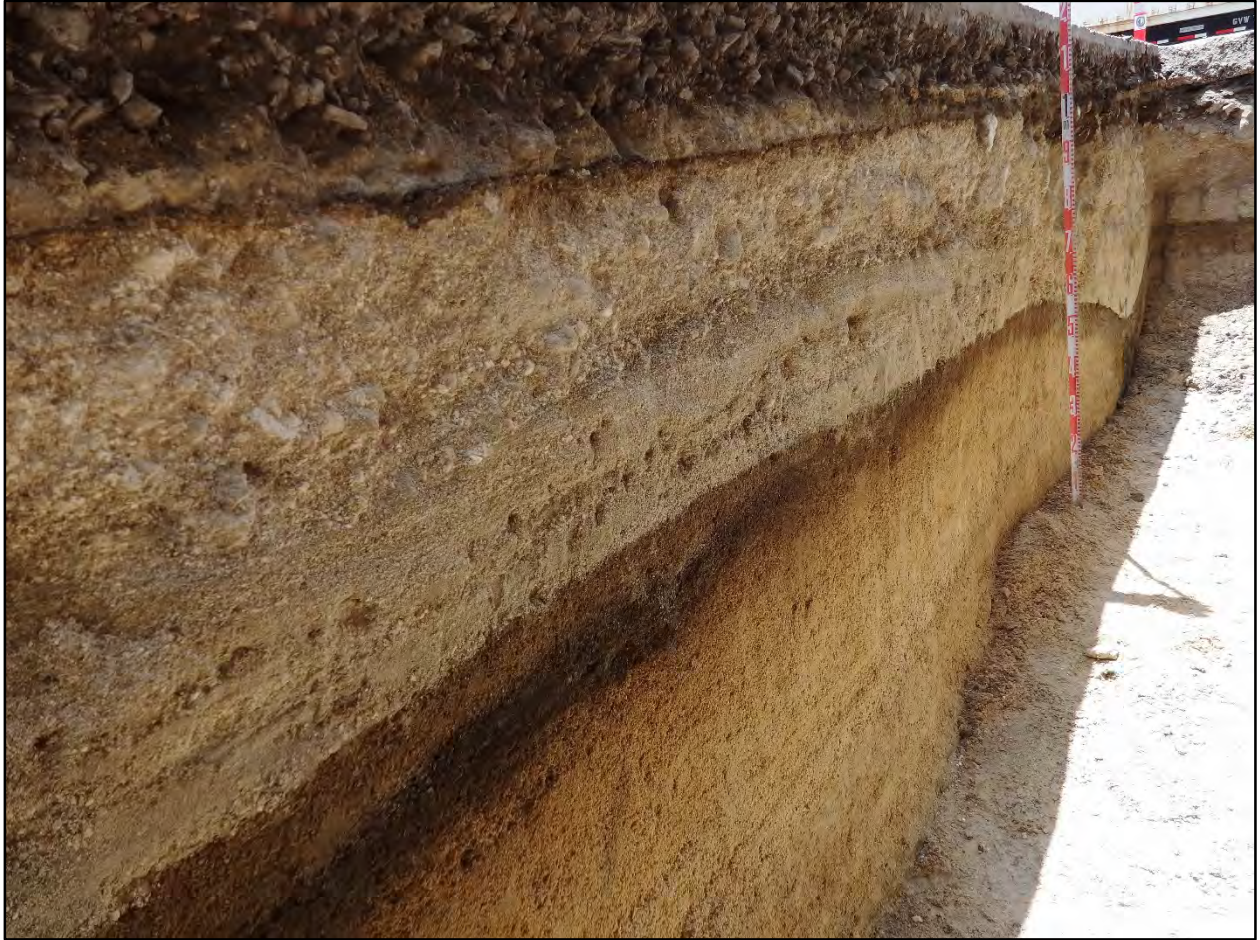
Figure 293. T-66 northeast (*mauka*) wall, showing fill deposits over a dark-stained A horizon and Jaucas sand, which transitions towards the south into a man-made *'auwai* (SIHP # - 7429 Feature 14), view to northwest

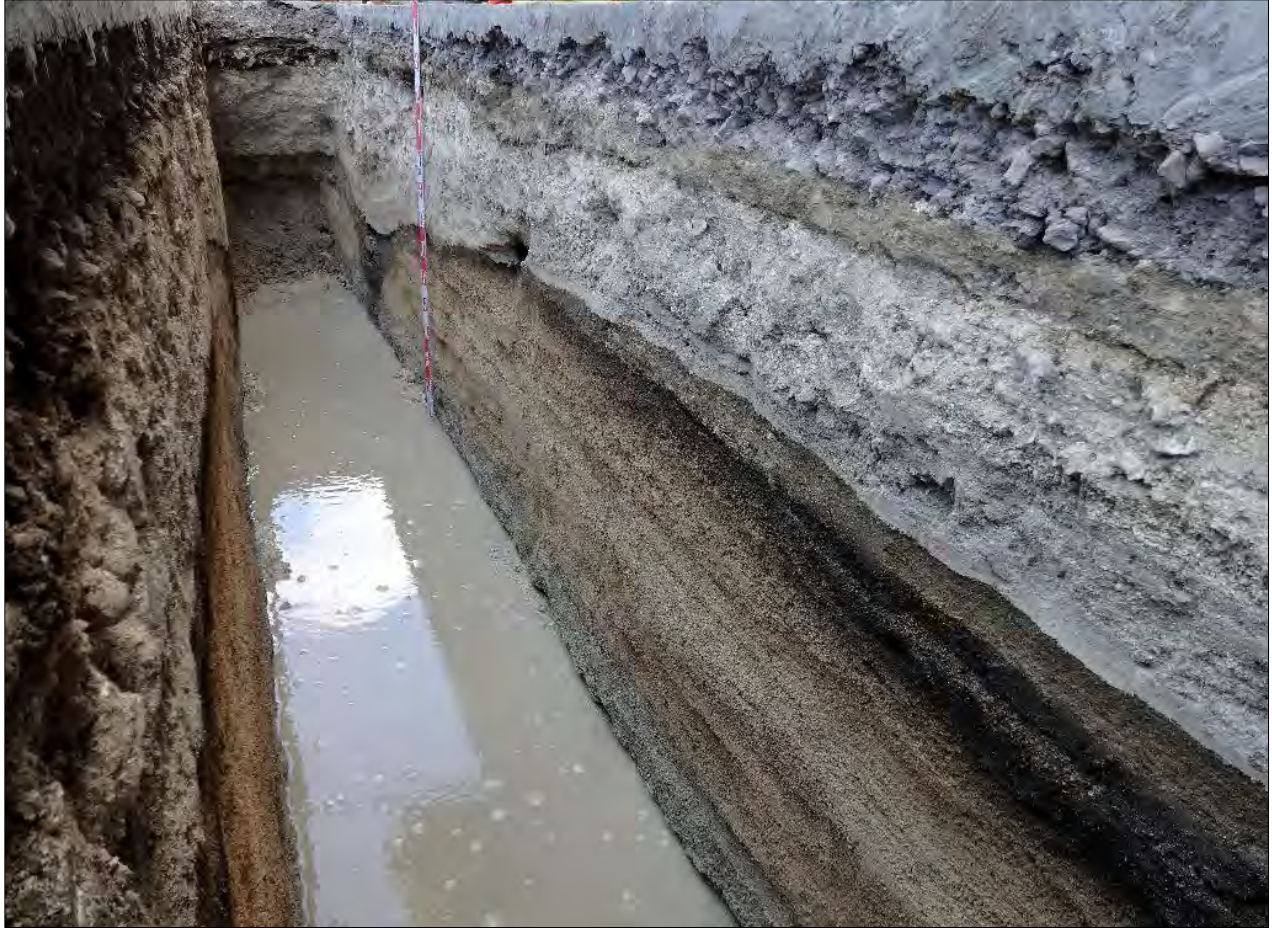
Figure 294. T-66 southwest wall, showing the man-made *'auwai* (SIHP # -7429 Feature 14) running *mauka-makai*, view to southeast

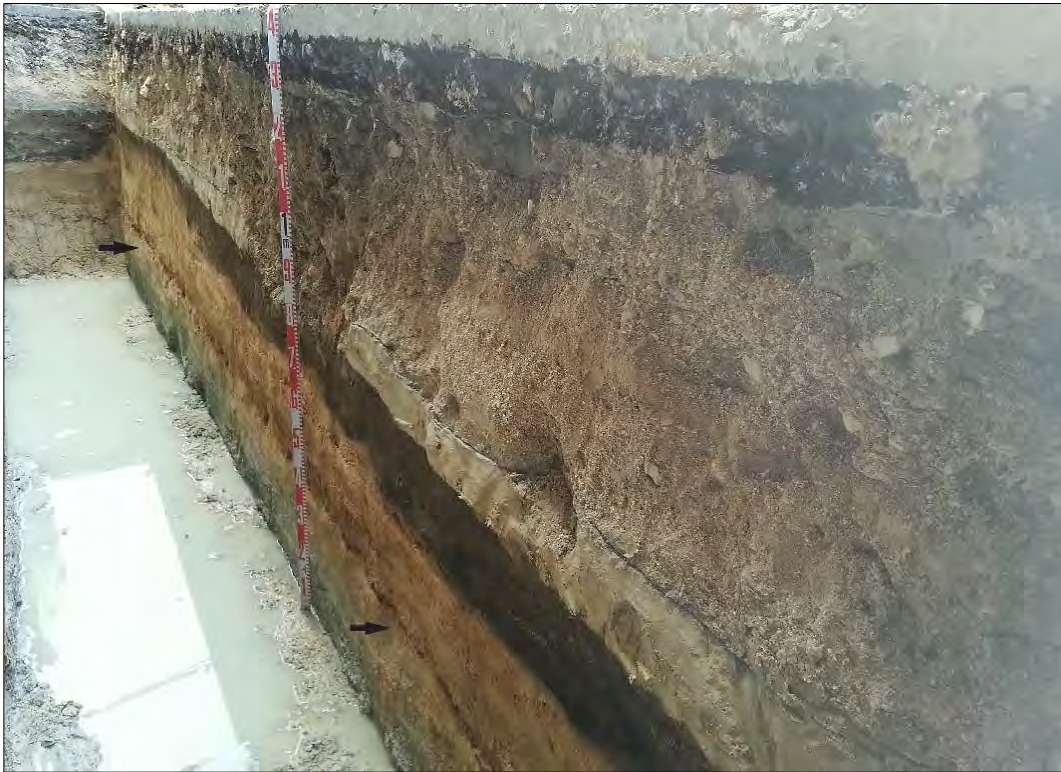
Figure 302. T-67 southwest wall, black arrows point to thin indurate lens

T-67 documented recent fill deposits (Strata Ia–Ib) over historic fill deposits (Strata IIa–IIb), over a disturbed A horizon (Stratum III) marbled with the underlying Jaucas sand (Stratum IV) and wetland clay (Strata Va–Vb). Five gallons of the disturbed A horizon (Stratum III) was screened in the field and yielded no cultural material. Heavy disturbance of this layer is indicated by the irregular, abrupt to diffused lower boundary, as well as the heavily marbled soil matrix that was incorporated with Jaucas sand, charcoal, and clay (see Figure 303). The boundary between Stratum IV (Jaucas sand) and Stratum V (wetland deposit) contained a thin indurate layer of coarse sand that either represents a different depositional environment or compaction from the weight of overlying deposits combined with water table fluctuations and calcification of the sediment grains (see Figure 302).

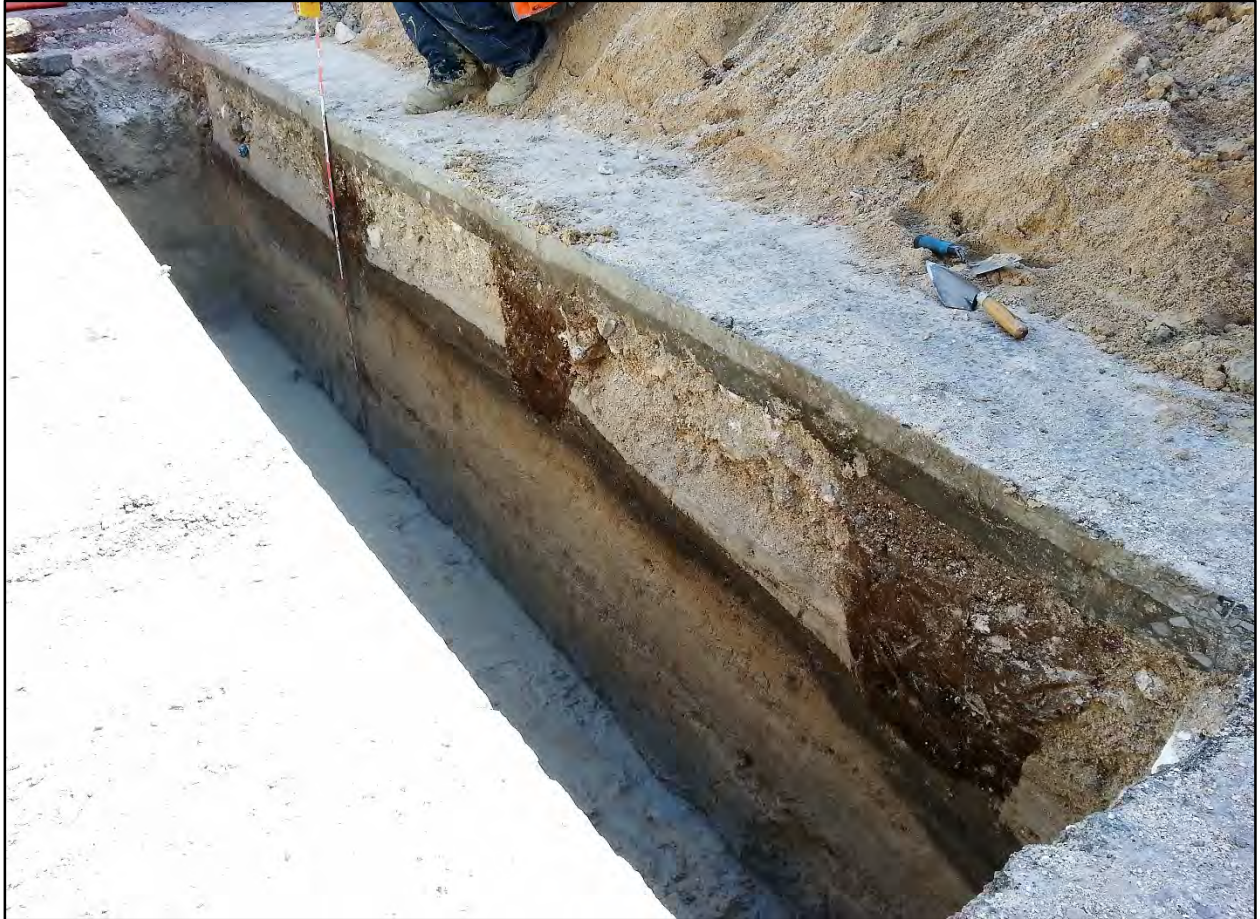
Figure 305. T-68 southwest wall, view to west

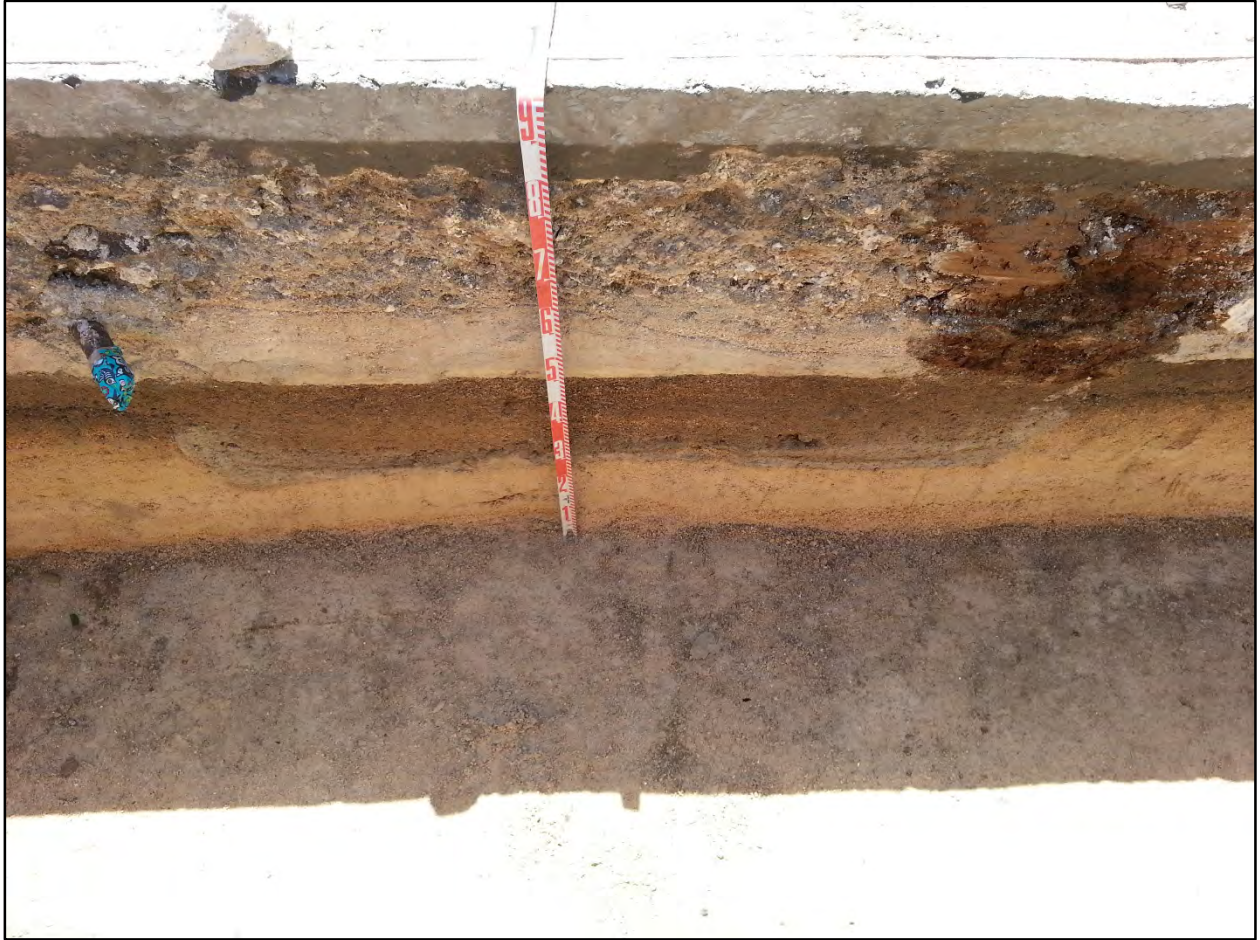
Figure 306. Close-up of SIHP # -7429 Feature 16, a clay-lined rectangular feature likely utilized to contain or channel water, southwest sidewall of T-68

Within the southern portion of T-68, a rectangular clay-lined feature was observed extending diagonally (north-south) across the test excavation floor, measuring 1.2 m wide by 0.24 m deep (see Figure 306 and Figure 307). The feature, designated SIHP # -7429 Feature 16, appeared to be laterally associated with Stratum IIIa, a redeposited locally procured sand fill layer utilized to level or build up the land surface and which served as a living surface for a period of time prior to reclamation activities. The feature cut down through the earlier, natural A horizon (Stratum IVa) and intruded into the underlying Jaucas sand (Stratum IVb). Based on the presence of clay lining, the feature functioned as either a water containment or water channel feature. Feature 16 was in-filled with a loamy sand (Stratum IIIb), interpreted as secondary fill material.

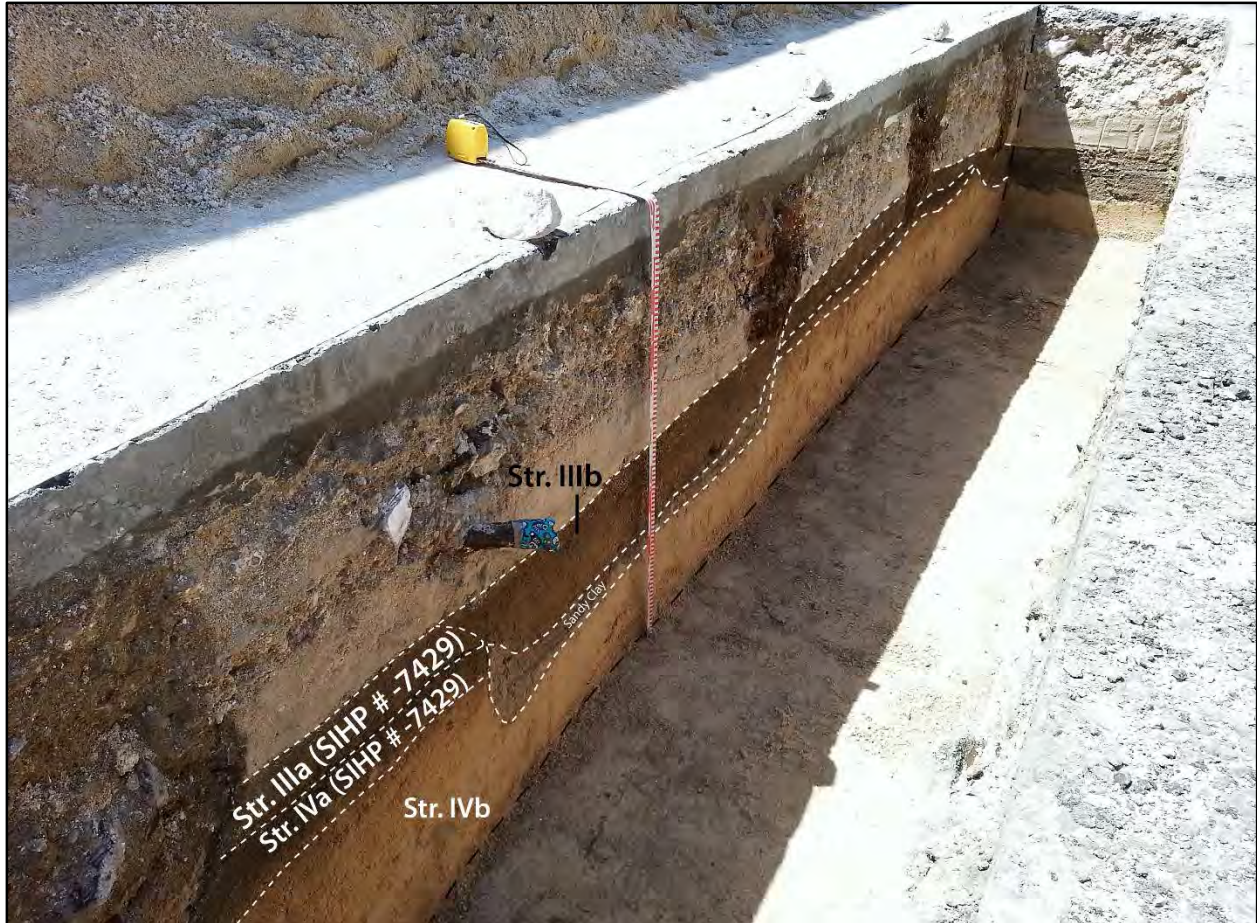
Figure 307. T-68 southwest wall, showing a historic fill layer utilized as a living surface (Stratum IIIa) overlying a natural A horizon (Stratum IVa) and Jaucas sand (Stratum IVb); a clay-lined feature, SIHP # -7429 Feature 16, cuts through the A horizon and appears to be laterally associated with Stratum IIIa

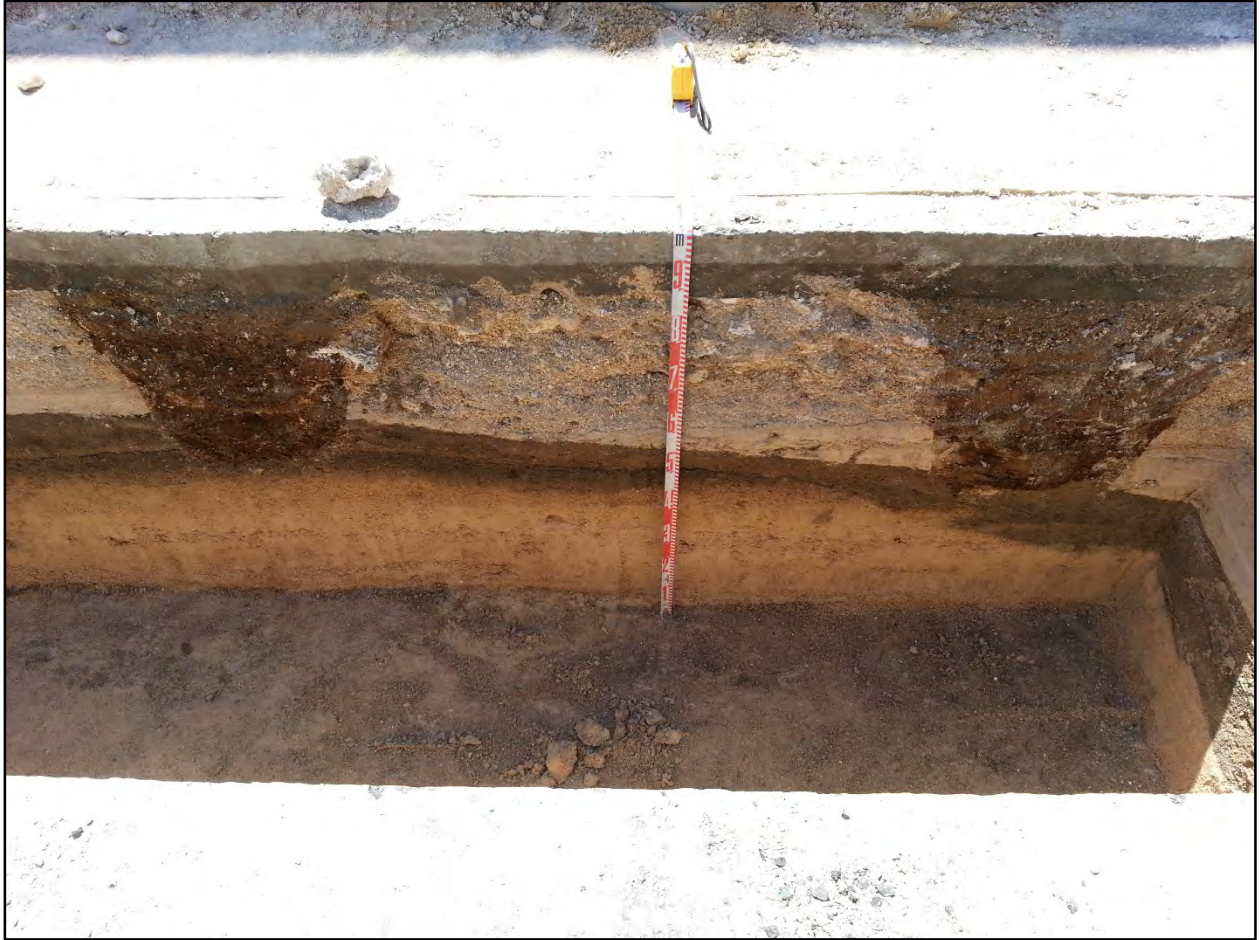
Figure 308. Close-up of the southwest sidewall of T-68 (northern end), showing uniform pit features truncated by the modern asphalt road and extending into Strata III (historic sand fill) and IVa (in situ A horizon)

T-68 differed from the surrounding test excavations in that the current asphalt surface (Stratum I) directly overlay the 1919–1927 Kaka‘ako reclamation fill deposits (Strata IIa–IIb) and appeared to have truncated three modern pit features (labeled as Pits 1–3 in Figure 309). The pit features were identical in shape and fill content and were uniformly spaced, indicating a potential structural function such as fence holes. Aside from oxidized metal fragments, no cultural material was observed in the clay pits. Due to truncation, the provenience of these pit features is unclear.

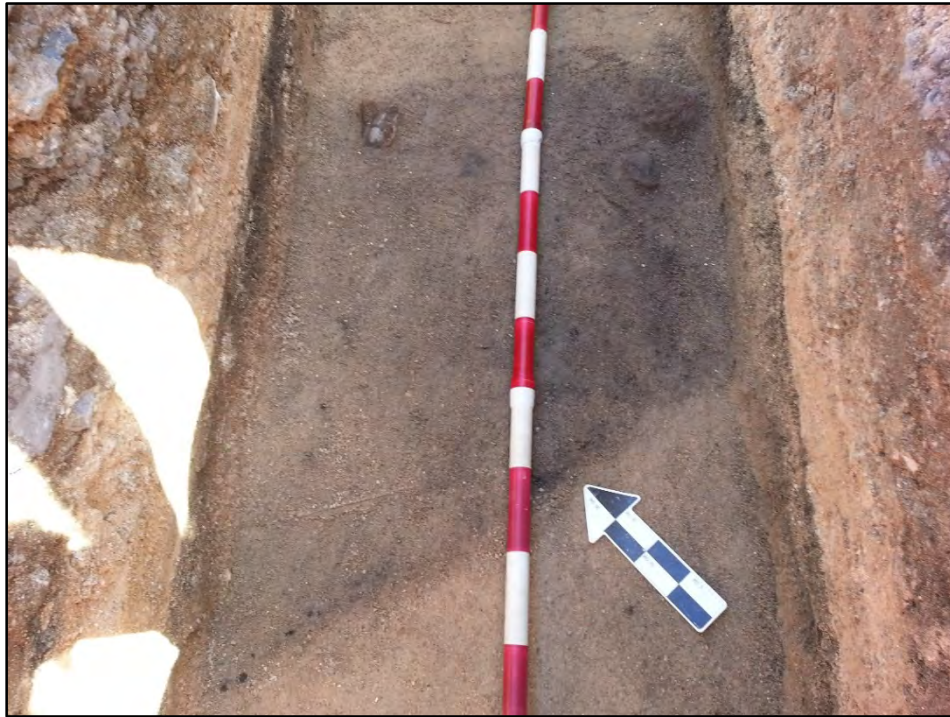
Figure 333. Close-up of SIHP # -7429 Feature 8, prior to excavation

SIHP # -7429 Feature 8 was a concentration of charcoal and fire-affected rock and coral identified within T-2, originating within the buried natural A horizon and extending into the underlying Jaucas sand (Figure 333 through Figure 337). The feature extended diagonally through the test excavation and was documented between 67 and 95 cmbs. It measured 86 cm long, 75 cm wide, and 15 cm thick. In addition to fire-altered material, Feature 8 contained marine midden consisting of *Echinothrix diadema* sp. (*wana*, or sea urchin) (1.8 g), *Tellina palatam* (19.0 g), and *Turbo sandwicensis* (13.1 g). A charcoal sample was collected for radiocarbon dating and yielded a date of Cal AD 1405 to 1445 (2 σ) (Beta -384715), which establishes the use of this area as early as the fifteenth century. SIHP # -7429 Feature 8 is interpreted as a fire pit for the preparation and consumption of food.
