Draft
Archaeological Inventory Survey Report for the
Block M Project, Kaka‘ako,
Honolulu Ahupua‘a, Honolulu (Kona) District, O‘ahu
TMK: [1] 2-3-002:001 (portion)

Prepared for
Victoria Ward Limited/Howard Hughes Corporation

Cultural Surveys Hawai‘i, Inc.
Kailua, Hawai‘i
(Job Code: KAKAAKO 122)

September 2014

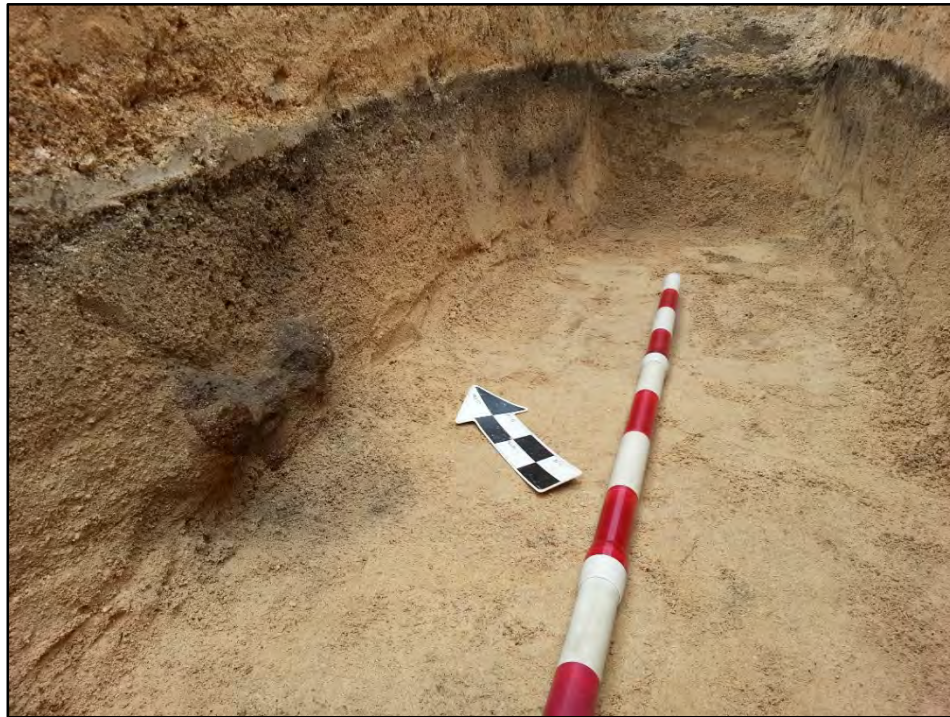
Figure 334. Photograph of T-2 (*mauka* portion), showing SIHP # -7429 Features 8 (rear) and 9 (fore)

SIHP # -7429 Feature 8 was a concentration of charcoal and fire-affected rock and coral identified within T-2, originating within the buried natural A horizon and extending into the underlying Jaucas sand (Figure 333 through Figure 337). The feature extended diagonally through the test excavation and was documented between 67 and 95 cmbs. It measured 86 cm long, 75 cm wide, and 15 cm thick. In addition to fire-altered material, Feature 8 contained marine midden consisting of *Echinothrix diadema* sp. (*wana*, or sea urchin) (1.8 g), *Tellina palatam* (19.0 g), and *Turbo sandwicensis* (13.1 g). A charcoal sample was collected for radiocarbon dating and yielded a date of Cal AD 1405 to 1445 (2 σ) (Beta -384715), which establishes the use of this area as early as the fifteenth century. SIHP # -7429 Feature 8 is interpreted as a fire pit for the preparation and consumption of food.

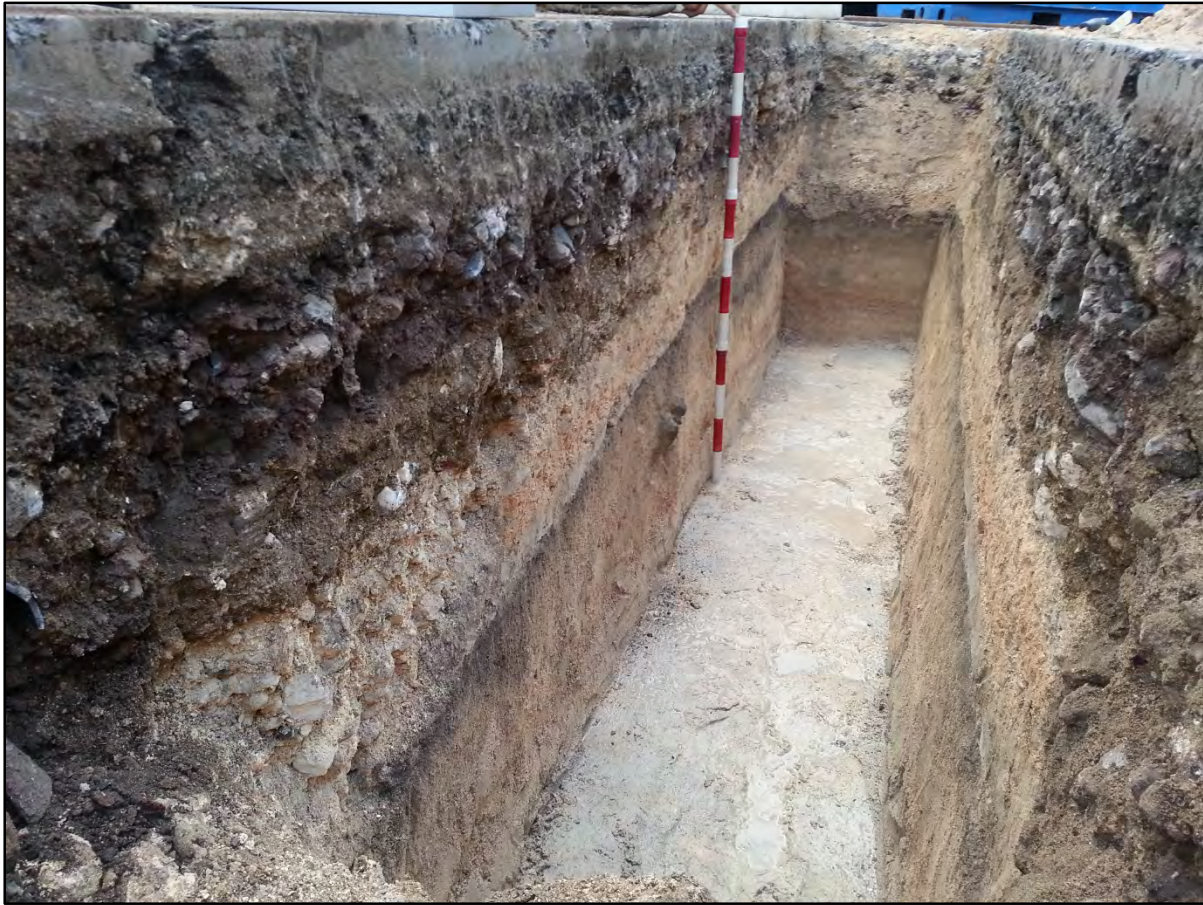
Figure 335. T-2 northwest wall, showing SIHP # -7429 Features 11, 9, and 8 (from front to back)

SIHP # -7429 Feature 11 was a stained pit identified in T-2, originating within the buried natural A horizon and extending into the underlying Jaucas sand (see Figure 335, Figure 336). Feature 11 was documented between 75–90 cmbs and measured 14 cm wide and 12 cm thick. No cultural material was observed. SIHP # -7429 Feature 11 is interpreted as a pit of indeterminate function.

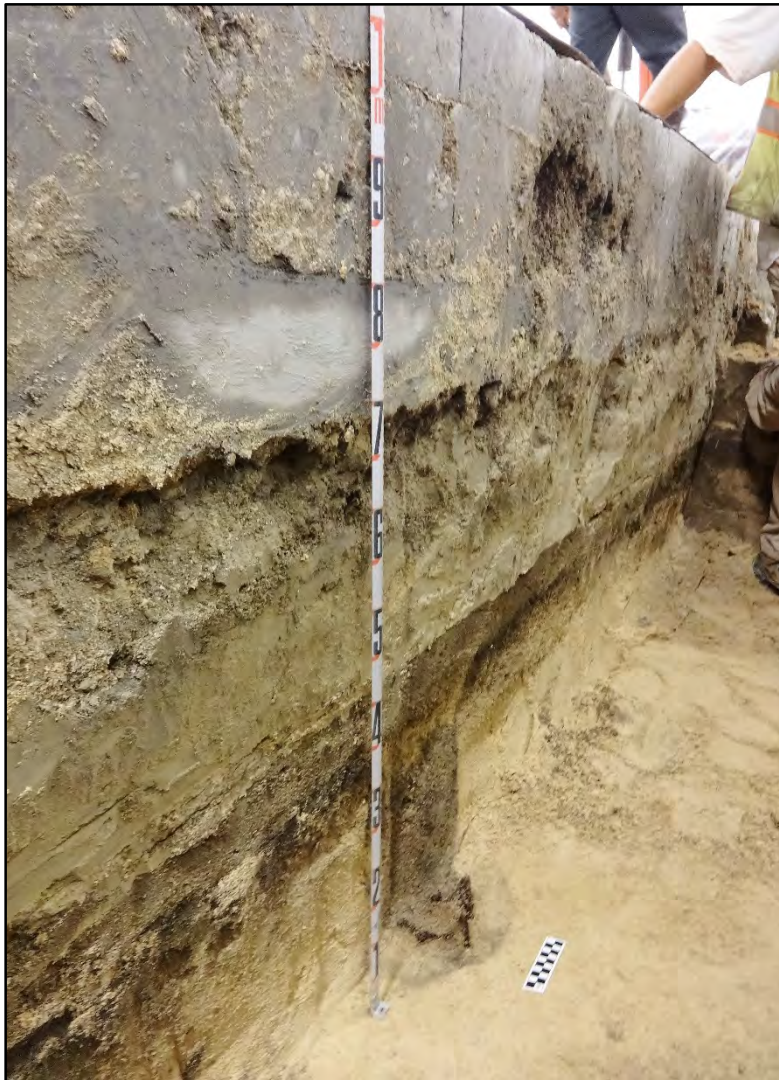
Figure 338. Photograph of T-31 southeast wall, showing SIHP # -7429 Feature 12, a posthole containing a historic milled wood post, originating from Stratum III (SIHP # -7429)

SIHP # -7429 Feature 12 was a posthole that contained decomposing milled wood, identified in T-31 (Figure 338 and Figure 339). Feature 12 originated from Stratum III (historic sand fill) and terminated at the interface of Strata IVb (Jaucas sand) and V (marine sand). The feature was documented between 82–117 cmbs and measured 31 cm long, 20 cm wide, and 12 cm thick. SIHP

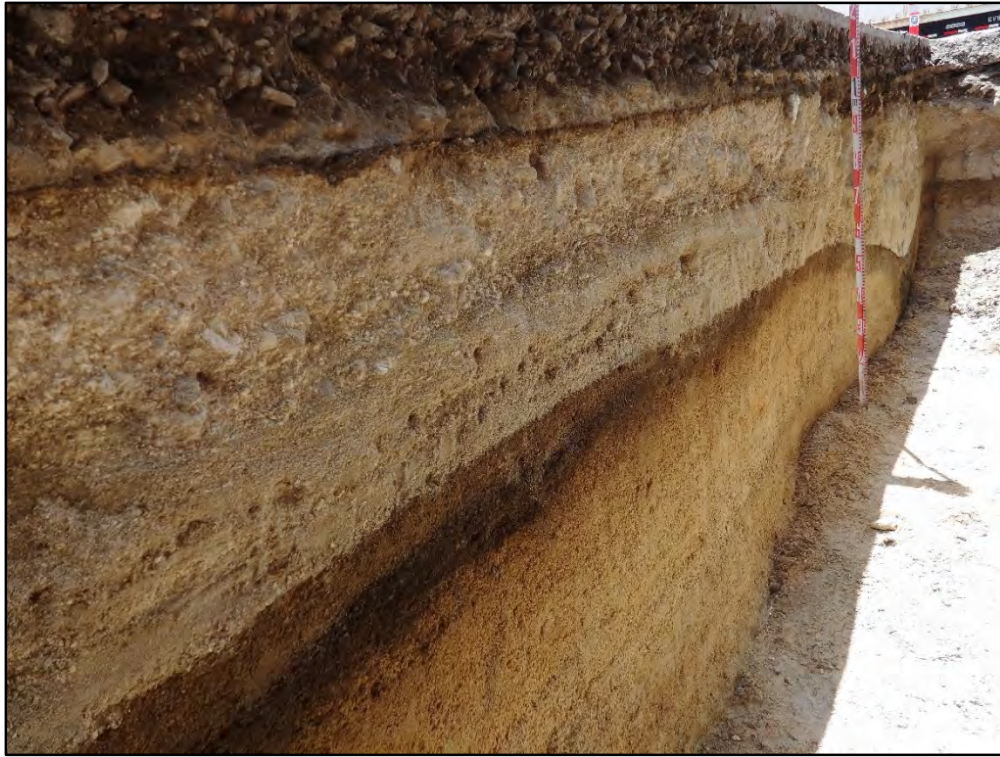
Figure 341. T-66 northeast wall, showing SIHP # -7429 Feature 14 (*'auwai*) at the south end

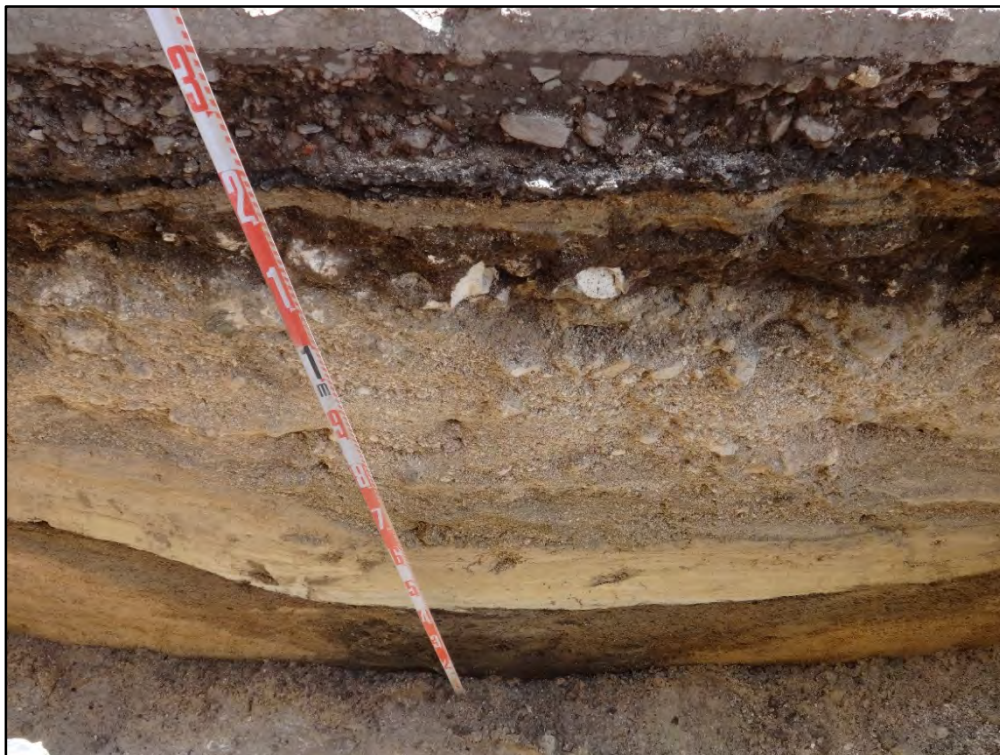
Figure 342. Close-up of SIHP # -7429 Feature 14

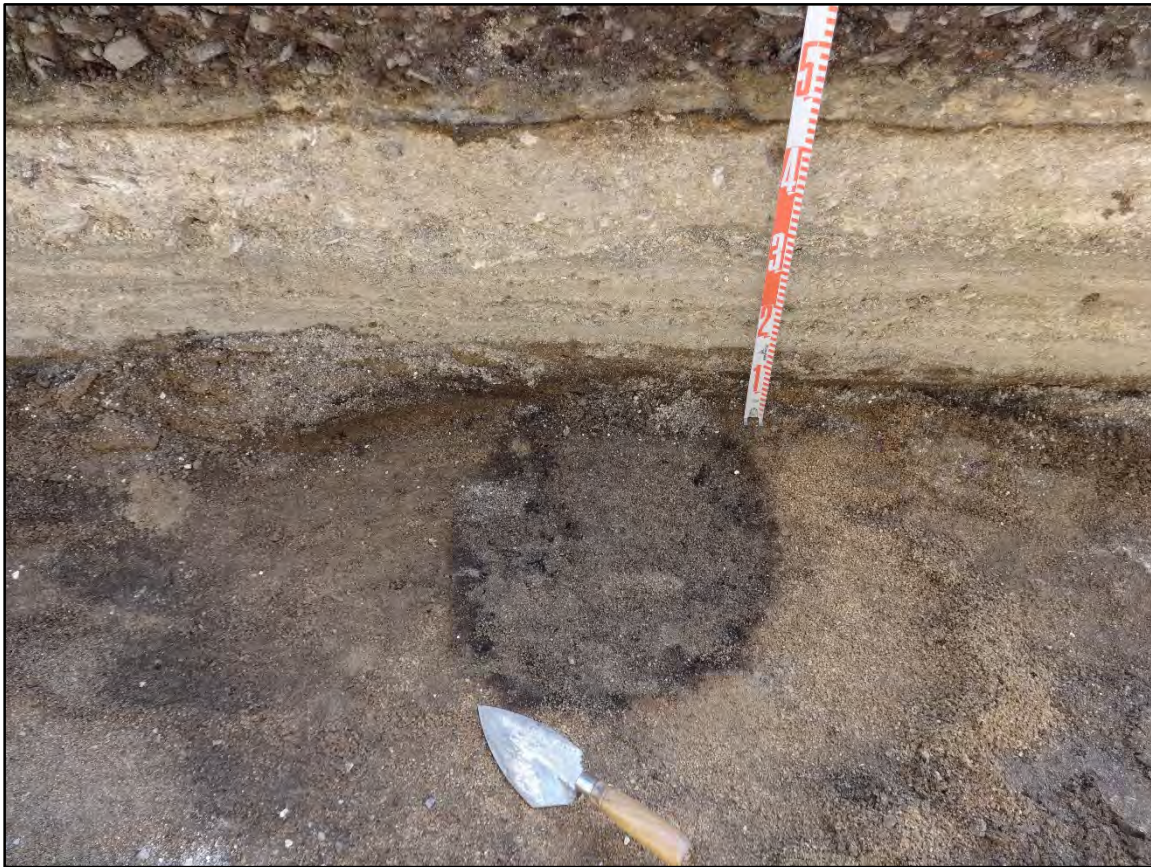
Figure 344. Close-up of SIHP # -7429 Feature 15, pit feature

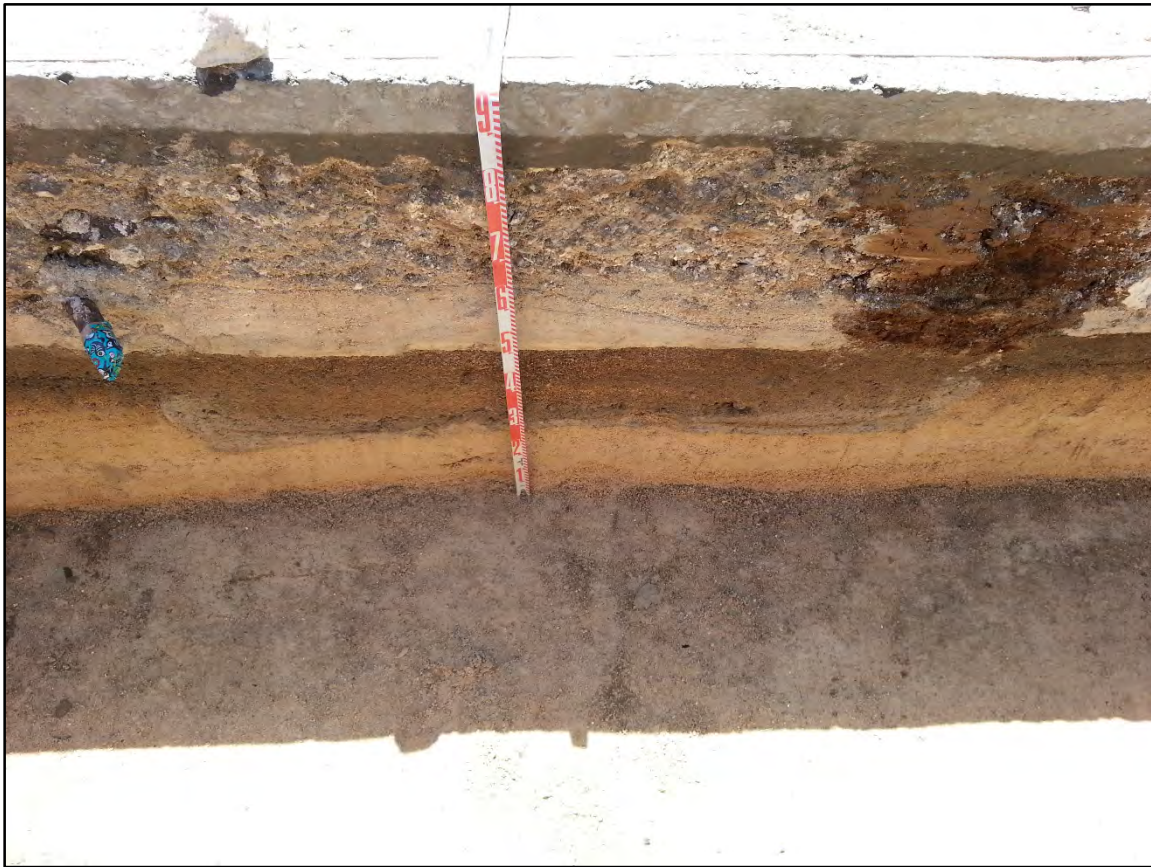
Figure 345. Close-up of SIHP # -7429 Feature 16, man-made irrigation feature

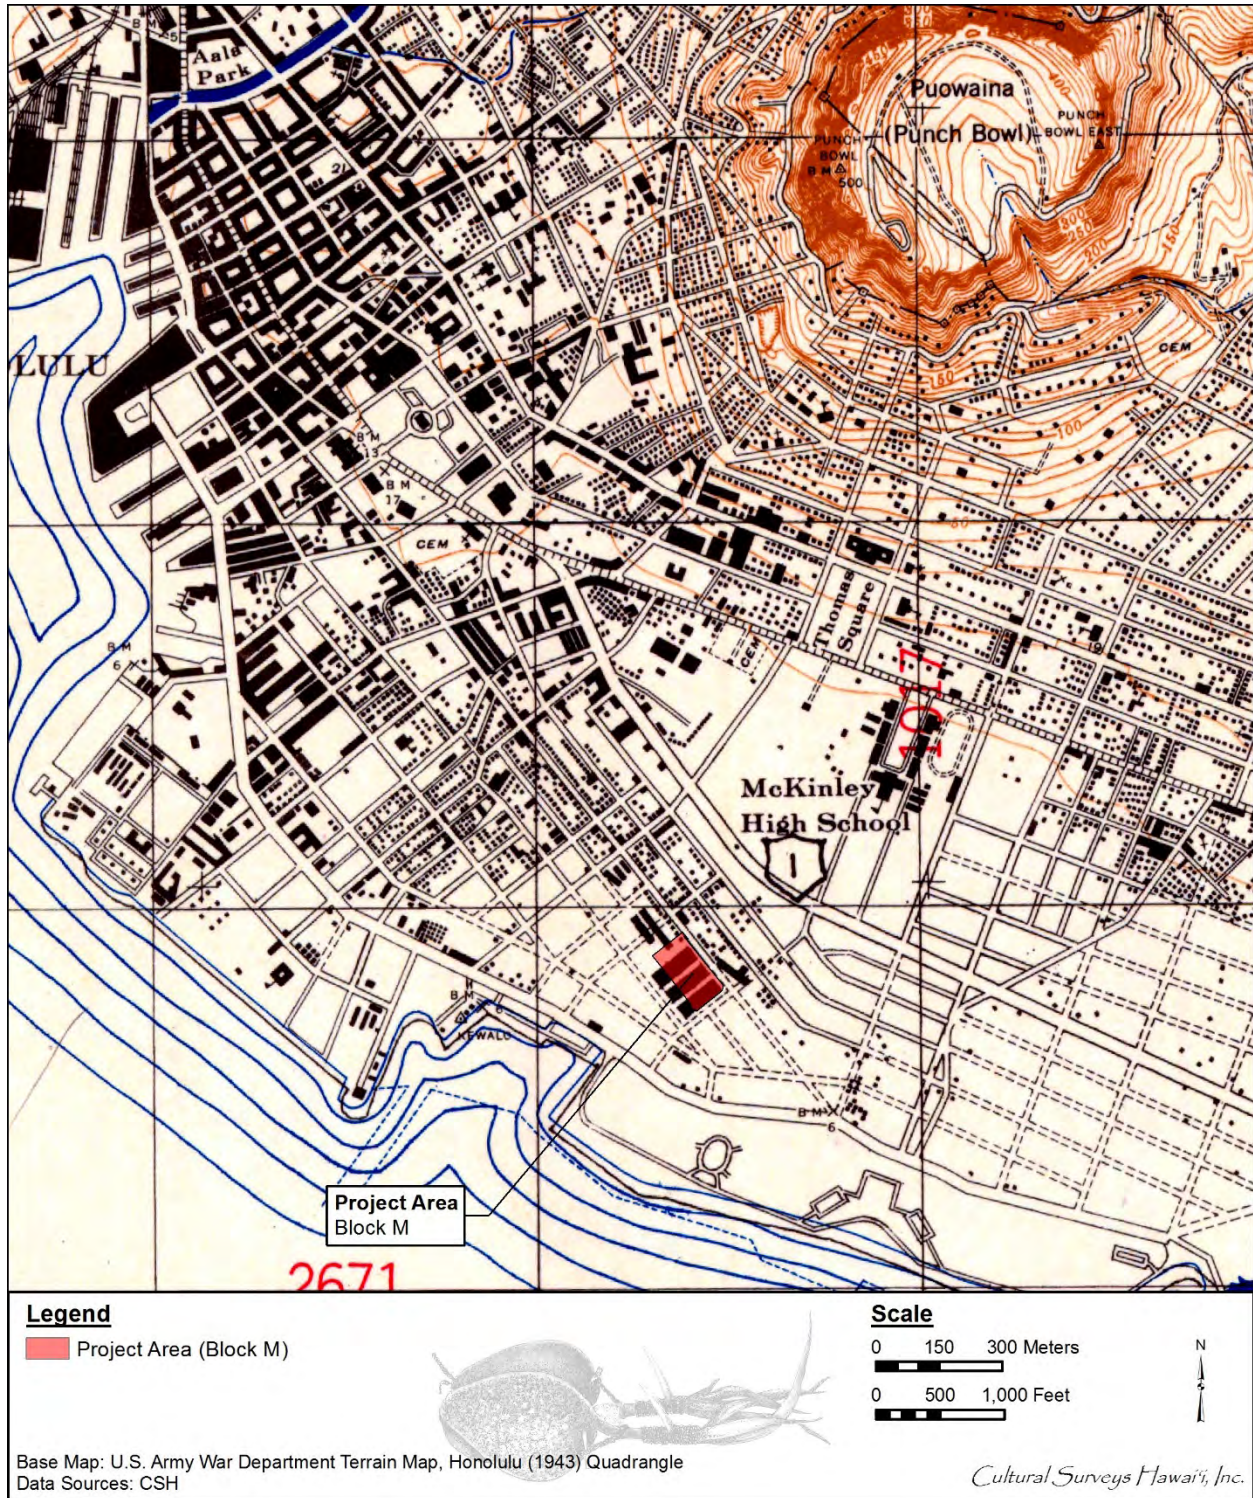
Figure 349. 1943 U.S. Army War Department terrain map showing a series of three parallel warehouse commercial structures located within the Block M project area

photos support estimation of a relative date range for the subsurface structures; however, due to the time span between each of the aerial photos and historic maps, only approximate dates could be determined. According to a 1927 aerial photograph (Figure 347), the project area is mostly barren with the exception of some trees. The area continued to lack commercial infrastructure on a 1939–1941 aerial photograph (Figure 348). On a subsequent 1943 U.S. Army War Department terrain map and a 1952 aerial photograph (Figure 349 and Figure 350), it is clear that three parallel commercial warehouses were constructed in the Block M project area, indicating these subsurface structures date to sometime between 1939 and 1943. A 1993 aerial photograph continues to show the three warehouses in Block M (Figure 351). By the time a 2000 NOAA aerial photograph (Figure 352) was taken, the three warehouses have been replaced by a new commercial structure. The new and currently standing commercial structure took the place of portions of the northeastern two-thirds of the two northernmost warehouses, and a parking lot took the place of the third warehouse. The Block M interior trenches likely identified the structural remnants from two of these warehouses. The potential structural remnants of the third warehouse, if present, would have most likely been identified in the southeastern portion of the Block M project area. However, no structural remnants were recovered in this area, suggesting they were removed sometime between 1993 and 2000, when the parallel warehouse structures were removed from the area and the current commercial building was constructed.

Asphalt parking areas are not visible on 1927 and 1939 – 1941 aerial photos (see Figure 347 and Figure 348). The asphalt alleyway and parking area Ewa (northwest) of the northernmost former commercial structure was visible in the 1952 aerial photo (see Figure 350) and presumably existed in the early 1940s, based on the 1943 terrain map (see Figure 349). This photographic evidence indicates that the historic buried asphalt surfaces associated with SIHP # -7686 were likely related to the former commercial structures in existence from approximately the early 1940s through the 1990s. Aerial photos taken in 1993 confirm the continued existence of the three

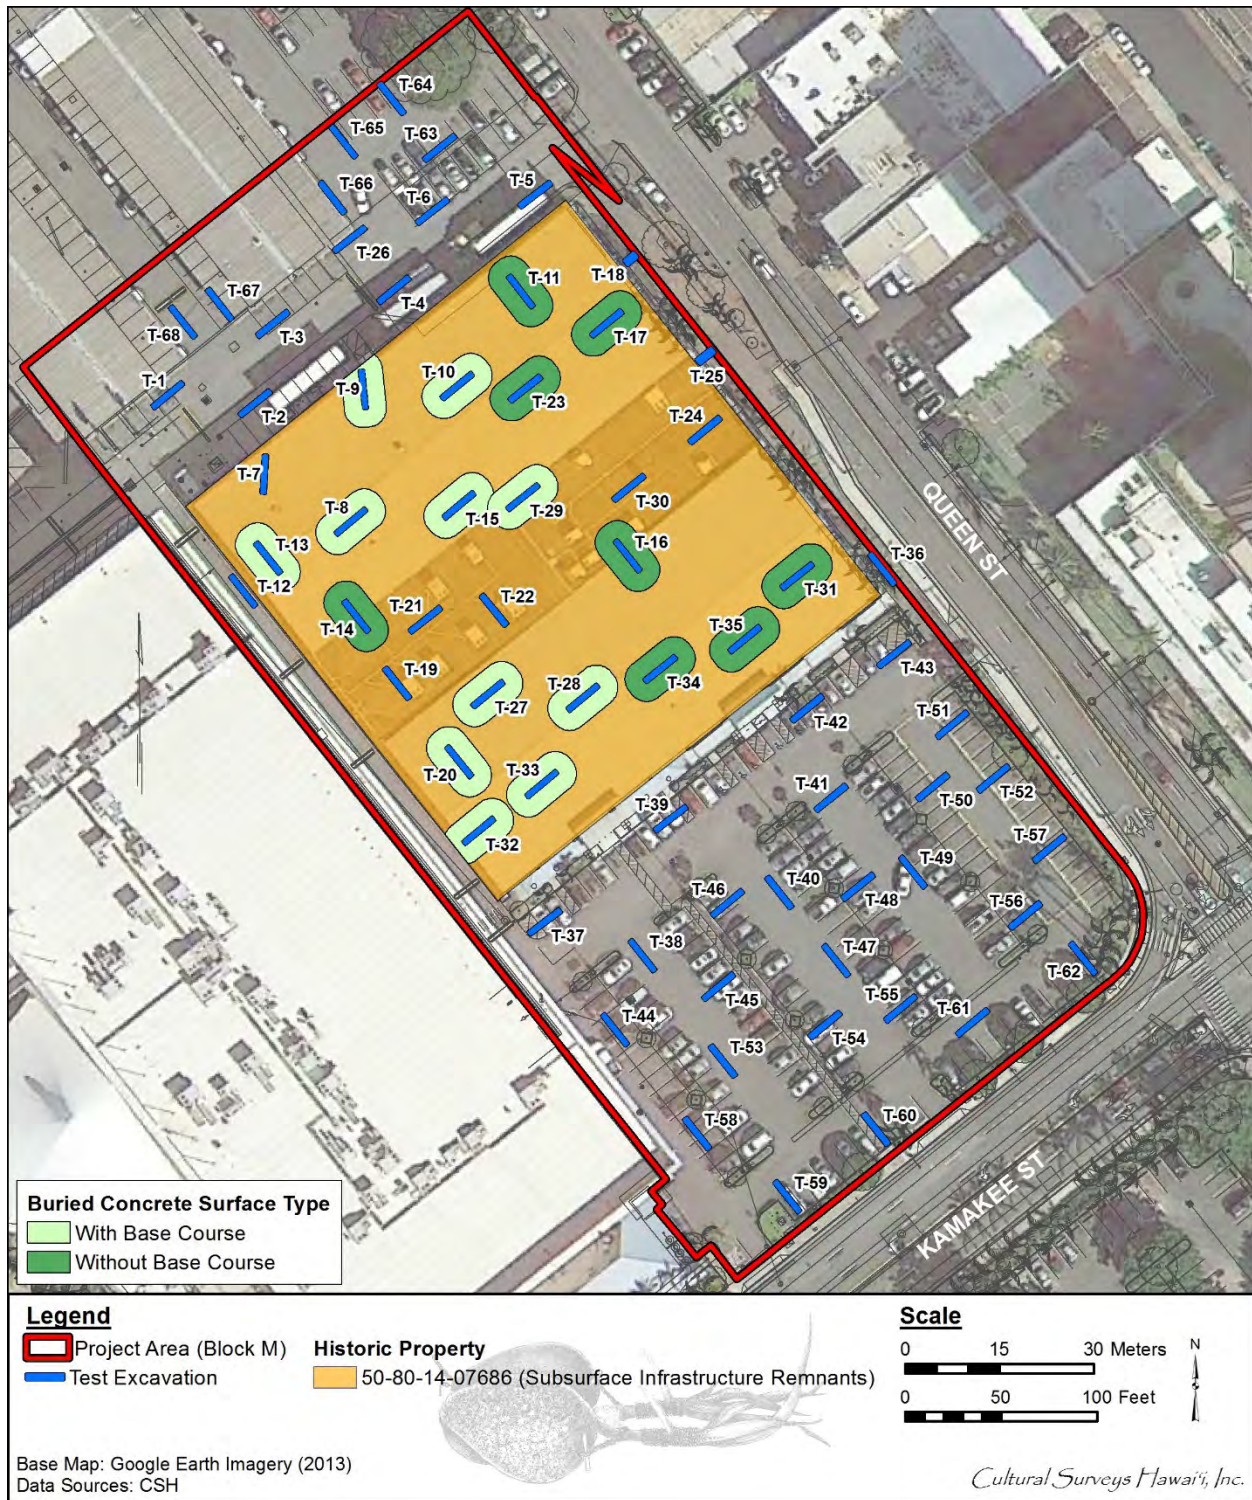
Figure 353. Aerial photo showing the locations of buried concrete surfaces with associated base course layers and concrete surfaces without associated base course layers (SIHP # - 7686) in the Block M project area

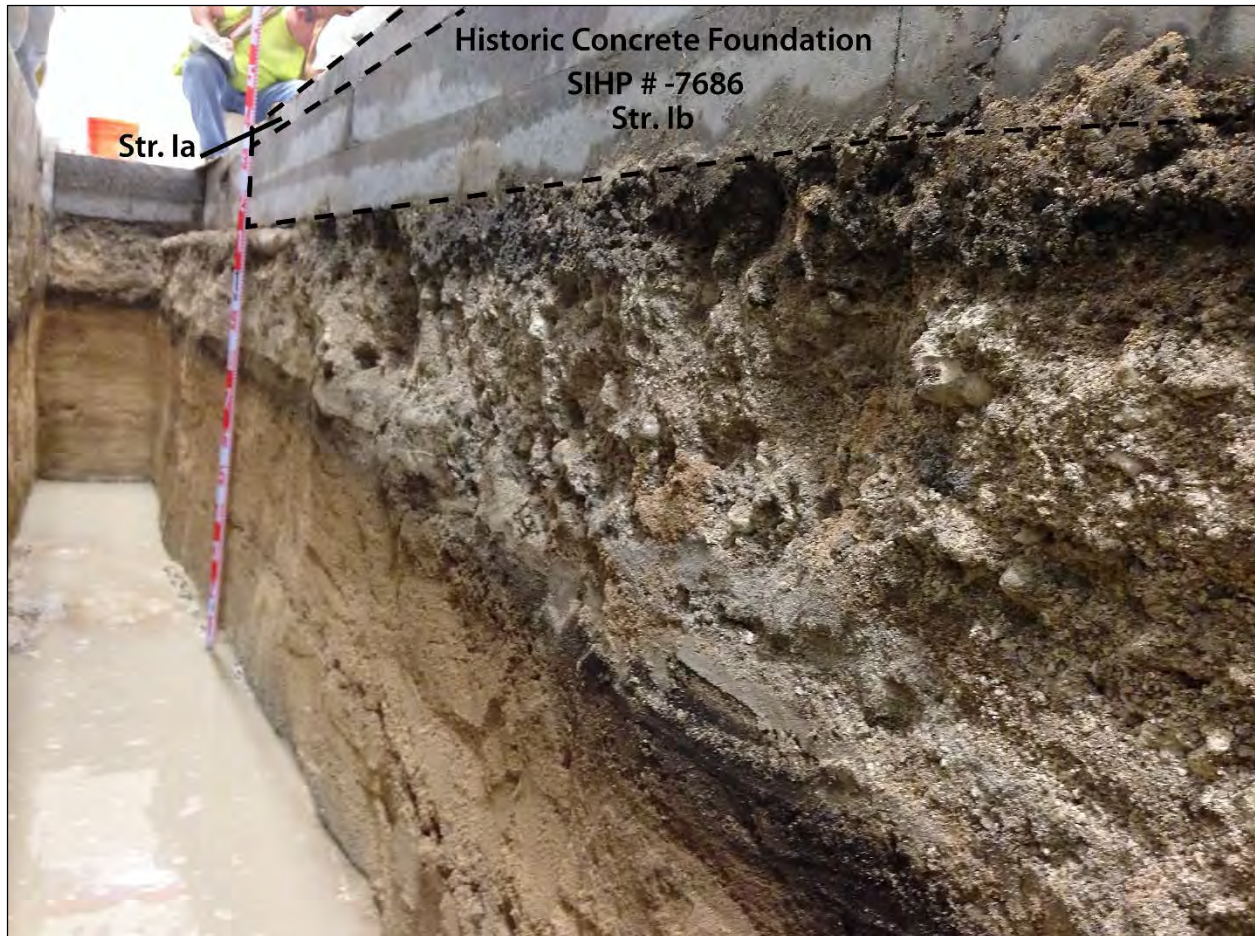
Figure 354. Photograph of a buried concrete surface (SIHP # -7686) without an associated base course layer within T-17 southeast wall

Buried concrete surfaces without associated base course layers were observed in eight test excavations (T-11, 14, 16, 17, 23, 31, 34, and 35) (Figure 354 through Figure 357). Continuity between these historic concrete layers is seen within seven test excavations (T-11, 17, 23, 31, 34, 35, and possibly T-16 (see Table 83). These surfaces range between approximately 7–37 cmbs, with an average thickness of 25 cm, and are directly underlying the current commercial building surface. Of note, T-14 presented a slightly different configuration, with two buried concrete surfaces that more closely resembled the buried historic surfaces with associated base course layers.

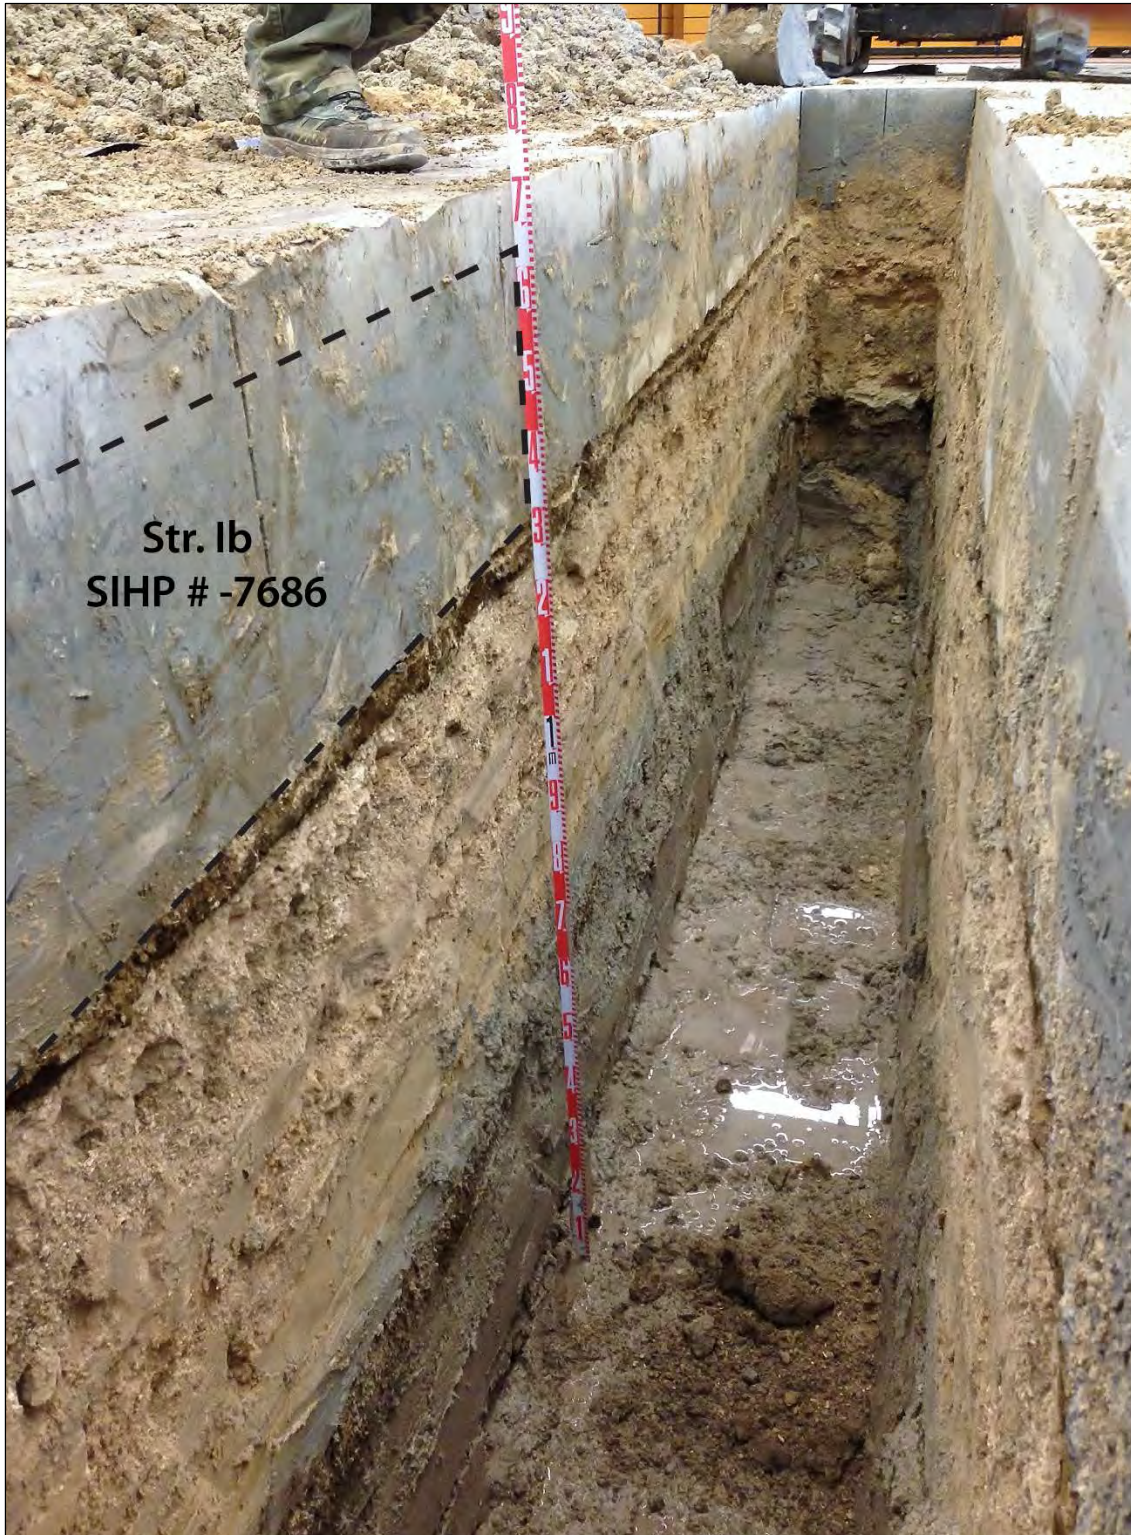
Figure 358. Photograph of the buried concrete surface (SIHP # -7686) with its associated base course layer within T-27 northwest sidewall

Thirteen buried concrete surfaces with associated base course layers were observed and documented in 11 test excavations (T-8, 9, 10, 13, 15, 20, 27, 28, 29, 32, and 33 (Figure 358 through Figure 361). The majority of these test excavations contained a single historic, subsurface concrete layer (see Figure 358 and Figure 359); however, T-13 and T-15 contained two historic subsurface concrete layers (see Figure 360 and Figure 361). The upper boundary of the concrete surfaces ranged from 7 to 37 cmbs with an average thickness of 21 cm.

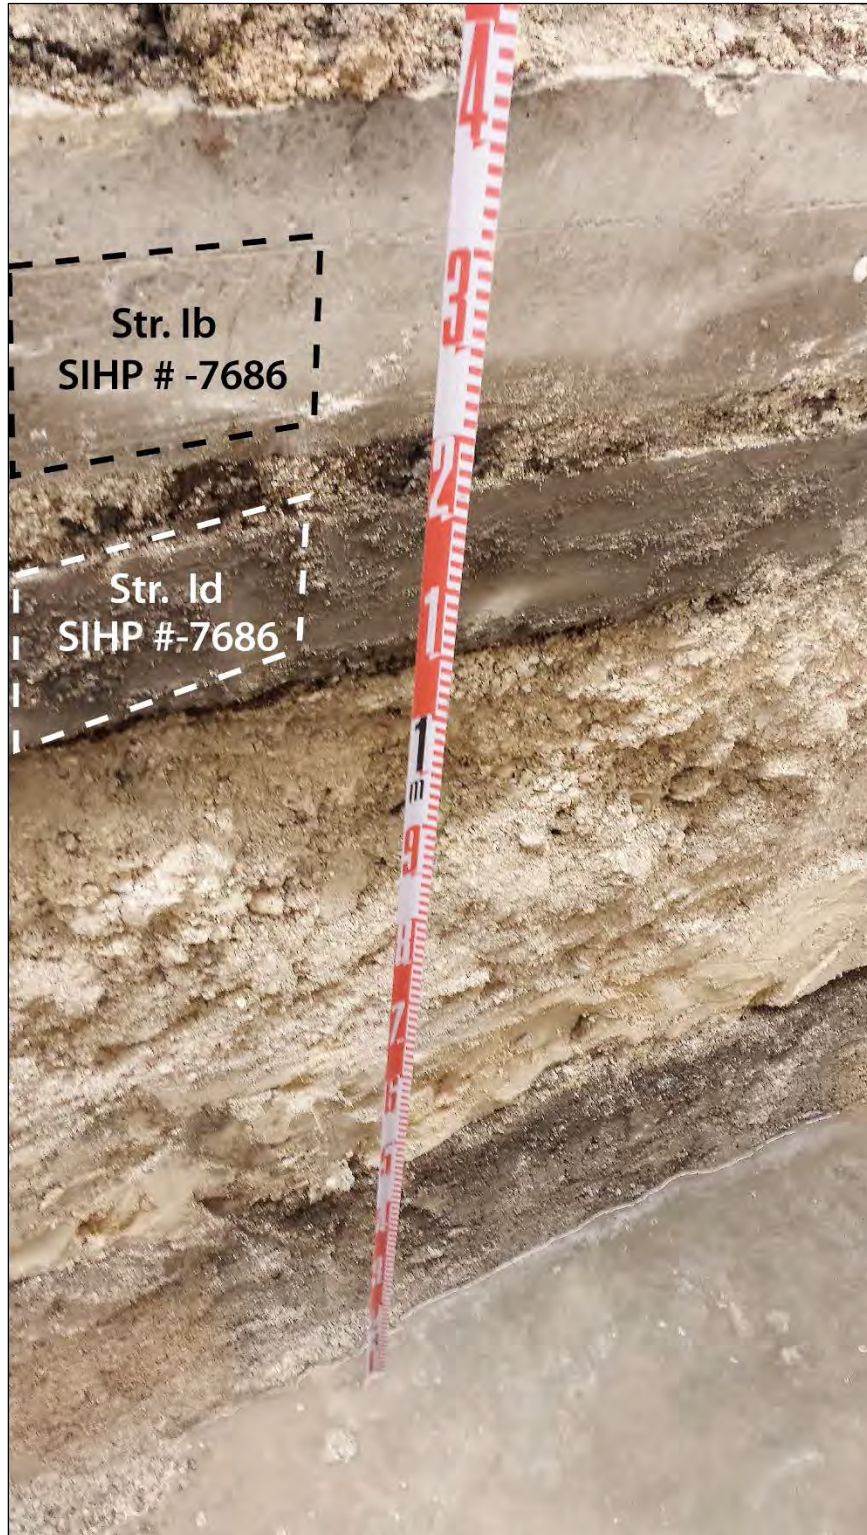
Figure 360. Photograph of the multiple buried concrete surfaces (SIHP # -7686) with associated base courses within the T-15 southeast wall

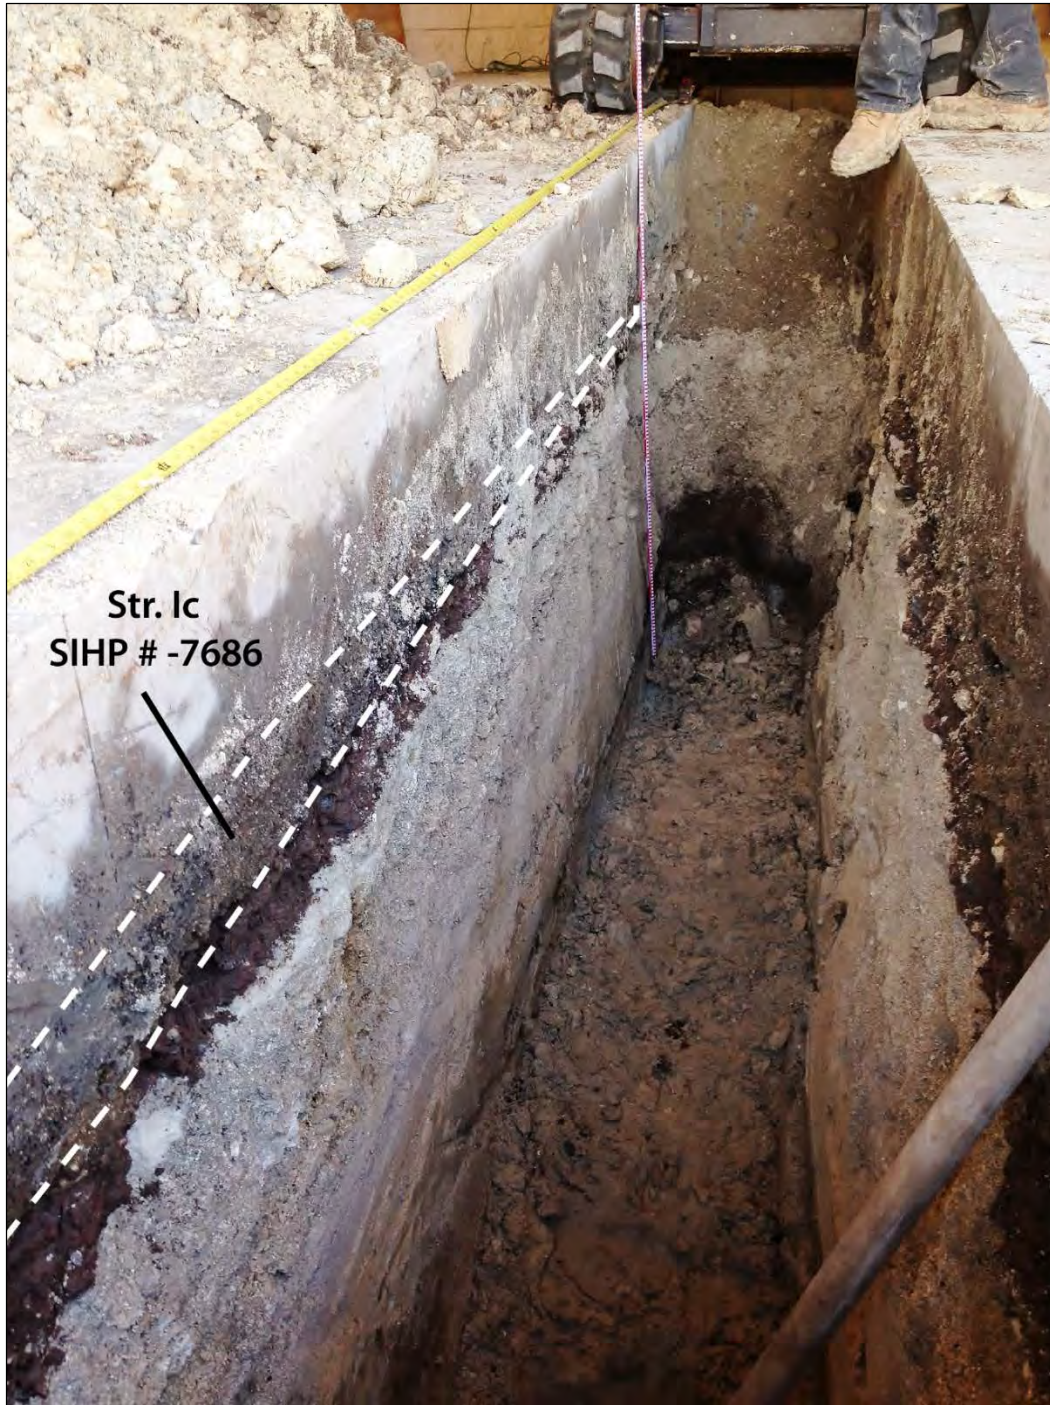
Figure 365. Photograph of the asphalt (SIHP # -7686) and associated base course within T-7 east wall

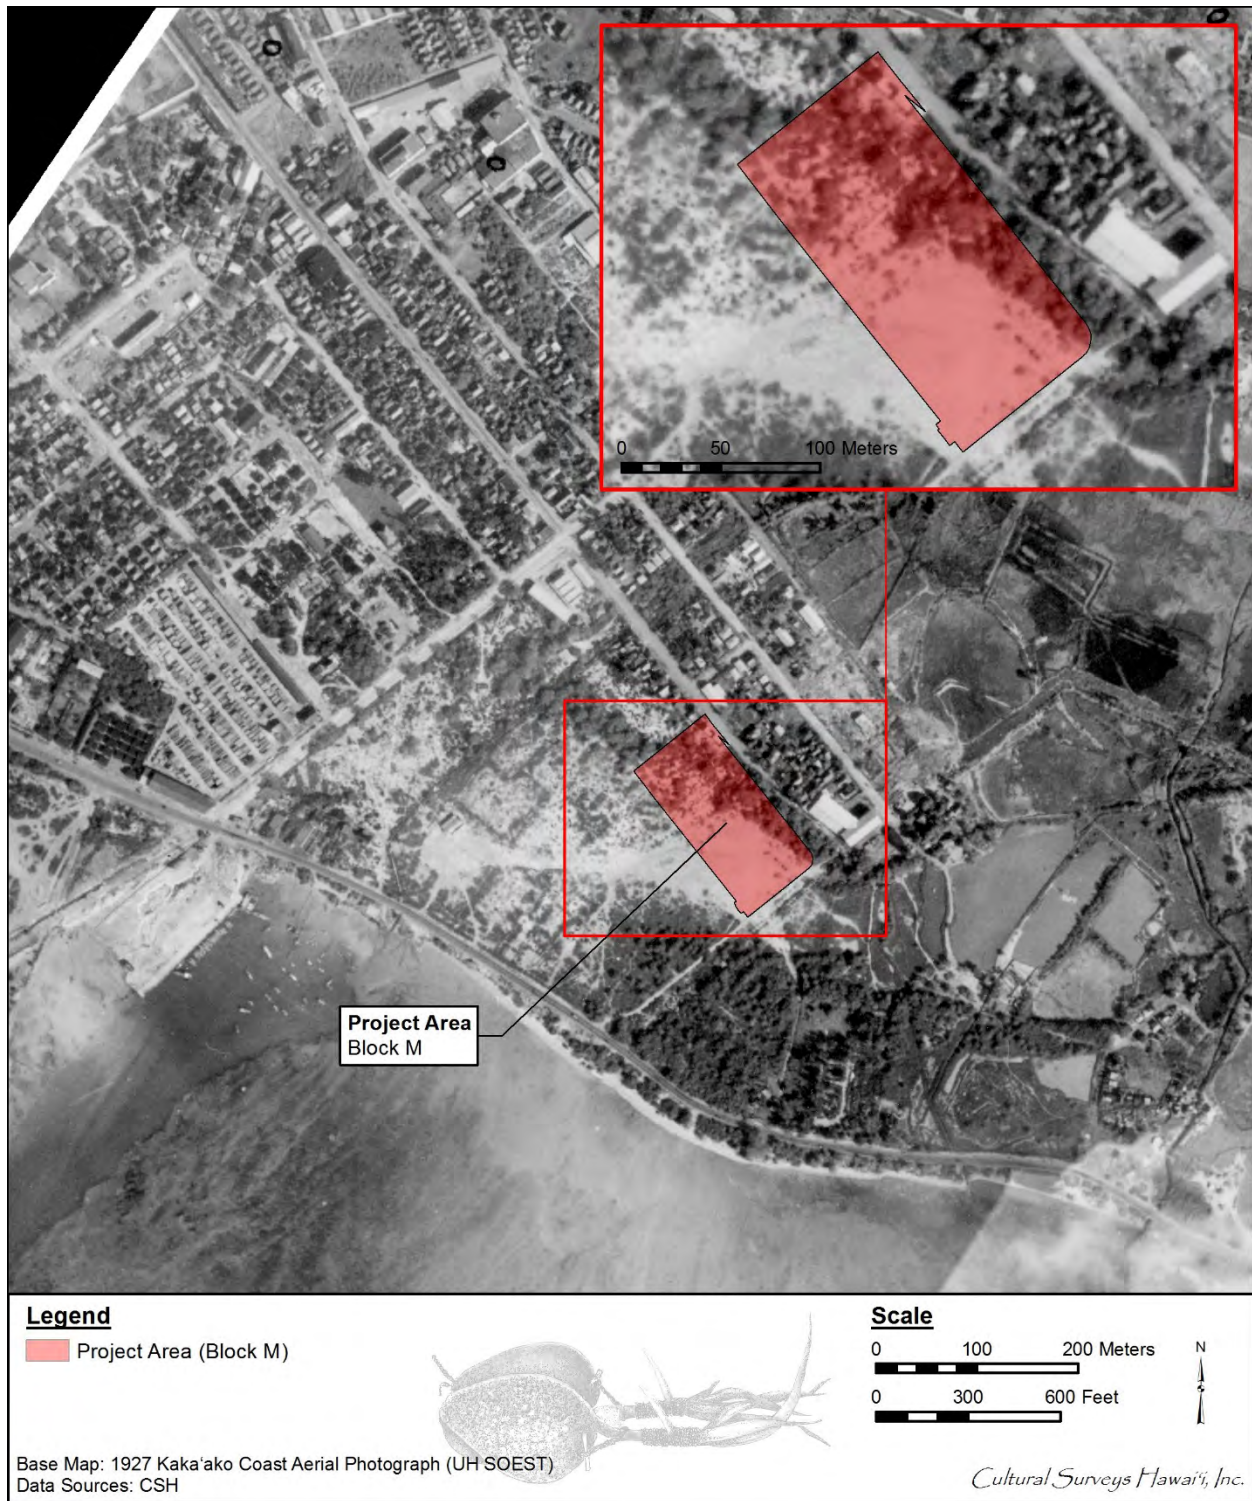
Figure 367. 1927 aerial photograph showing the Block M project area infilled with light colored crushed coral reclamation fill, with thick vegetation already growing along the mauka portion

A 1927 aerial photograph depicts the filled and leveled Block M project area, relatively barren in terms of structures (Figure 367). Vegetation extended diagonally through the project area from southeast to northwest, with small structures in the northeast corner along Queen Street. An active dredge is positioned within Kewalo Basin, a trough or pipeline extending from the dredge to the shore, continuing reclamation of the shoreline *makai* of the project area.
