Subject: *Archaeological Monitoring Plan for the Howard Hughes Corporation's Redesigned Block N East Project, Kaka'ako, Honolulu Ahupua'a, Honolulu (Kona) District, O'ahu, TMKs: [1] 2-3-002:001 (por.), 086, and 087 (McDermott and Hensley 2016)*

**Archaeological Monitoring Plan for the
Howard Hughes Corporation's Redesigned Block N East
Project, Kaka'ako, Honolulu Ahupua'a,
Honolulu (Kona) District, O'ahu
TMKs: [1] 2-3-002:001 (por.), 086, and 087**

**Prepared for
Victoria Ward, Limited/Howard Hughes Corporation**

**Cultural Surveys Hawai'i, Inc.
Kailua, Hawai'i
(Job Code: KAKAAKO 193)**

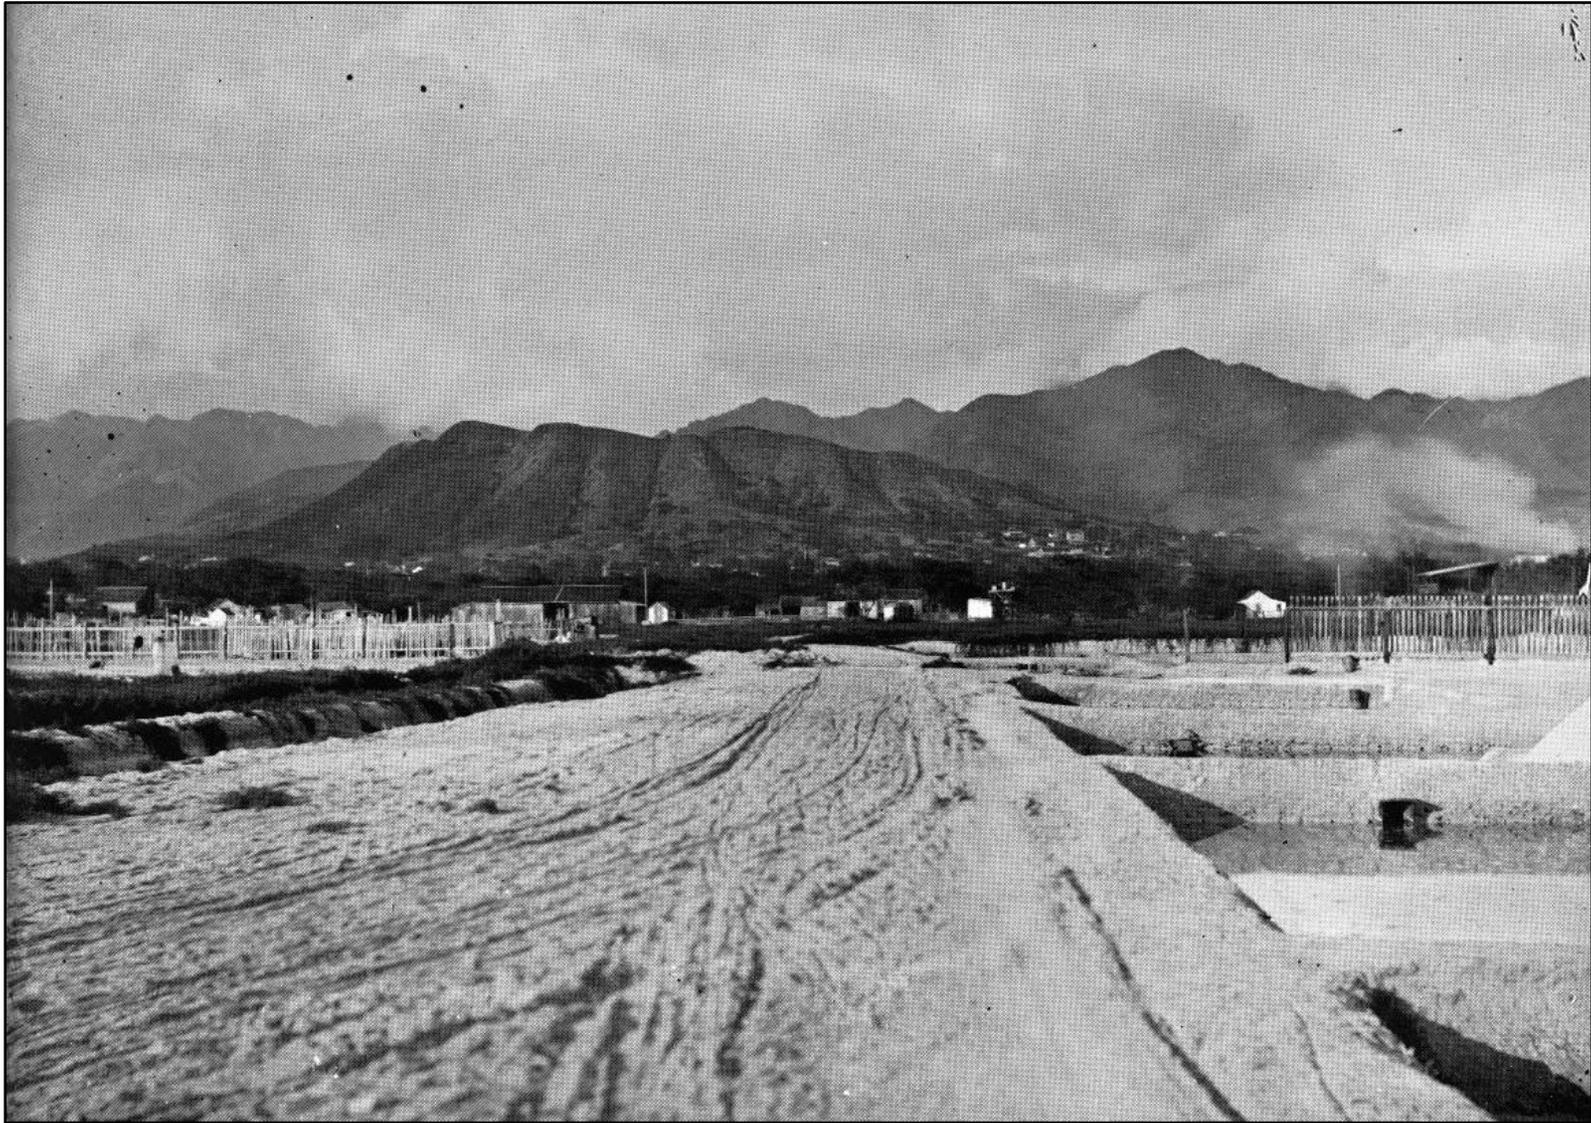
Figure 19. Historic salt works within Kaka'ako, 1902 photograph (Bishop Museum Archives, reprinted in Scott 1968:579)

Figure 19 shows these types of large scale historic salt works, comprised of grid-like salt pans separated by man-made berms, wide transport causeways, and water transport channels.

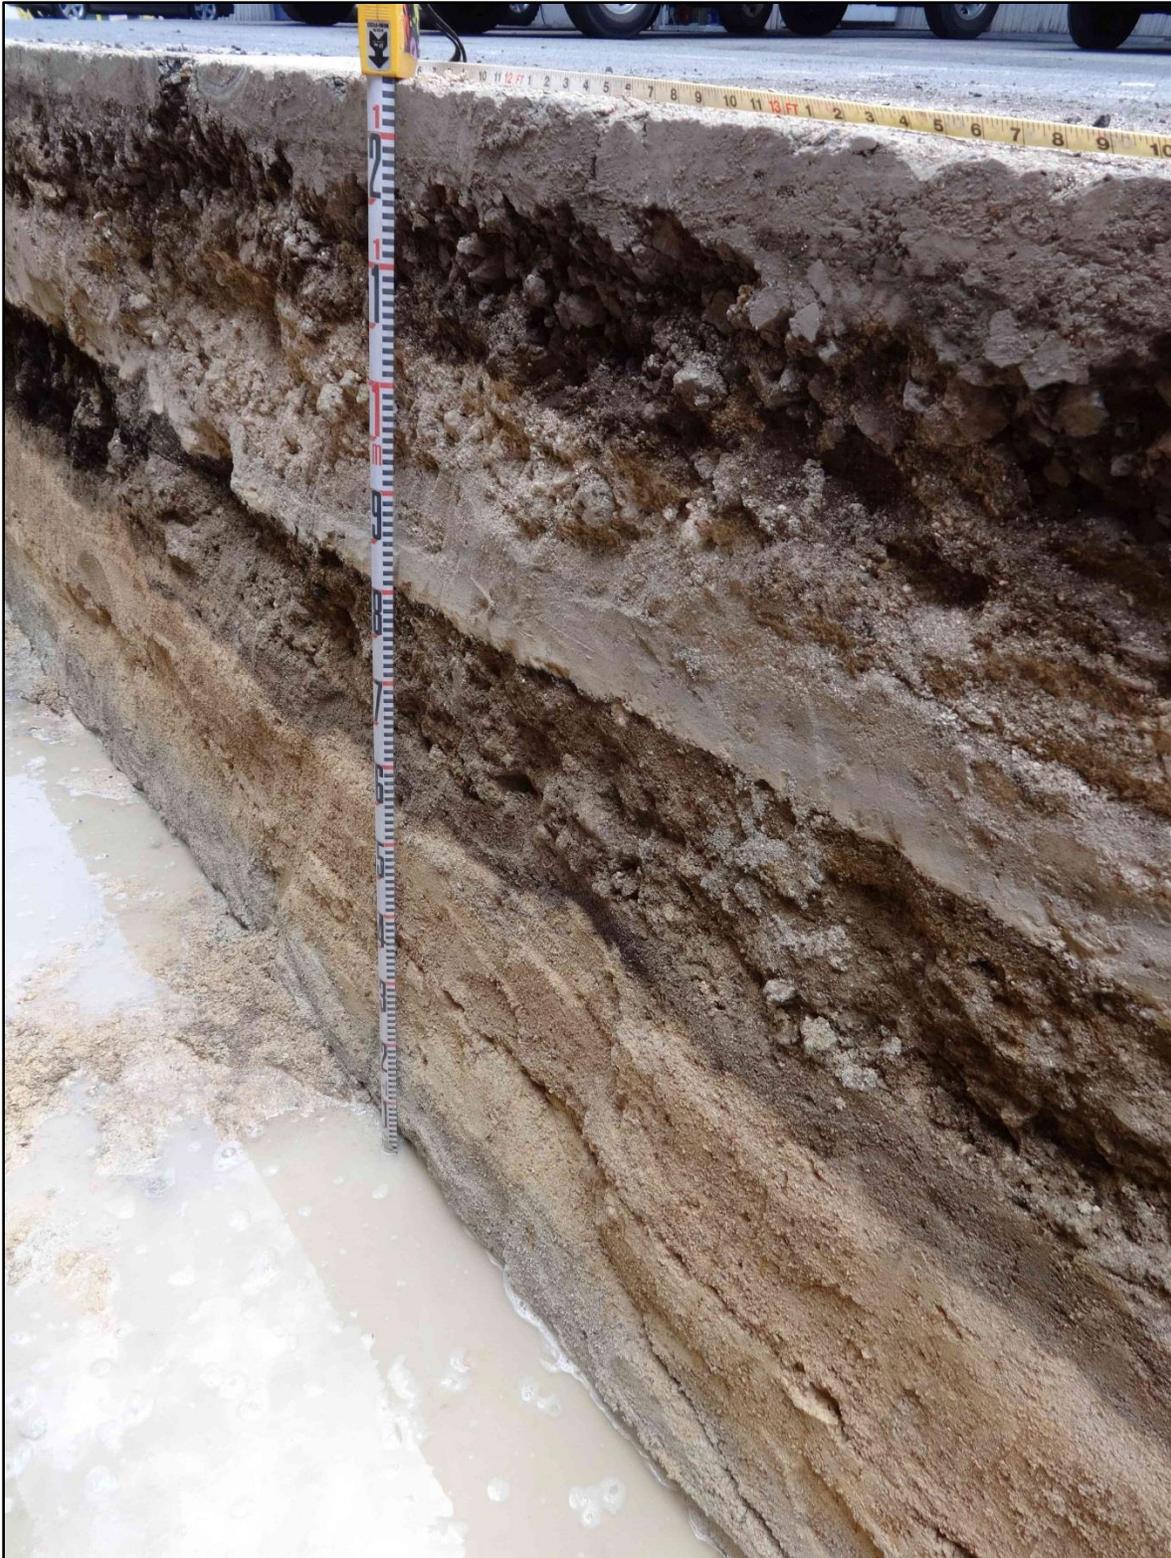
Figure 58. Original Block N East T-3 southwest sidewall, view to south

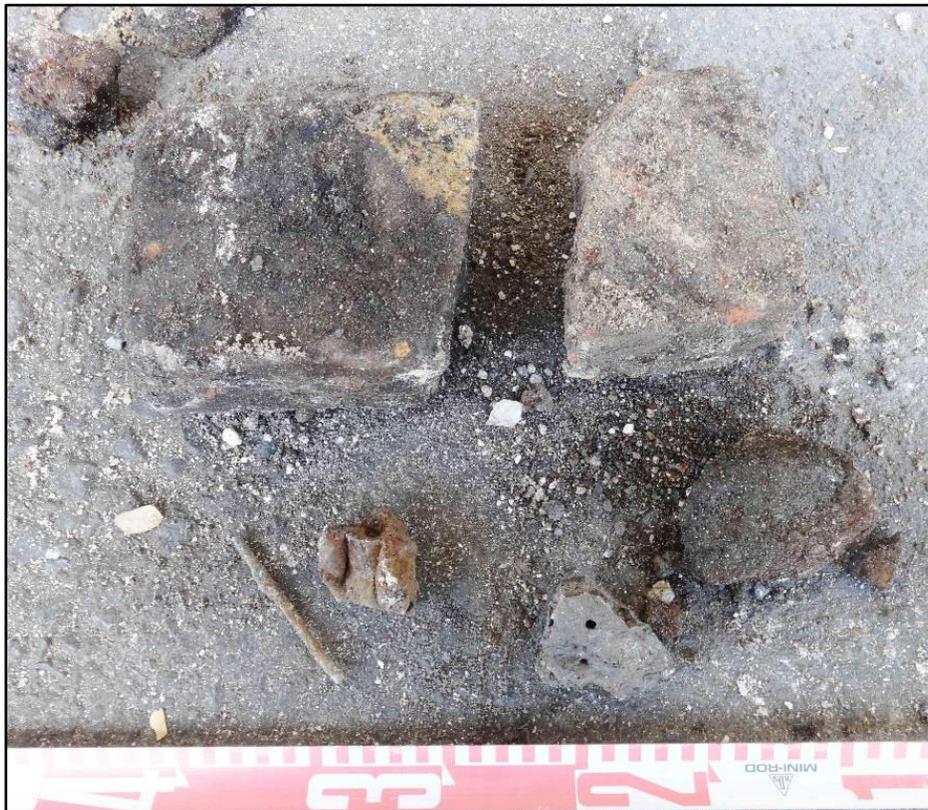
Figure 60. Original Block N East T-3 Brick and metal fragments observed in Stratum III

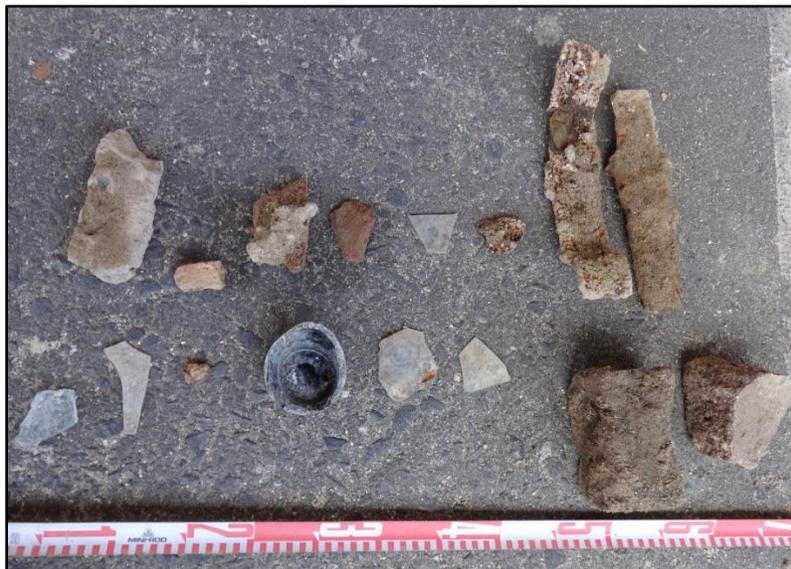
Figure 62. Original Block N East T-3 Glass bottle fragments, bricks, and oxidized metal observed in Stratum IV

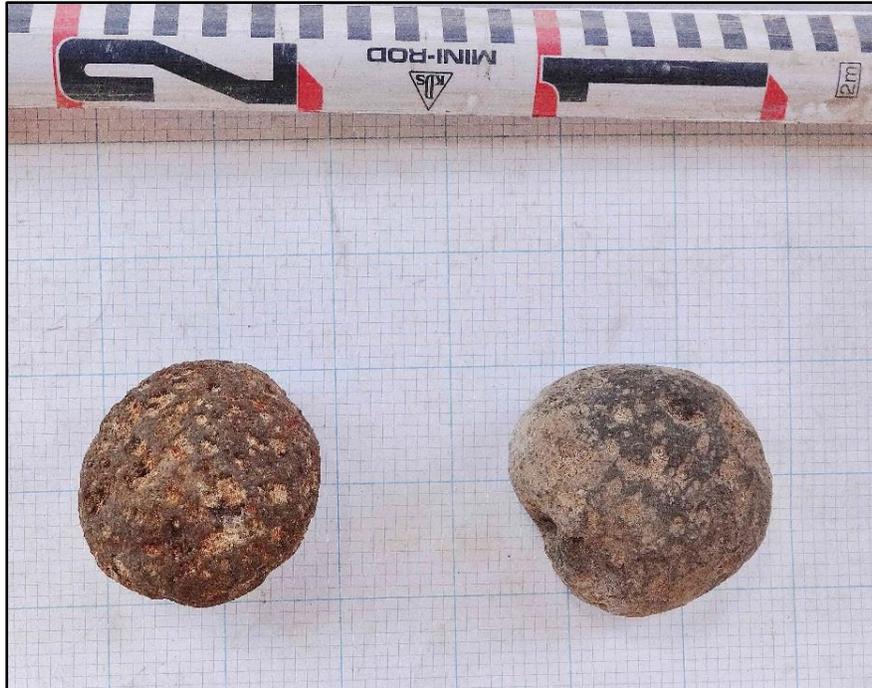
Figure 63. Original Block N East T-3 Water worn basalt cobbles observed in Stratum VI

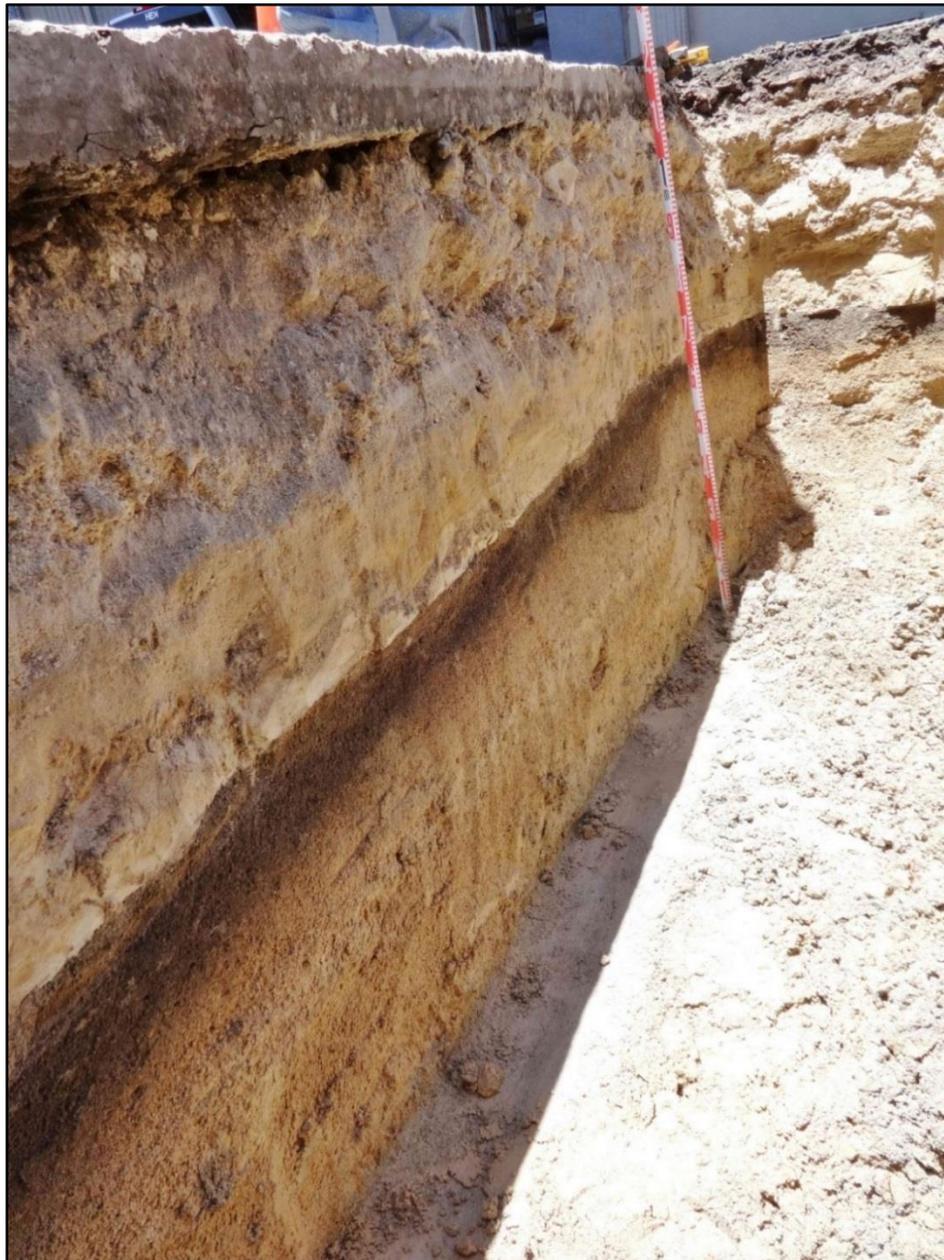
Figure 64. Original Block N East T-5, southeast sidewall, southwest half; note SIHP # -7429 Feature 86 within the sidewall, view to south

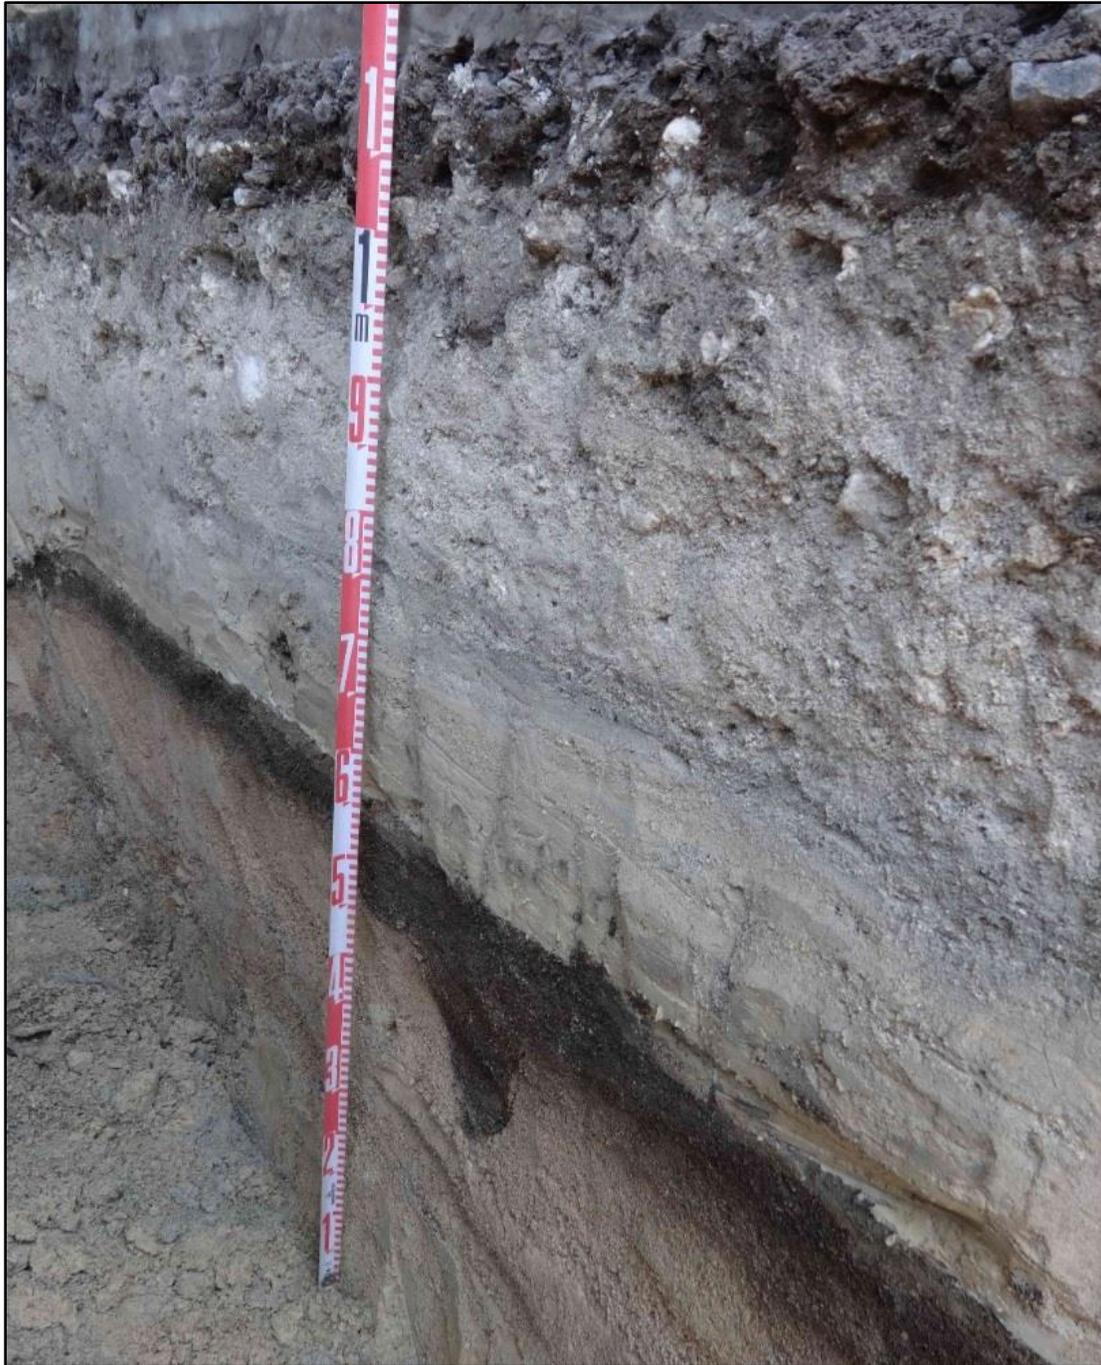
Figure 65. Original Block N East T-5, southeast sidewall, northeast half; note SIHP # -7429 Feature 89, view to east

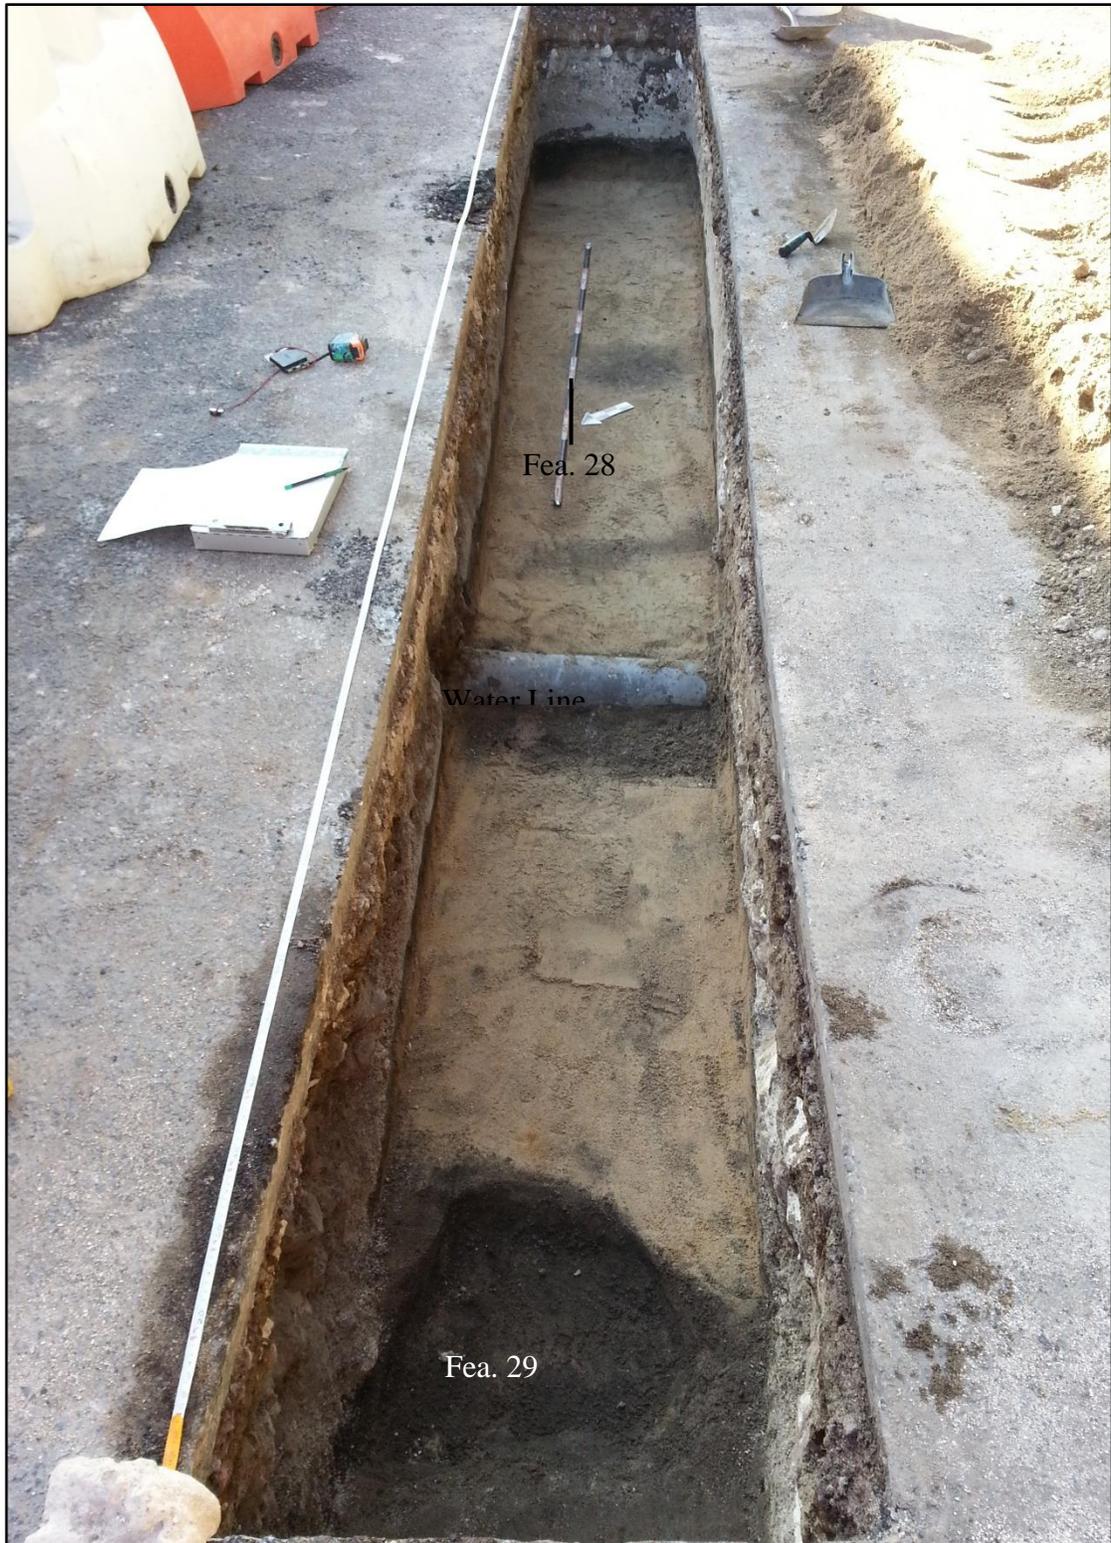
Figure 109. Block I photograph of T-9 at approximately 0.65 mbs depicting Features 28 and 29 and the water line and associated utility trench

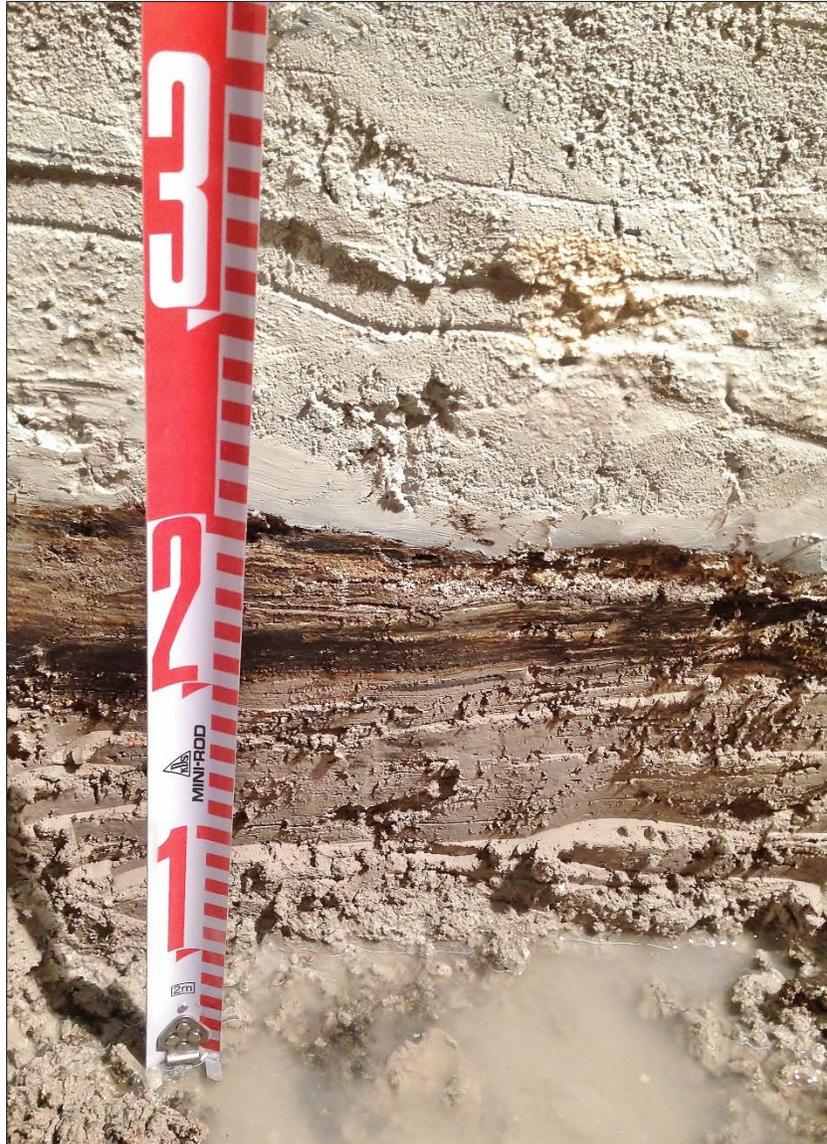
Figure 113. Block I T-28 close-up of in situ laminations of SIHP # -7655, Stratum III

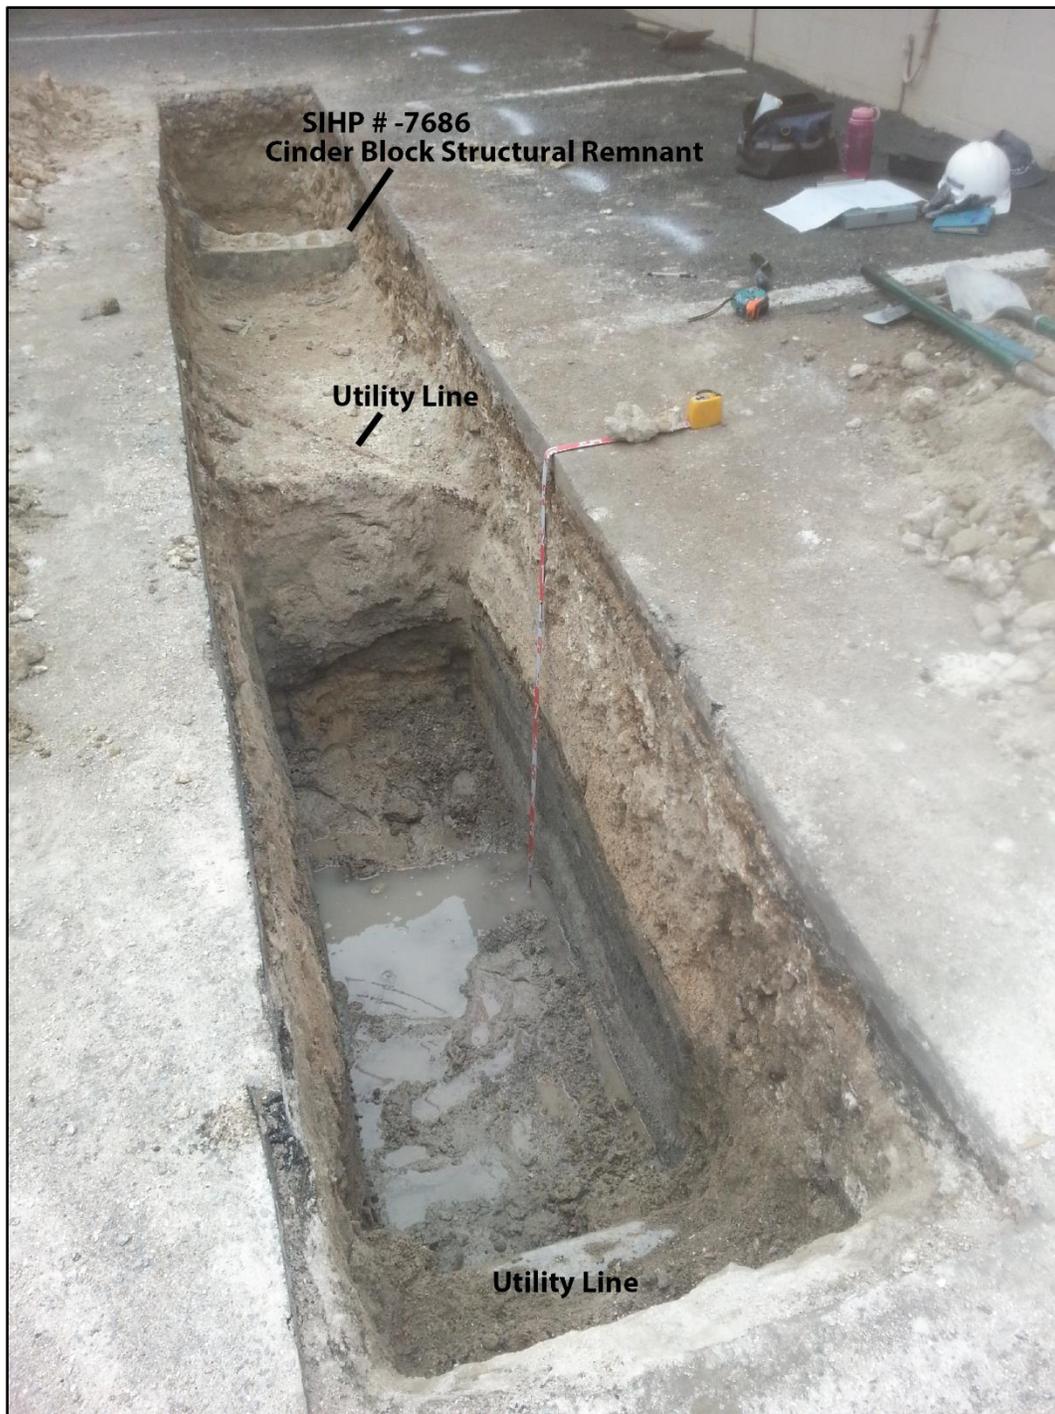
Figure 116. Block M photograph of T-1 showing a cinder block structural remnant (SIHP # -7686) and a 7-cm utility line within the *makai* portion of the test excavation and wetland sediments underlying modern and historic fill deposits and a utility line within the *mauka* portion

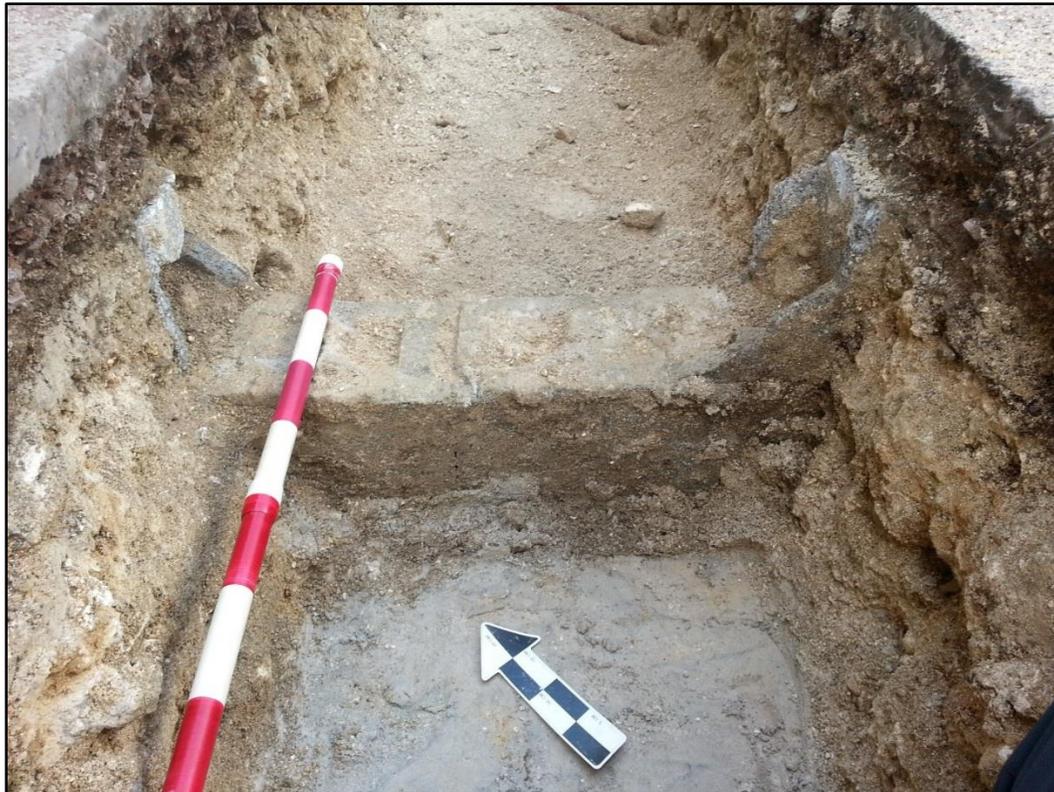
Figure 118. Block M T-1 photograph of cinder block structural remnant (SIHP # -7686) within the *makai* portion of test excavation
