September 26, 2017

**Subject: Letter Report for Fisherman's Wharf Structural Inspection and Evaluation,  
Kewalo Basin, Honolulu, Hawaii**

Attachments: Photographs, Inspection Plans, Vehicle and Pedestrian Operational Restriction Plan

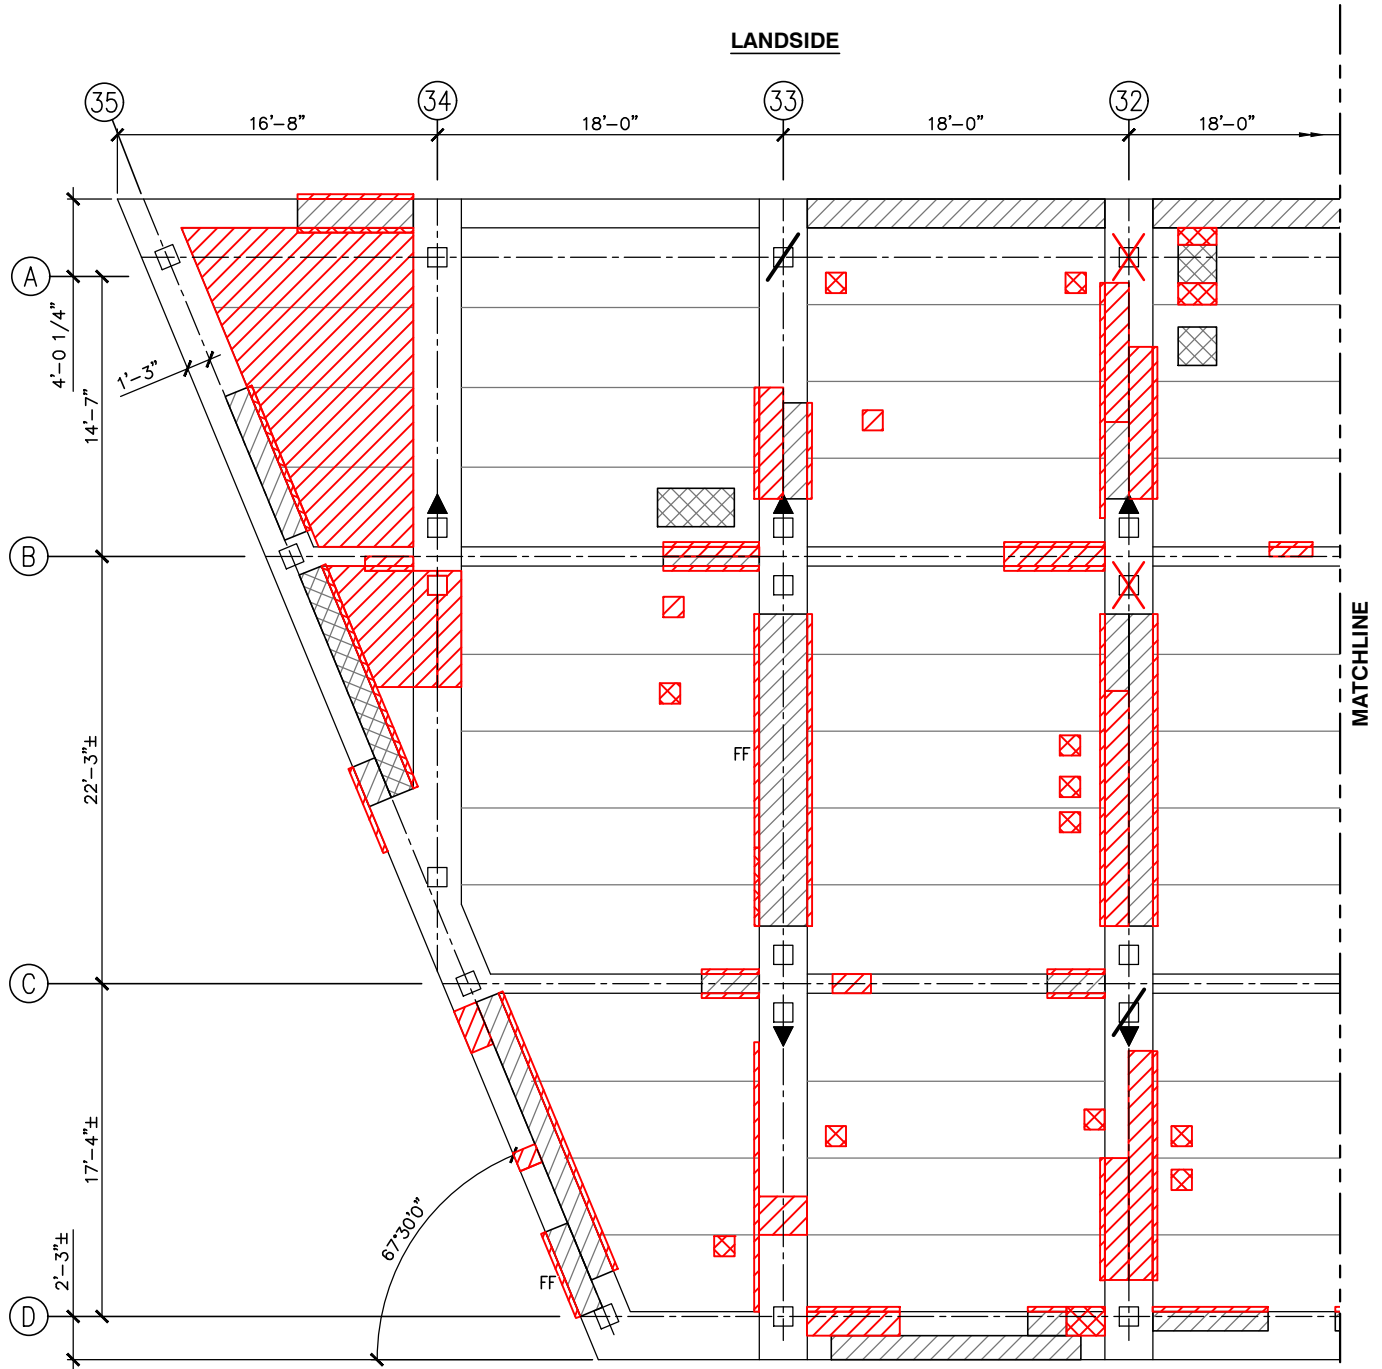
FIGURE 13 OF 14

The majority of the prestressed concrete plank soffits appear to exhibit small areas of delamination, which are consistent throughout the deck soffit (Refer to Figure No. 11 thru 13). Many of these small delaminated areas have occurred since the previous 2012 inspection. The repetition and location of these damages appears to be consistent with typical locations of precast panel lifting inserts used to place the panels during construction. The lifting panel inserts likely have about ½ inch less concrete cover than the high strength prestressing strands in the planks. Since the corrosion of this hardware is significant enough

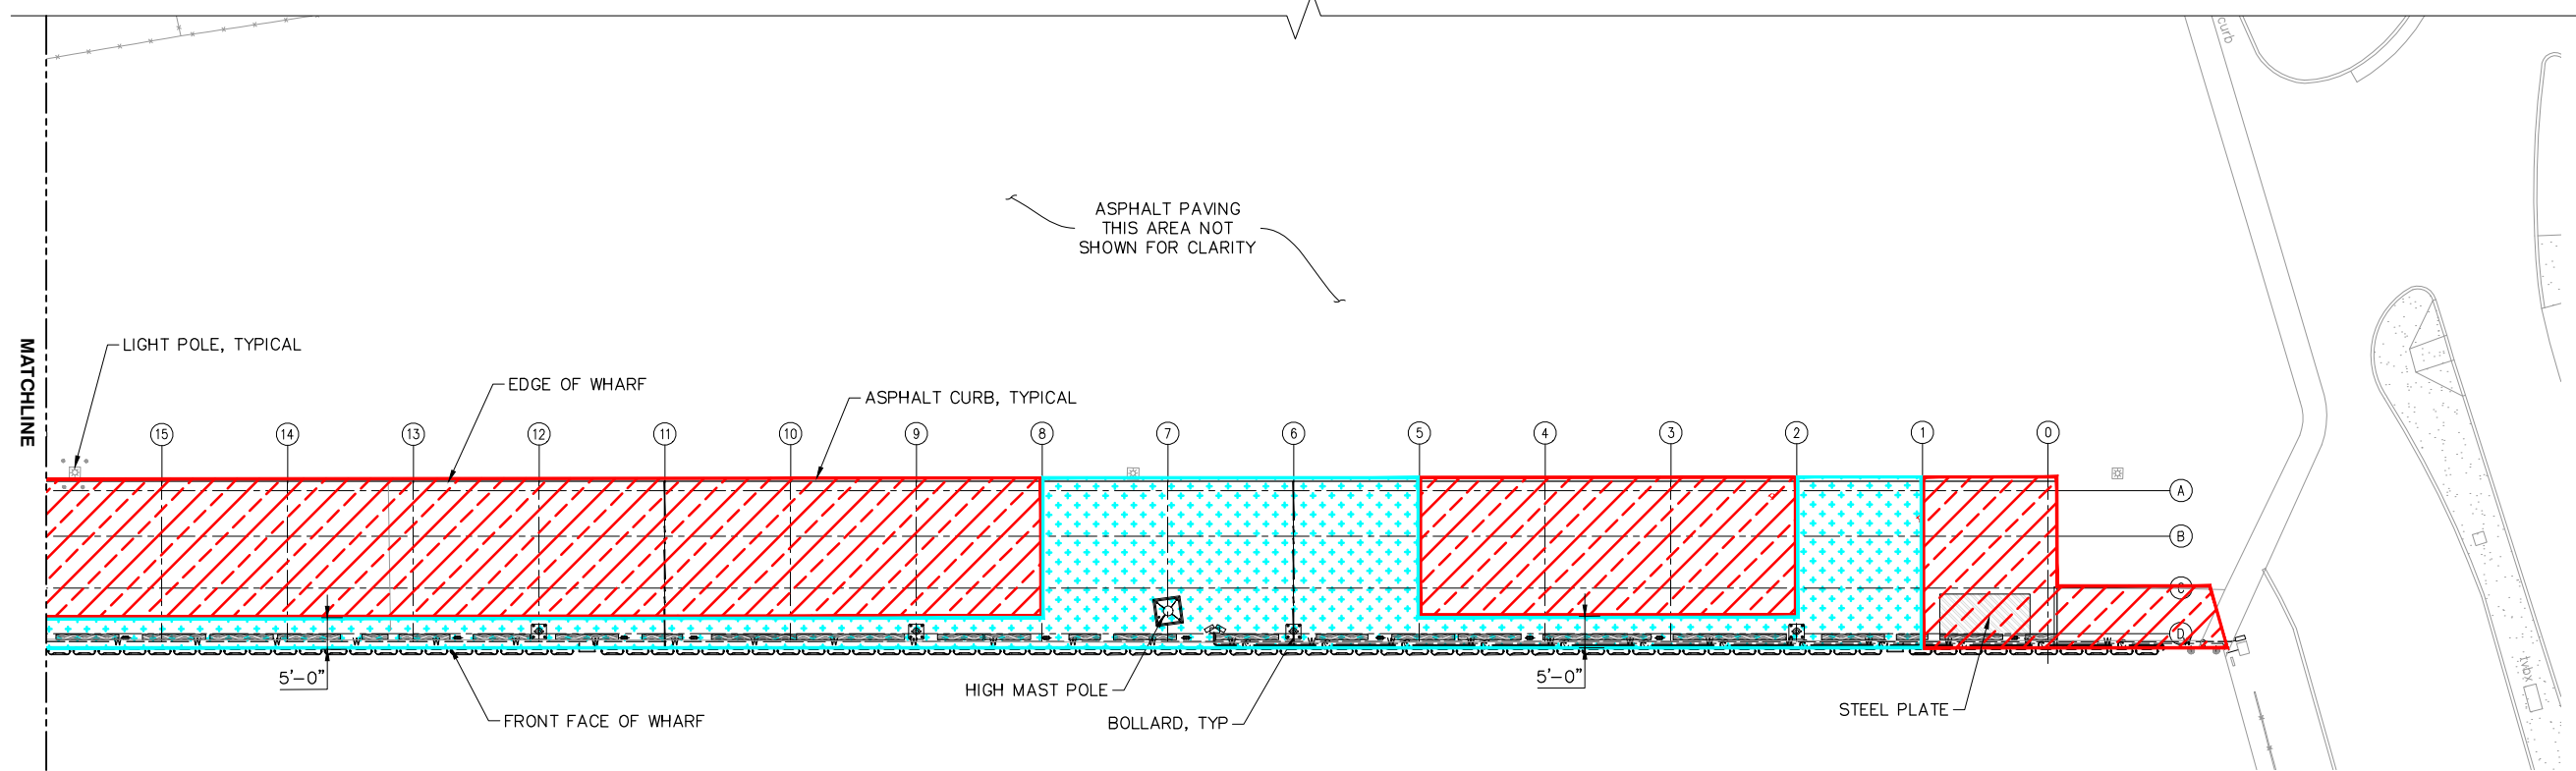
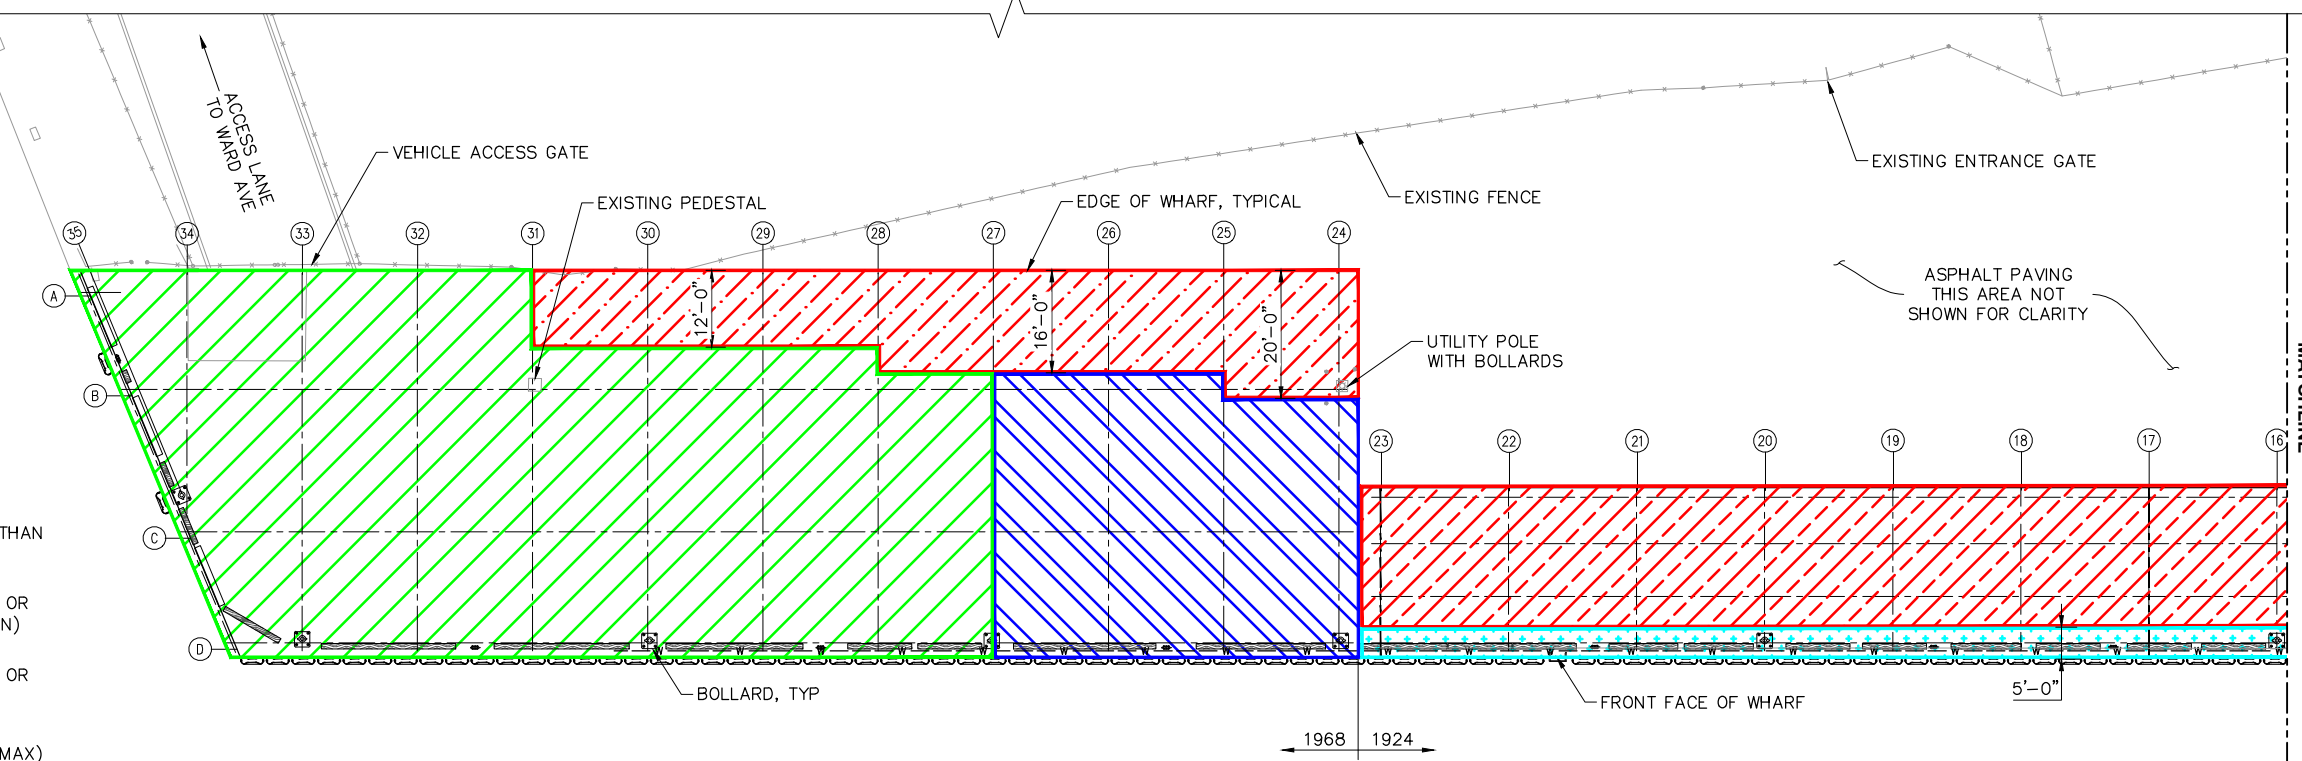
- After the 2012 inspection, it was determined that vehicular access to the wharf should be restricted to a 20 ft. wide strip against the landside of the wharf.
- The current level of deterioration observed in 2017 requires further prohibitions of vehicular and pedestrian access (see Figure 14).
- The types of new spalls observed at many locations appear to indicate that the chloride concentration at the level of the main flexural reinforcement has already, or will shortly, reach the threshold for the onset of corrosion. Literature indicates that once the corrosion process initiates spalling can begin within 5 to 10 years.

A prohibition on pedestrian and/or live loads should be imposed on all other areas of the 1924 wharf deck that are not specifically mentioned above (see Figure 14).

- Prohibit all access to the area between gridlines 24 and 31 and gridlines A and B (See Figure 14 for refinement of specific area).
- Prohibit all vehicles which exceed 5,000 lbs. Gross Vehicle Weight (GVW) and prohibit all occupancies or uses which exceed 100 psf to the area between gridlines 24 and 27 and between gridlines B and D.

Figure 14 of this report provides a graphic that summarizes the 1924 and 1968 wharf live load restrictions mentioned above.

- Maintain prohibition of all vehicle traffic on the 1924 wharf segment. Maintain adequate measures using striping, barricades, signage, etc. to prevent vehicles from driving over this portion of deck;
- Limit loading to pedestrian loading in the locations shown on Figure 14. Implement adequate measures using deck striping, signage, etc. to restrict public access.

- Prohibit all live loads above the precast planks adjacent to the bulkhead (refer to Figure 14 for specific area). Implement adequate measures to prevent accidental access to these areas and avoid the use of heavy barricades on the deck;

- Vehicles accessing the 1968 segment of wharf between gridlines 24 and 27 and outside of prohibited areas indicated above should be limited to personally owned vehicles with 5,000 lbs. maximum GVW or a live load of 100 pounds per square foot (psf) acting non-concurrently (refer to Figure 14 for specific area);

- Vehicles accessing the 1968 segment of wharf between gridlines 27 and 35 and outside of prohibited areas indicated above should be limited to 10,000 lbs GVW or a live load of 100 pounds per square foot (psf) acting non-concurrently (refer to Figure 14 for specific areas);
