Mother Waldron Playground

Cultural Landscape Report

March 2020

Prepared for
Honolulu Authority for Rapid Transportation
and
Jacobs (formerly CH2M)

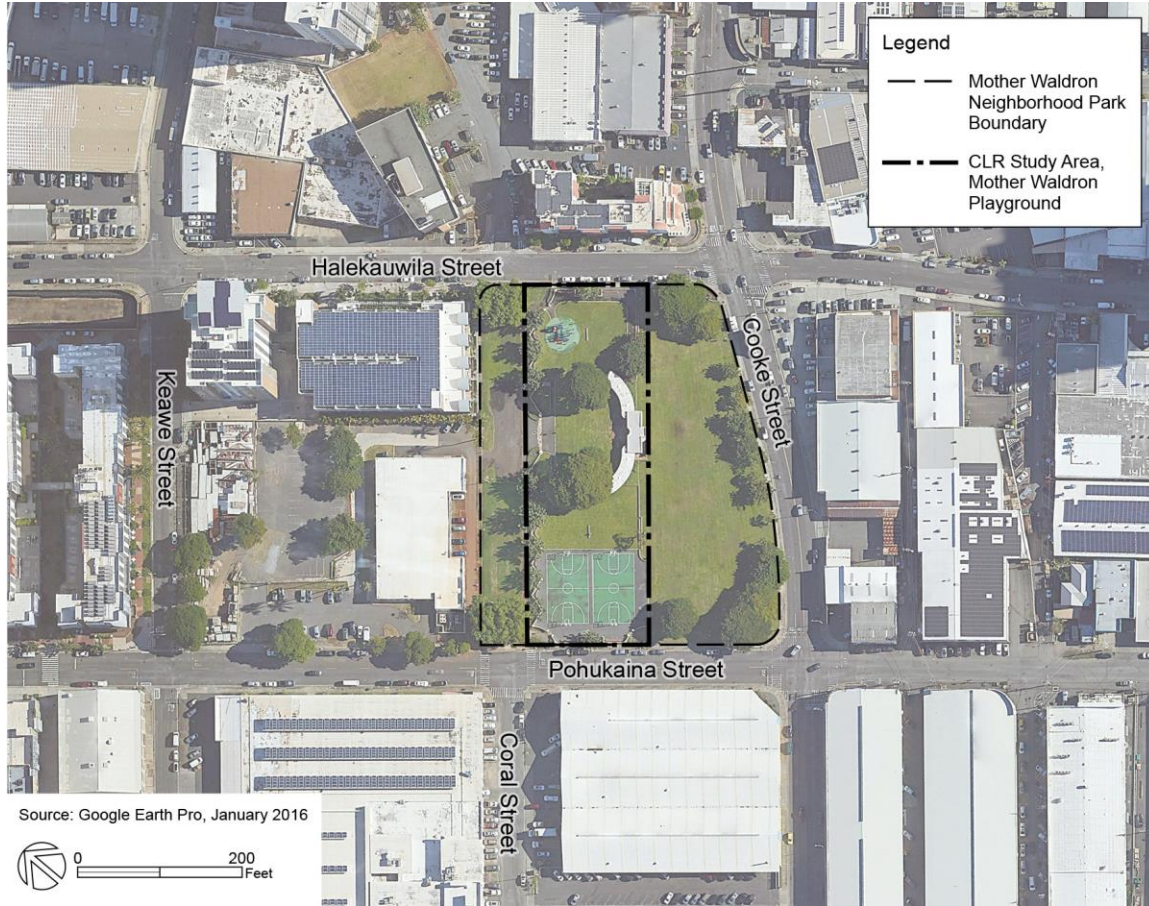
Figure 1.2: CLR Study Area. (Base Map: Google Earth Pro, 2016)

Mother Waldron Neighborhood Park is a 3.4-acre site in the Kaka’ako district of Honolulu. Kaka’ako is an urbanized community situated on a portion of a low-lying coastal plain, located between downtown Honolulu and Waikīkī (Figure 1.1). The City and County of Honolulu neighborhood park incorporates the extant lands of the original Mother Waldron Playground, constructed in 1937 and bounded by Lana Lane, Pohukaina and Coral Streets, and what would become an extension of Halekauwila Street. In the 1990s, changes to the playground’s boundaries resulted in the combined 3.4-acre park that is bounded by the ‘Ewa edge of the former Coral Street right-of-way and Halekauwila, Cooke, and Pohukaina Streets (Figure 1.2).

The historic landscape of Mother Waldron Playground is within the broader boundaries of Mother Waldron Neighborhood Park, which is managed and maintained by the City and County of Honolulu Dept. of Parks & Recreation. (Figure 1.2). The landscape preservation treatment strategies and design measures that follow may influence future landscape decisions for the playground site. The treatment plan recommends concepts for managing the historic landscape, with a focus on protecting landscape features identified as contributing to the historic significance of the site. These landscape treatment measures provide specific, near-term recommendations, as well as a comprehensive vision for the cultural landscape that may serve as a guide for long-term management. All landscape treatment measures were developed in accordance with the *Secretary of the Interior's Standards for the Treatment of Historic Properties with Guidelines for the Treatment of Cultural Landscapes* in order to minimize adverse impacts to Mother Waldron Playground.⁹¹

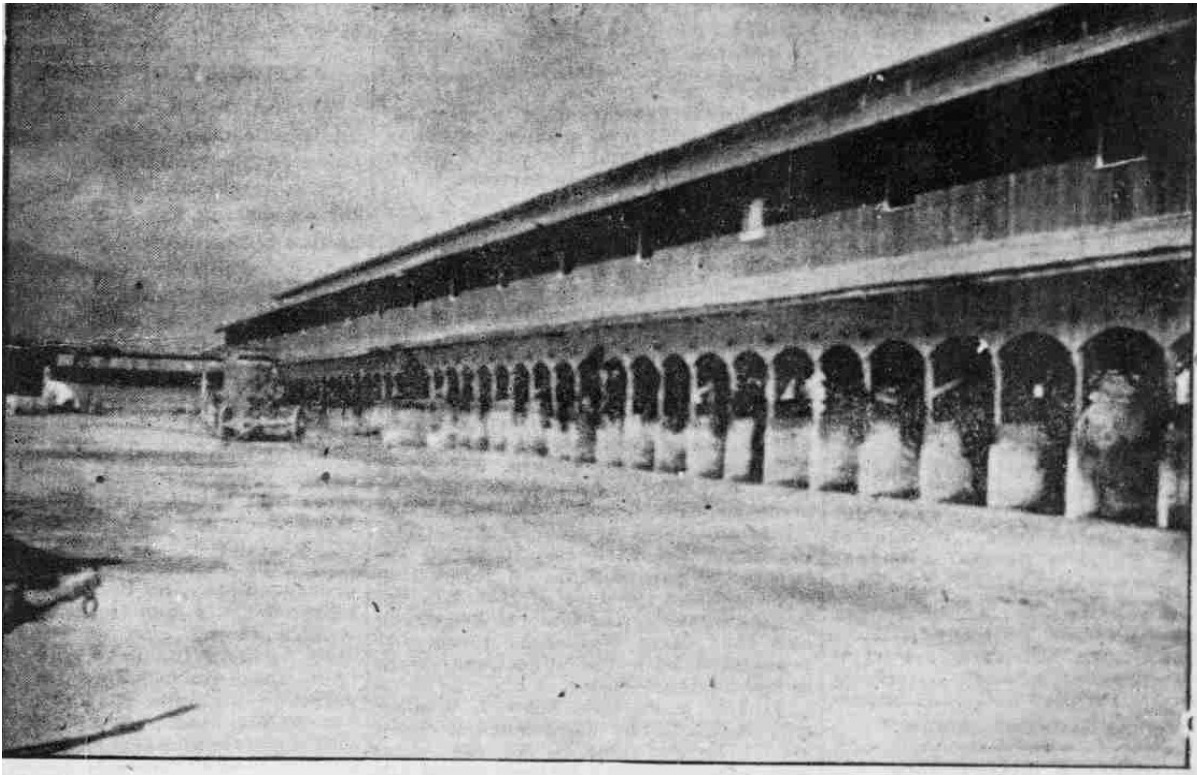
Figure 2.10: Government Stables in Kaka'ako, built ca. 1904, (Source: "Honolulu Highways and Byways: Lake Dwellers in the Suburb - Regeneration of the District and the Japanese Invasion," *Honolulu Advertiser*, Section 2, (March 29, 1908), 9)

By October 1901, plans had been drawn for new stables to house the mules and horses, wagons and rolling stock of the county's public works department, initially planned to front Keawe Street.³⁹ By February 1904, a newspaper article indicated that "all that hinders now is the weather."⁴⁰ The stable complex was ultimately built northeast of the Coral Street/Second Street (Pohukaina) intersection on the land that would later become Mother Waldron Playground (Figure 2.10). The complex consisted of an elongated, two-story wood-frame barn near the center of the lot. The barn had a side-facing, double-vented shed roofline and open double-loaded bays that enabled horses to be quartered on both sides of the building. Each bay was further defined by an arch that opened onto the yard. A 1914 Sanborn map

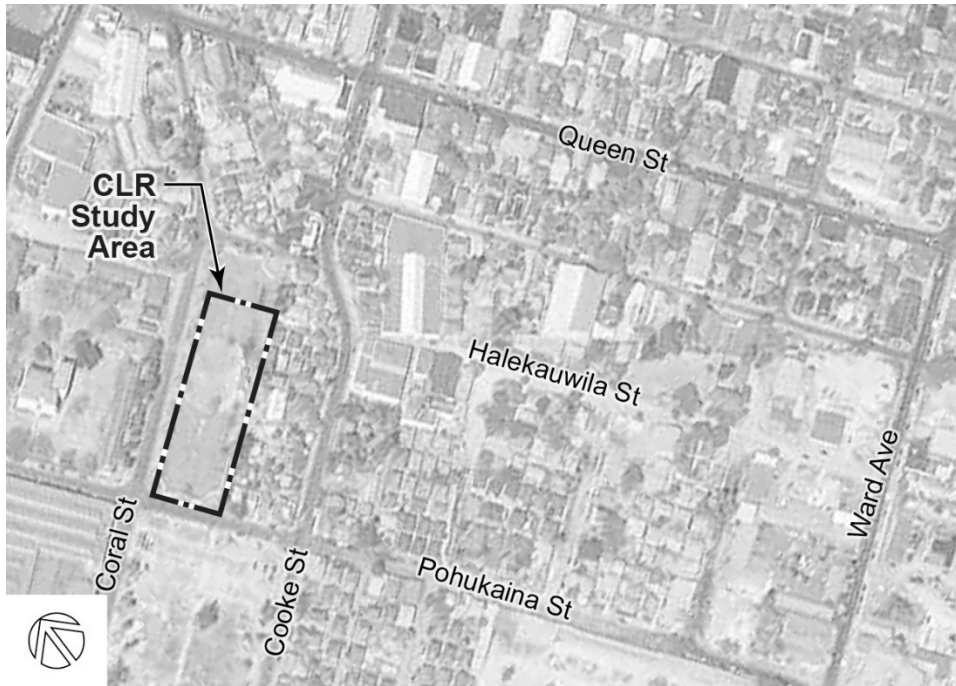
Figure 2.11: Aerial photo showing Mother Waldron Playground, 1952.
(Source: University of Hawai'i, Mapping and Geographic Information Systems:
<http://guides.library.manoa.hawaii.edu/magis>)

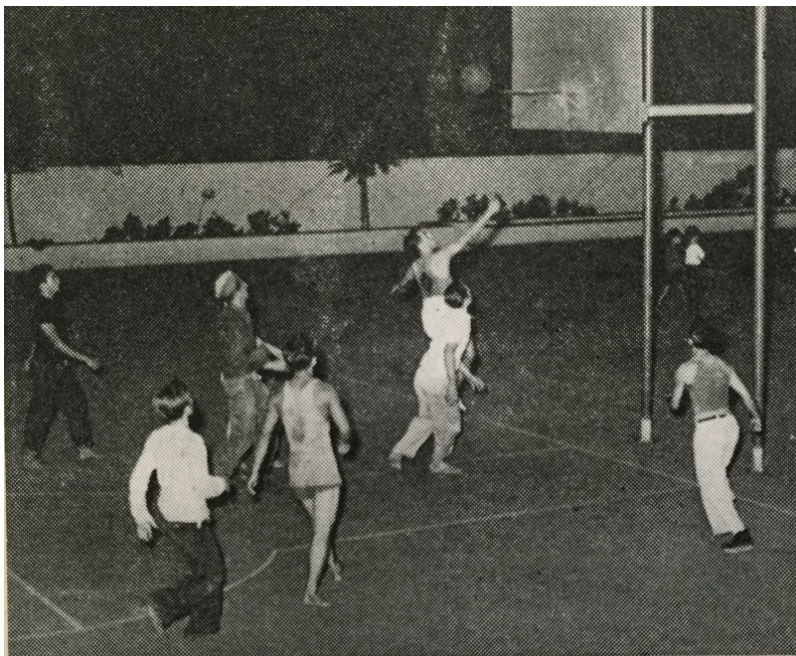
Figure 2.16: This 1938 photo depicts the nighttime use of the basketball court. Also visible are the 5-foot-high wall along Lana Lane and the low curb wall in front of it, with plantings between. (Source: Honolulu Park Board, *Your Parks: Annual Report for 1938*)

The playground was enclosed by concrete brick walls of varying heights and designs. Bent's plan identified a solid, straight, 5-foot-high wall capped with a precast concrete coping on the rear boundary along Lana Lane. A 2-foot-high "brick curb wall" topped with thin padre tile (terracotta) ran parallel to, and 7–11 feet inside the higher wall as well (Figures 2.15 and 2.16).

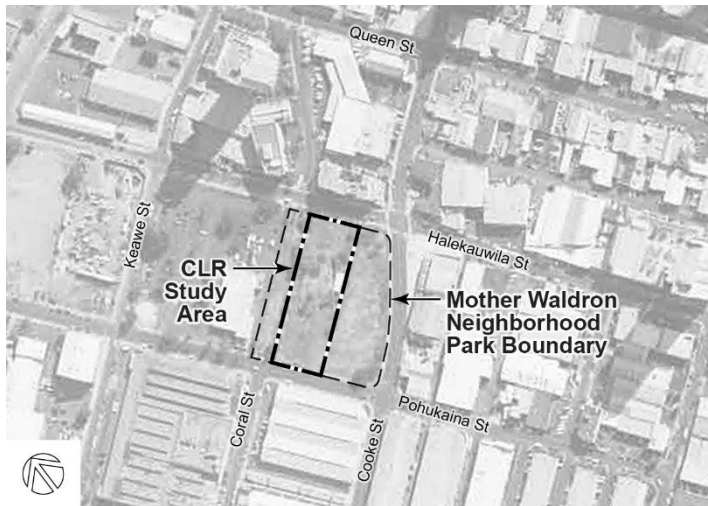
Figure 2.19: Aerial photograph from 2000 depicts the Mother Waldron Neighborhood Park following realignment of Halekauwila Street and the incorporation of Coral Street right-of-way and land area to Cooke Street as part of the park. It also shows redevelopment of the former school site and lands *mauka* of Halekauwila Street. (Source: <http://magis.manoa.hawaii.edu/remotesensing/GeoserverFiles/ShpFiles/Oahu/018/jpegs/930>)

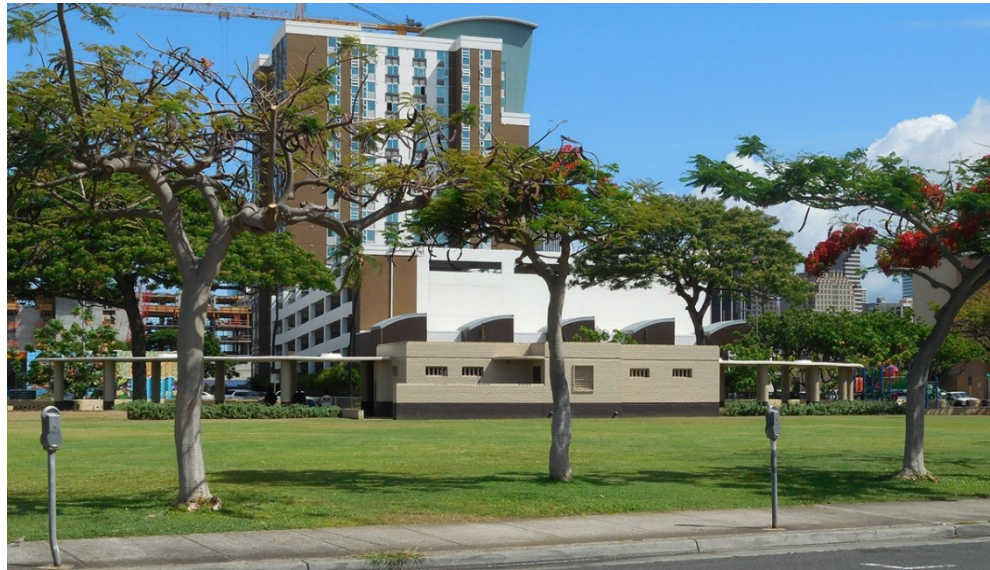
Figure 3.2 (top): Panorama of study area from Cooke Street.

The neighborhood park is oriented *mauka-makai* and delineated on four sides by the generally rectilinear grid of Kaka'ako district streets. The park is characterized by three distinct *mauka-makai* linear areas. Closest to Cooke Street is an expansive lawn with shade trees on the periphery. (Figure 3.2). The central area, the CLR study area and the extant lands of the original Mother Waldron Playground, is defined by perimeter sidewalks and planting spaces along Halekauwila, Pohukaina, and former Coral Streets, and enclosed by low walls on four sides. It has four distinct subareas (from

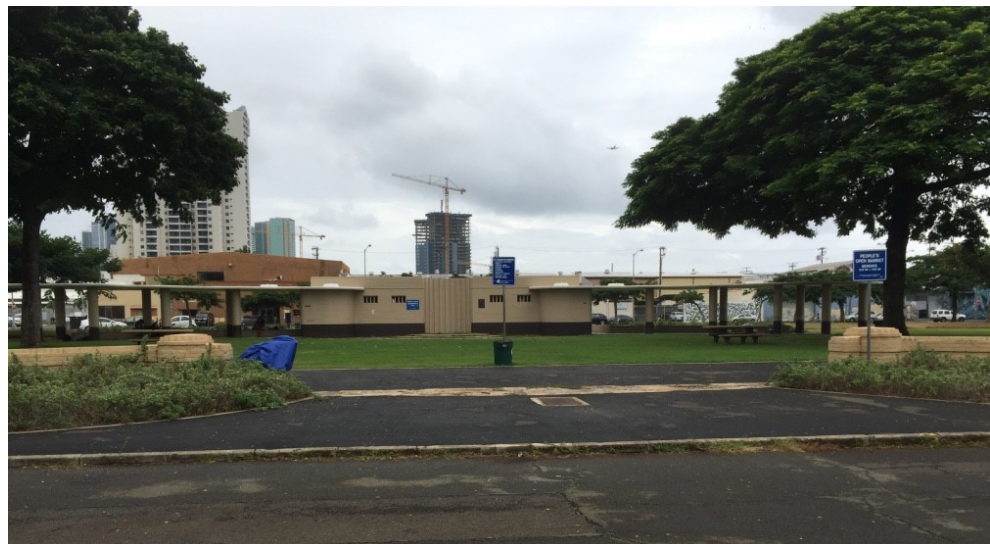
Figure 3.3 (bottom): Panorama of study area from Coral Street ROW.

Halekauwila Street to Pohukaina Street): a play structure area, the central comfort station with pergolas and lawn area, a lawn area with benches, and ball courts. The Coral Street ROW is a visually open, non-vehicular corridor with a grove of trees at each end. (Figure 3.3). The makai third of the ROW is a fenced-in dog park.

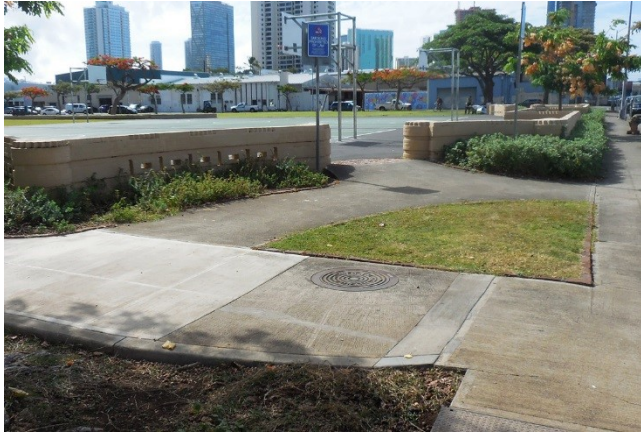
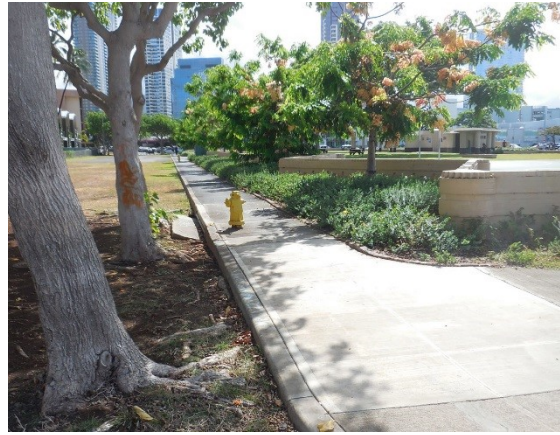
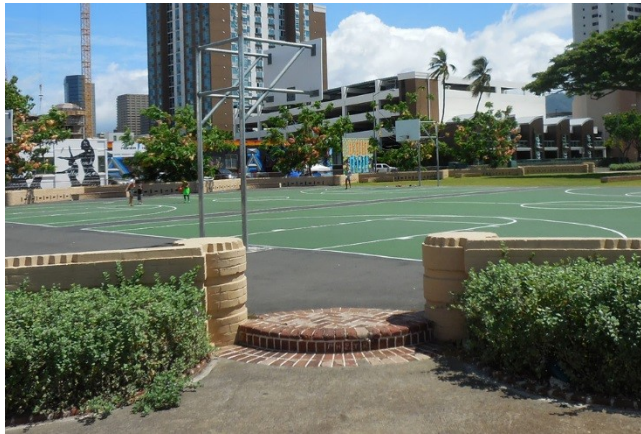
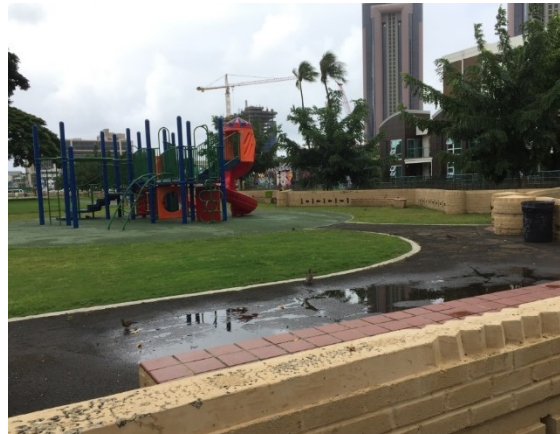
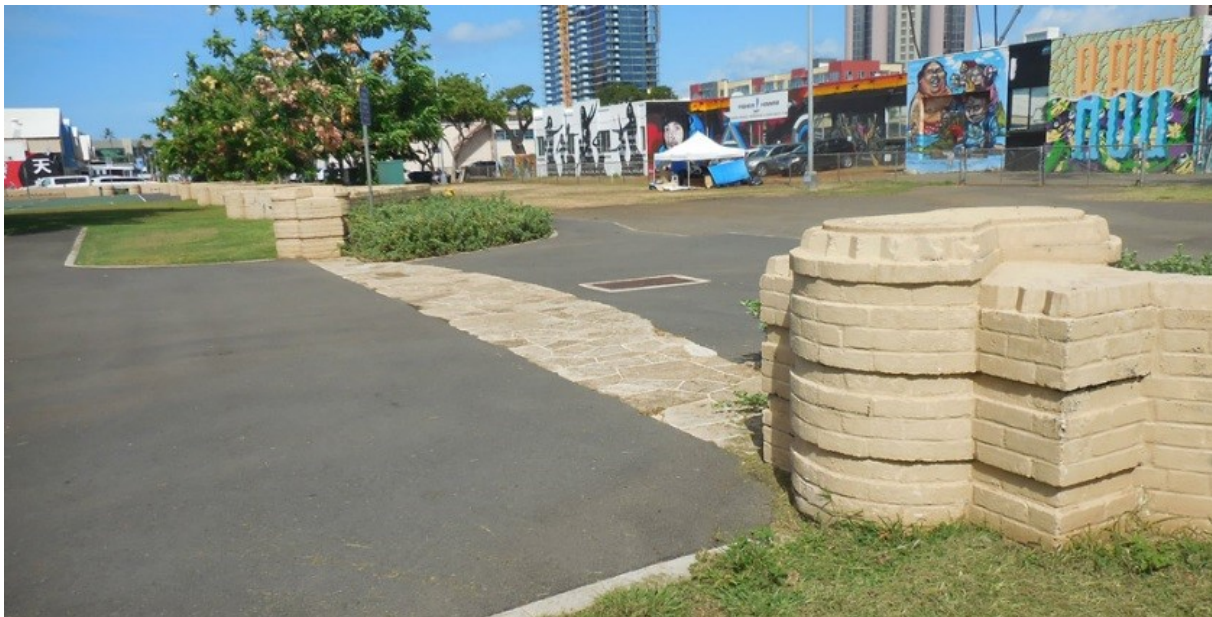
Figure 3.4 (top left): Pohukaina Street perimeter sidewalk (right) links with a playground entry (center) and Coral Street ROW sidewalk (left). **Figure 3.5 (top right):** Coral Street ROW sidewalk looking toward Halekauwila Street. **Figure 3.6 (middle left):** Pohukaina Street playground entry closest to Cooke Street with an almond-shaped brick step. **Figure 3.7 (middle right):** Asphalt paving near play structure. **Figure 3.8 (bottom):** Coral Street ROW playground entry looking toward the ROW.

A perimeter pedestrian circuit is formed by 6-foot-wide concrete sidewalks along Halekauwila and Pohukaina Streets and a 6-foot-wide walkway along the edge of the Coral Street ROW that connects with the Halekauwila and Pohukaina Streets sidewalks. (Figure 3.4). The grassy area of the *makai*-third of the ROW was enclosed by chain link fencing in early 2020 for use as a dog park.

From the entry at Halekauwila Street/Coral Street ROW intersection, a broad asphalt paved area abuts the inside of the playground walls and provides access to the play structure and the comfort station. (Figure 3.7). A 6-inch-wide concrete curb is level with and borders the inside edge of the asphalt paving. The entries on Pohukaina Street provide access to two adjoining asphalt-paved basketball courts.

Midpoint along the Coral Street ROW, the walkway links to a playground entry highlighted by a lens shape of flagstone pavers with light-colored mortar joints that stretches across the opening in the perimeter walls. (Figure 3.8). On the playground side of the flagstone pavers, an asphalt walkway provides access to the playground's central lawn area.

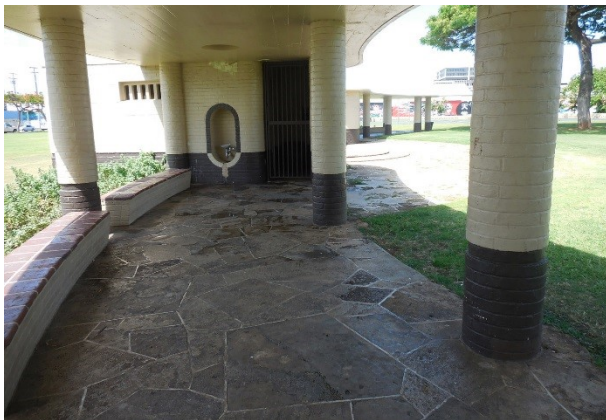
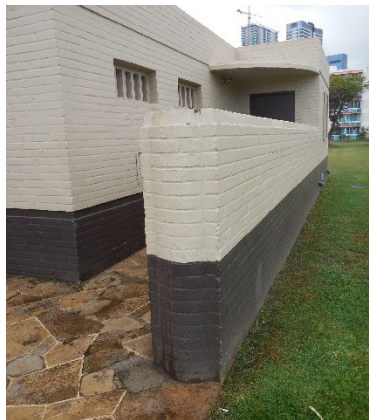
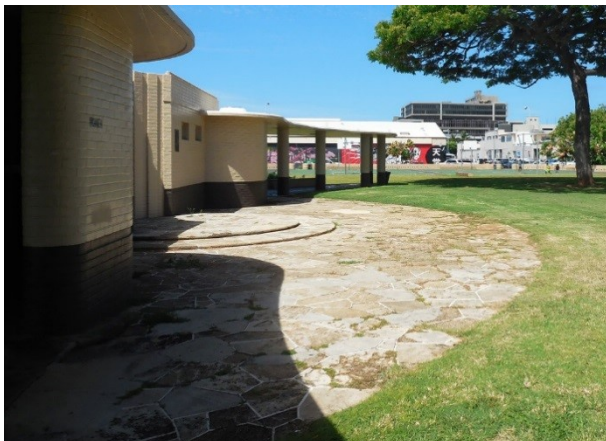
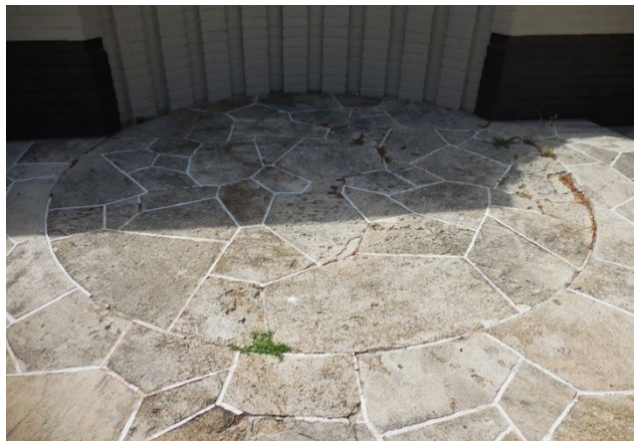
Figure 3.9 (top left): Flagstone paving beneath the pergola on the Halekauwila Street side of the comfort station. **Figure 3.10 (top right):** Flagstone paving for access to storeroom door. **Figure 3.11 (left):** Looking toward Pohukaina Street at the curved band of flagstone paving that connects the pergola walkways. **Figure 3.12 (right):** Distinctive circular paving joint on top of the circular platform at the center of the comfort station.

Below the central comfort station pergolas are walkways of coral flagstone paving with light-colored mortar joints (Figure 3.9) that provide access to the men's and women's toilets. The flagstone extends 9-11 inches beyond the pergola columns and wraps around the Pohukaina Street end of the comfort station to a storeroom doorway. (Figure 3.10). A broad band of the same flagstone material in front of the comfort station connects to the pergola walkways. (Figure 3.11). At the center of the curved band is a two-tier circular platform. The top tier has a distinctive circular paving joint that is 2.5 feet from the edge of the tier. (Figure 3.12). Herbaceous plants, including turf, are growing in the joints and growing in and extending over the pavers. Missing pavers have been replaced with concrete.

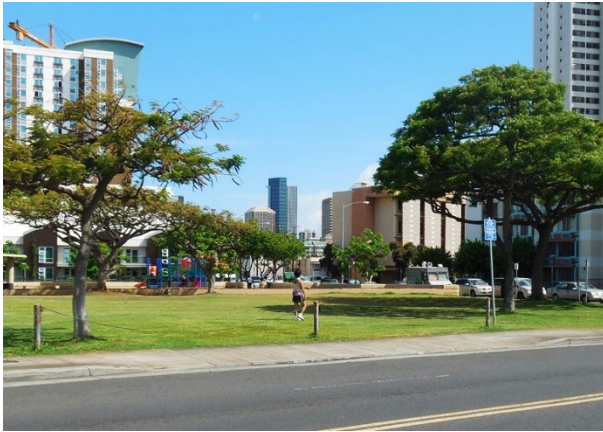
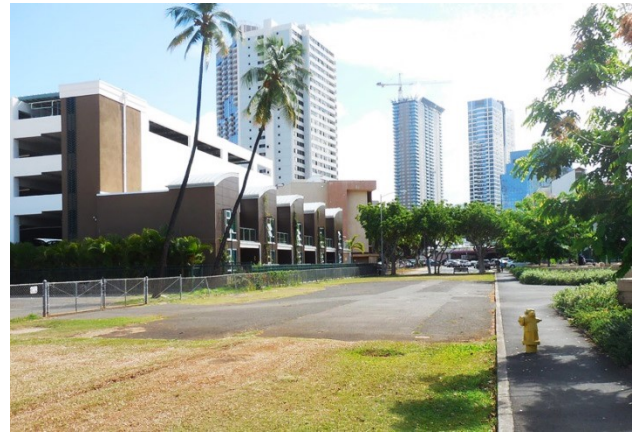
Figure 3.13 (left): Curb cut on Cooke Street for park maintenance vehicle access. **Figure 3.14 (right):** View of Coral Street ROW looking *mauka* toward central asphalt paving at gates in property line fence to the left.

Two streets border the CLR study area. Halekauwila and Pohukaina Streets are 50-foot wide, two-way asphalt arterials with 6-inch high concrete curbs and on-street meter parking on both sides. A wide curb cut on Cooke Street provides access for park maintenance vehicles, such as lawn mowers. Other vehicles are deterred from entering the park by a stanchion and chain assembly in the lawn adjacent to the curb cut. (Figure 3.13). The Coral Street ROW is closed to vehicular traffic. On both the Halekauwila Street and Pohukaina Street ends of the ROW, a sidewalk and concrete curb have been constructed and groves of trees has been planted. The remainder of the ROW is mostly lawn, except for asphalt paving in the central area, which aligns with the playground entry and a double gateway in the property line chain link fence. (Figure 3.14).

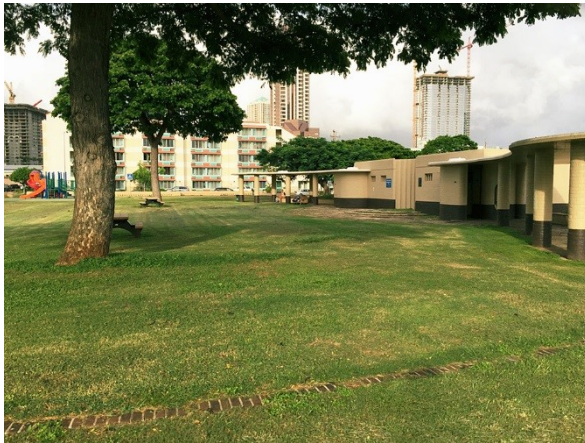
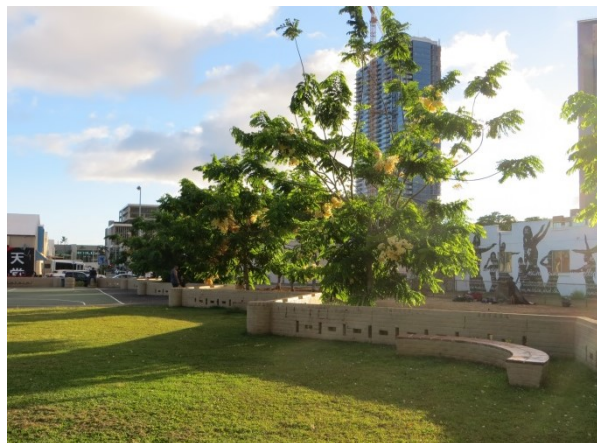
Figure 3.15 (left): Brick edging separates the original central lawn from the grass that replaced part of the asphalt courts in 2014. **Figure 3.16 (right):** Rainbow shower trees are planted in alcoves of the zig-zag wall.

The CLR study area is vegetated primarily with turf ground cover, which is a mixture of Bermuda grass (*Cynodon dactylon*), St. Augustine grass (*Stenotaphrum secundatum*), and a sedge known as McCoy grass (*Cyperus gracilis*). (Figure 3.15). The coverage is complete and healthy, with few signs of wear from foot traffic. Masses of *akia* (*Wikstroemia uva-ursi*) ground cover, a native Hawaiian species, are planted in three locations: along the Coral Street ROW between the zigzag wall and a concrete curb; along Pohukaina Street between the playground walls and the sidewalk; along Halekauwila Street between the playground walls and the sidewalk; and in the planting spaces on the Cooke Street side of both pergolas.

- Rainbow Shower (*Cassia x nealiae*): Ten rainbow shower trees are in the alcove planting spaces formed by the zigzag perimeter walls. The shower trees range in height from between 15-25 feet. (Figure 3.16).

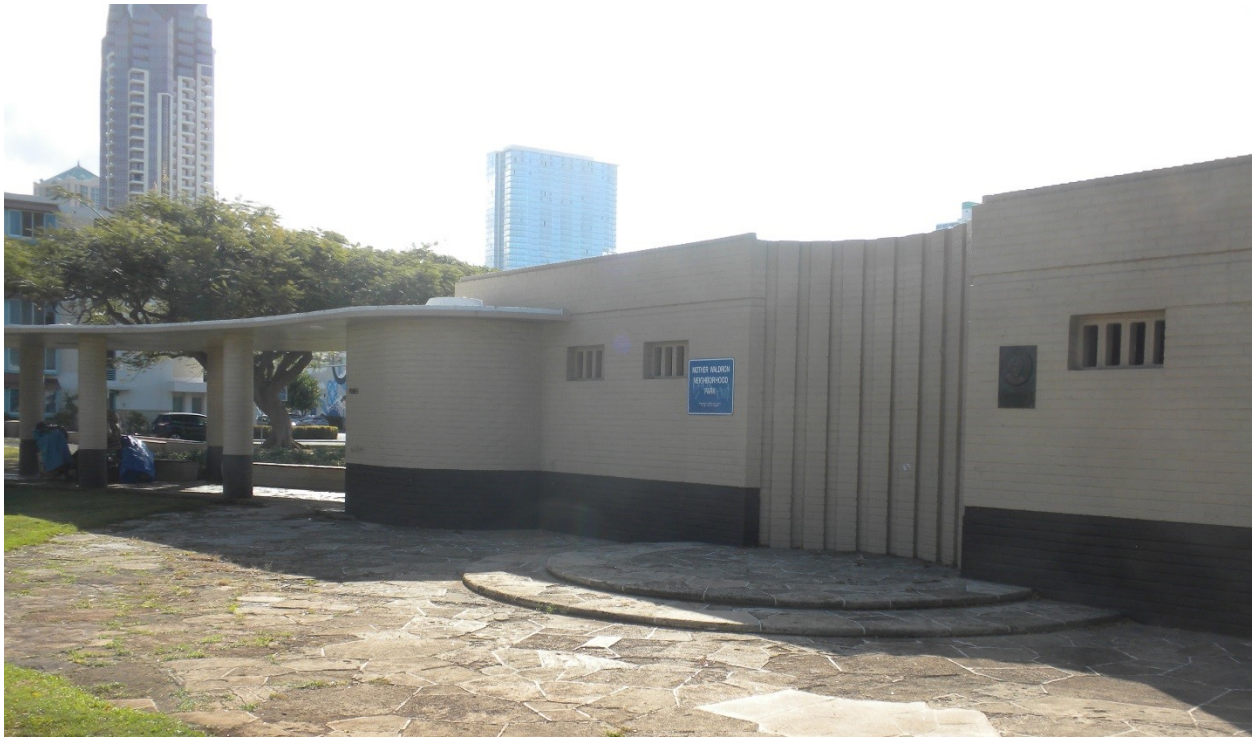
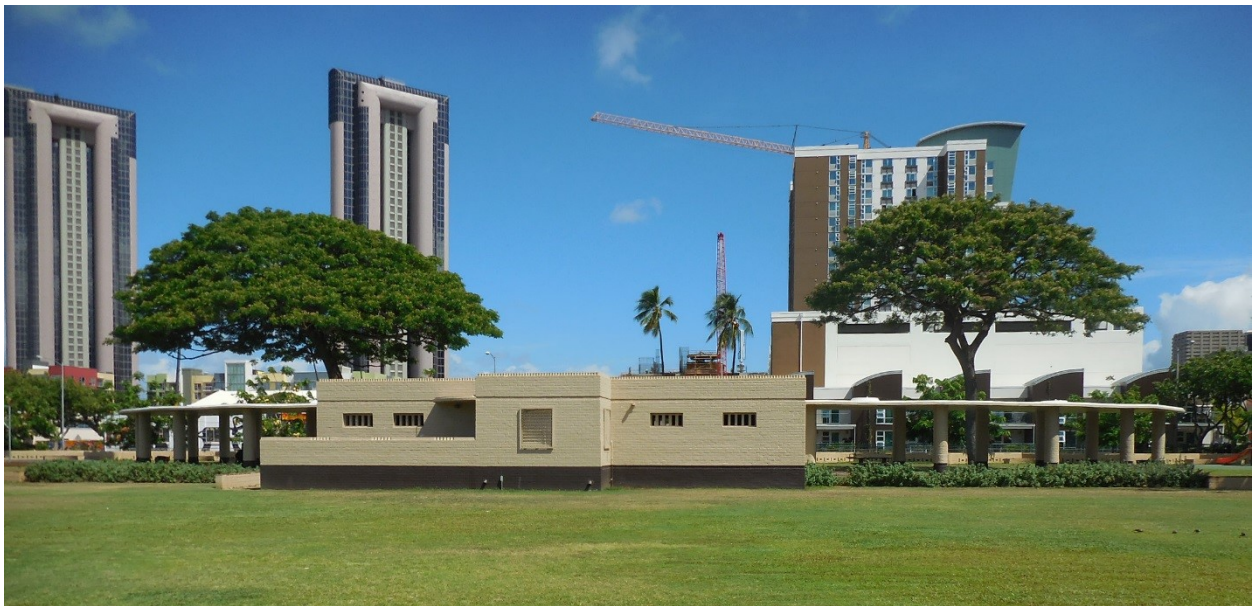
Figure 3.17 (top): Front façade of the comfort station and *mauka* pergola. **Figure 3.18 (bottom):** Comfort station and pergolas as seen from Cooke Street.

A single-story rectangular comfort station flanked by curved pergolas is located approximately in the center of the playground. (Figures 3.17 and 3.18). The concrete brick building walls and the pergola columns are painted dark brown from finish grade up to and including a recessed course of brick. The upper portion of the walls, columns, and roof parapet are painted beige, including a second recessed course of bricks. At the center of the comfort station wall facing the Coral Street ROW is a semicircular pilaster-like alcove comprised of alternating stacks of recessed bricks. On each side of the semicircle are two matching horizontal niches with five vertical opening, which ventilate the men's and women's toilet areas. Facing Cooke Street, the comfort station's storeroom extends 5.5 feet beyond the toilet areas and possesses a vertical rectangular louvered opening for ventilation. In the toilet area walls, on either side of the storeroom, are pairs of horizontal recesses matching the recesses in the wall facing the Coral Street ROW. Above the storeroom door is a quarter-circle concrete hood at the same height as the building wall's upper course of recessed brick. Extending beyond the storeroom toward Pohukaina Street is a 5-foot-high wall; it does not have a recessed course of bricks but does have concrete coping that matches other walls in the playground.

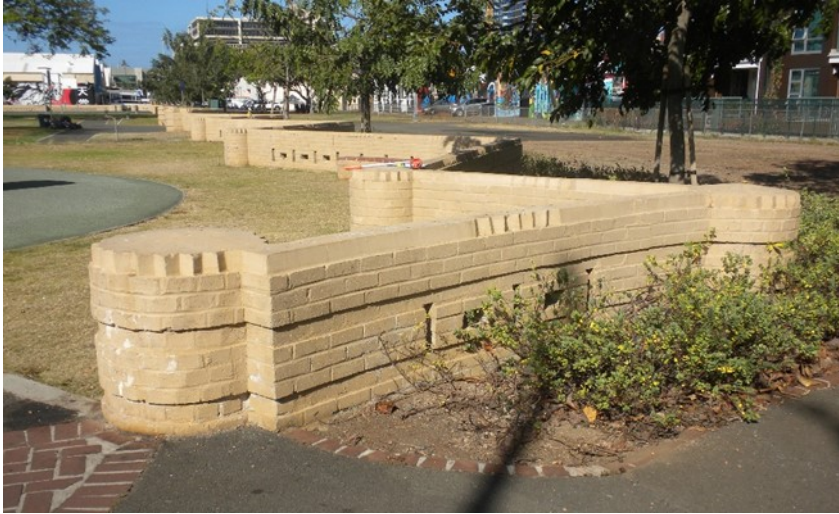
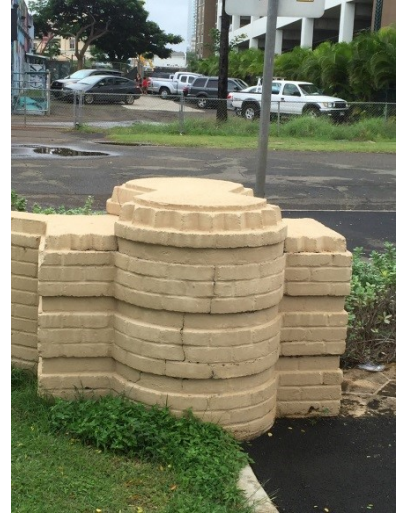
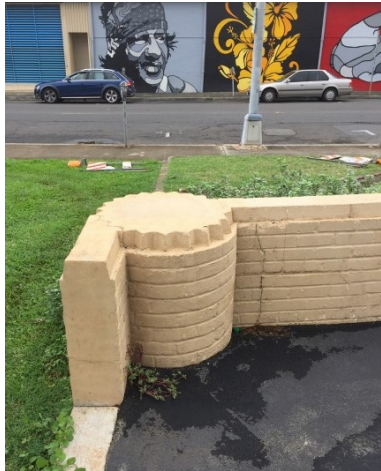
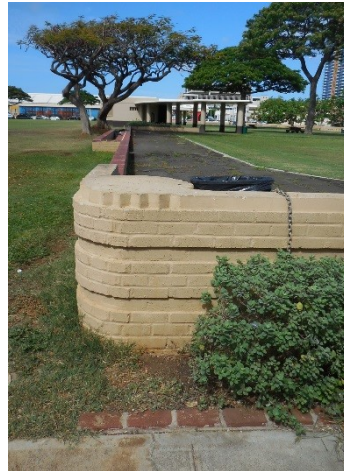
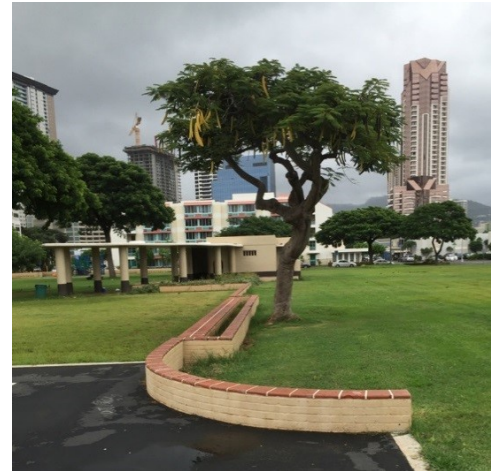
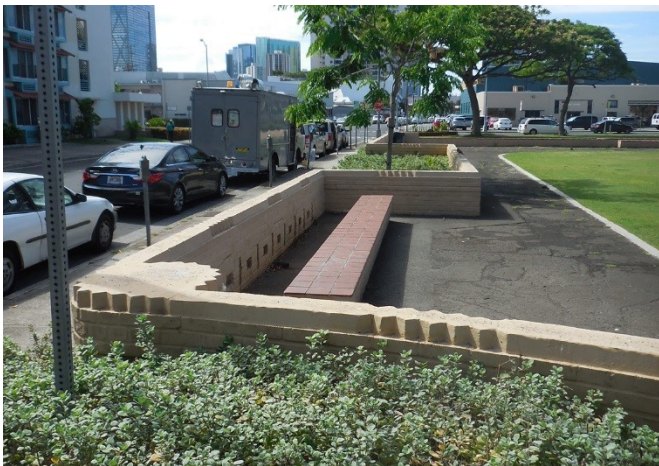
Figure 3.19 (top left): Zigzag wall along Coral Street ROW from Halekauwila Street playground entry. **Figure 3.20 (top right):** Double pier at Coral Street ROW playground entry. **Figure 3.21 (middle left):** Wall along Pohukaina Street looking toward Halekauwila Street. **Figure 3.22 (middle center):** Brick and terracotta wall from Halekauwila Street. **Figure 3.23 (middle right):** Brick and terracotta wall from Pohukaina Street. **Figure 3.24 (bottom left):** Pohukaina Street wall wrapping around pier at corner of basketball court. **Figure 3.25 (bottom right):** Wall along Halekauwila Street looking toward Pohukaina Street.

The historic Mother Waldron Playground is almost completely enclosed by walls. Along the Coral Street ROW, a 3-foot-high, 9-inch-thick wall of beige-painted running bond concrete bricks zigzags on a centerline parallel with the ROW; in some locations, two courses of brick are inset from the others on the outside of the wall. Each 9-foot-long angled wall segment has an alternating central pattern of vertical and horizontal openings and a cap of poured concrete with a regularly spaced zigzag pattern. At the ends and intersections of wall segments are 2-foot diameter piers topped by poured concrete caps with zigzag edges. At the playground's Coral Street ROW entry, the ends of the walls have double piers. (Figures 3.19, 3.20, 3.21, 3.22).

Connecting to the Cooke Street end of the Halekauwila Street wall is an 18-inch-high rectilinear wall that extends to the pergola on the Halekauwila Street side of the comfort station. The wall is constructed of running bond brick painted beige and is capped with square terracotta tiles with mortar joints. A similar wall extends from the pergola on the Pohukaina Street side of the comfort station and ends with a curved segment at the basketball courts. (Figure 3.23).

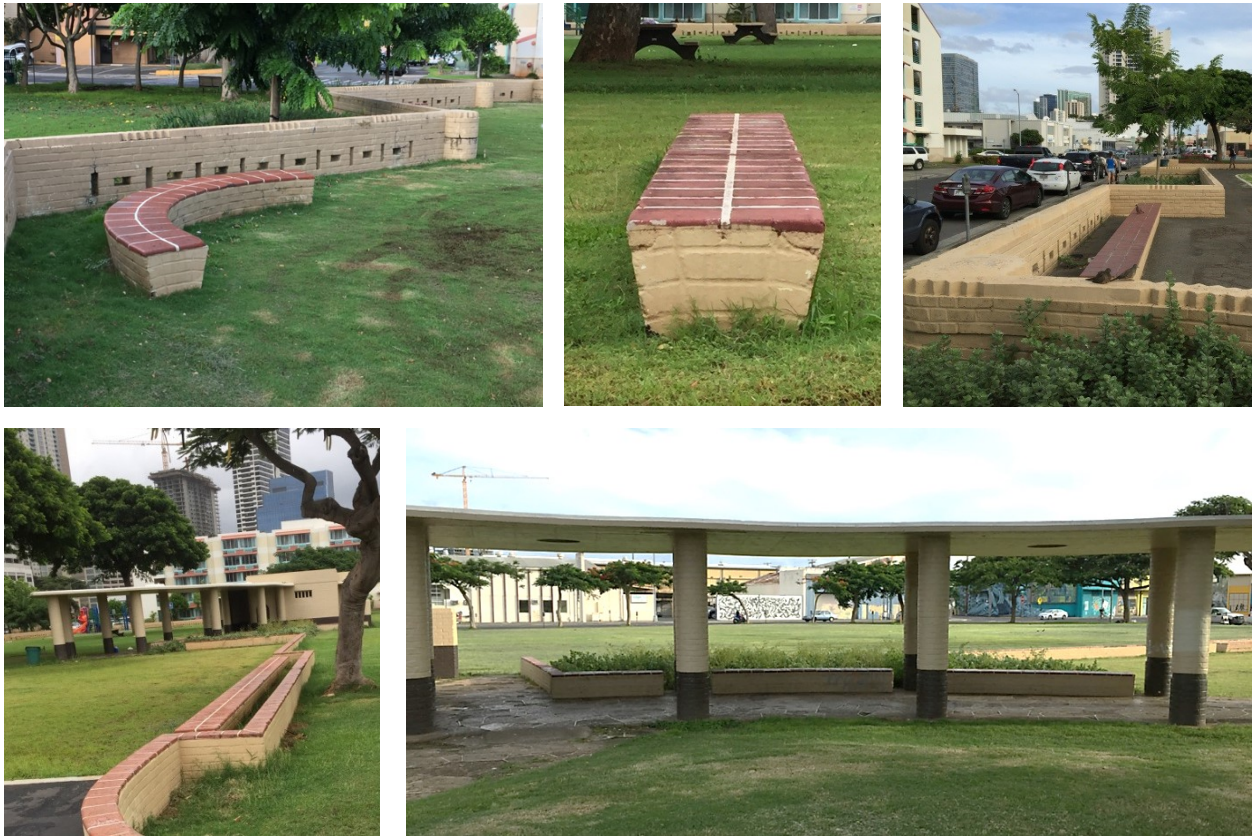
Figure 3.26 (top left): Curved bench inside the zigzag wall along the Coral Street ROW.

Figure 3.27 (top center): Rectilinear bench in the lawn area adjacent to the basketball courts.

Within the original playground, there are three types of benches, all constructed of beige-painted concrete bricks capped by red clay mortared tiles. Six curved benches are in the triangular-shaped alcoves created by the zigzag perimeter wall along the Coral Street ROW. (Figure 3.26). Long rectilinear benches are in several locations: one each is in the lawn areas adjacent to the play structure area and the basketball courts; two each are in alcoves created by the Halekauwila and Pohukaina Street perimeter walls; and two are in niches created by the configuration of the Cooke Street wall. (Figures 3.27, 3.28, and 3.29). A third bench type is located beneath the pergolas and duplicates their curve in plan. (Figure 3.30). The lengthwise faces of all benches taper inward from top to bottom.

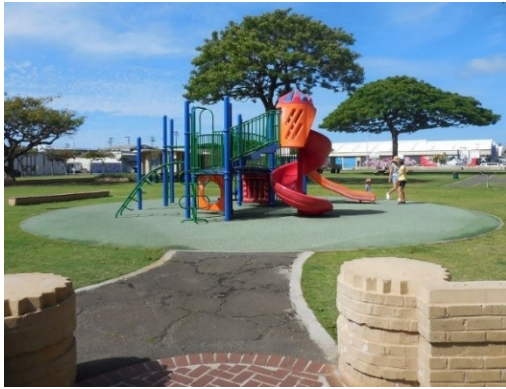
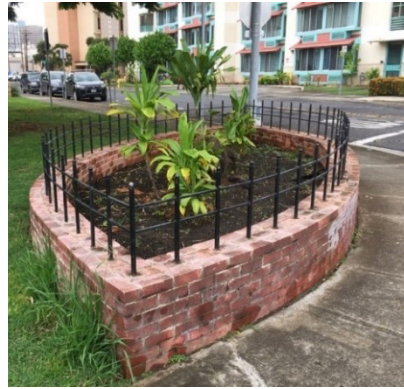
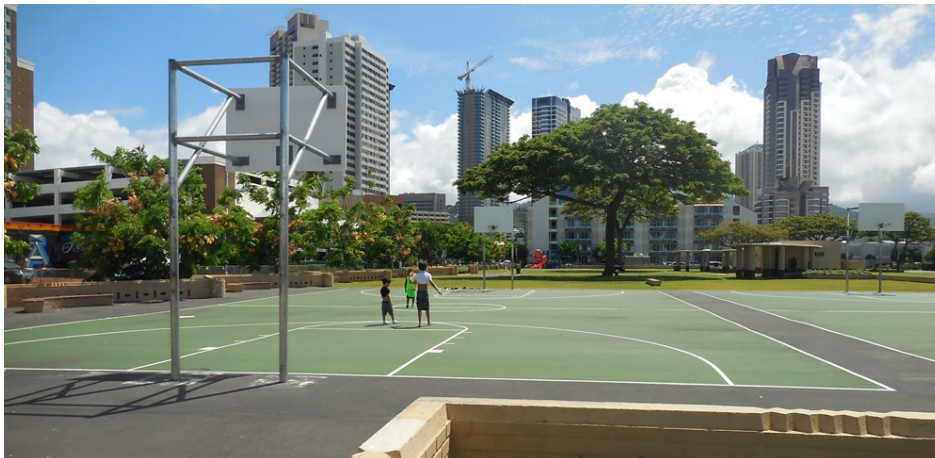
Figure 3.31 (top left): Interment vault looking toward Halekauwila Street.
Figure 3.32 (top right): Play structure looking from Halekauwila Street.
Figure 3.33 (left): Basketball courts with hoops viewed from Pohukaina

A prefabricated play structure mounted on a rubber surface is located near the Coral Street ROW/Halekauwila Street park entry. (Figure 3.32).

Each of the two basketball courts on the Pohukaina Street side of the study area has two metal hoop structures anchored at each end of the court. (Figure 3.33).

Outside of the CLR area, at the corner of Halekauwila and Cooke Sstreets, two 3-foot-high red clay brick walls laid in a running bond pattern with mortar joints define an almond shape, which secures an interment vault. Wrought iron fencing is anchored in the top of the walls, and inside the walls are planting soil, green ti plants, a lava rock boulder, and lava rock cinders over black weed fabric. A small bronze plaque at the top of the wall adjacent to the sidewalk says, "KAPU." (Figure 3.31).

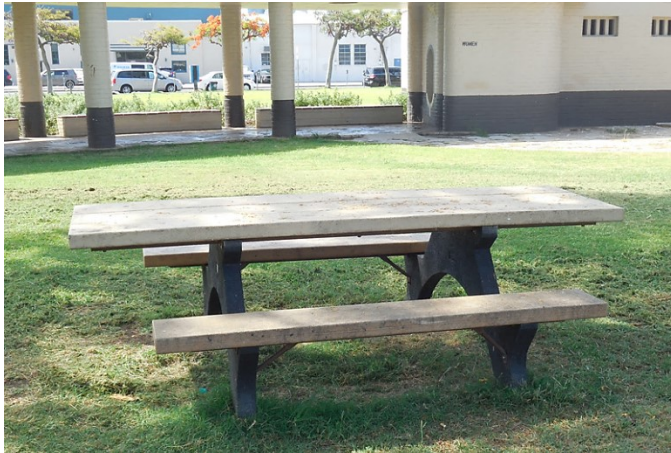
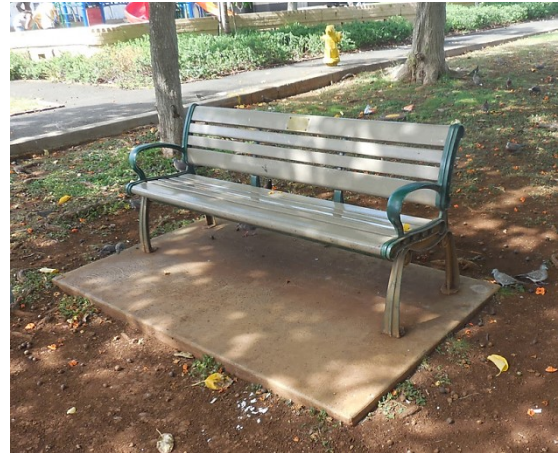
Figure 3.34 (left): Moveable picnic table in central lawn area looking toward comfort station.

Figure 3.35 (right): Park bench facing Halekauwila Street.

Two plastic picnic tables with attached benches are situated under trees in the central lawn in front of the comfort station. (Figure 3.34). In the grove of kou trees on the Halekauwila Street end of the Coral Street ROW, a plastic bench is anchored on a concrete slab and a small brass plaque is affixed to the back of the bench (see Plaques and Signs section). (Figure 3.35).

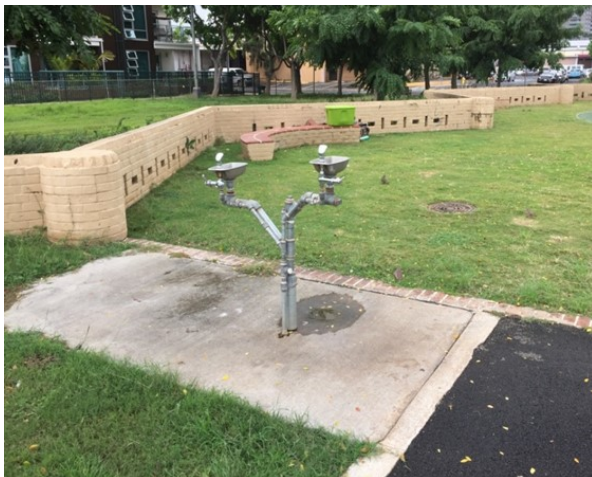
Figure 3.36 (top): Small scale features include the drinking fountain mounted on a poured concrete pad.

A 3-foot high drinking fountain is mounted on a 9-foot by 5-foot poured concrete pad inside the playground entry from the Coral Street ROW. (Figure 3.36).

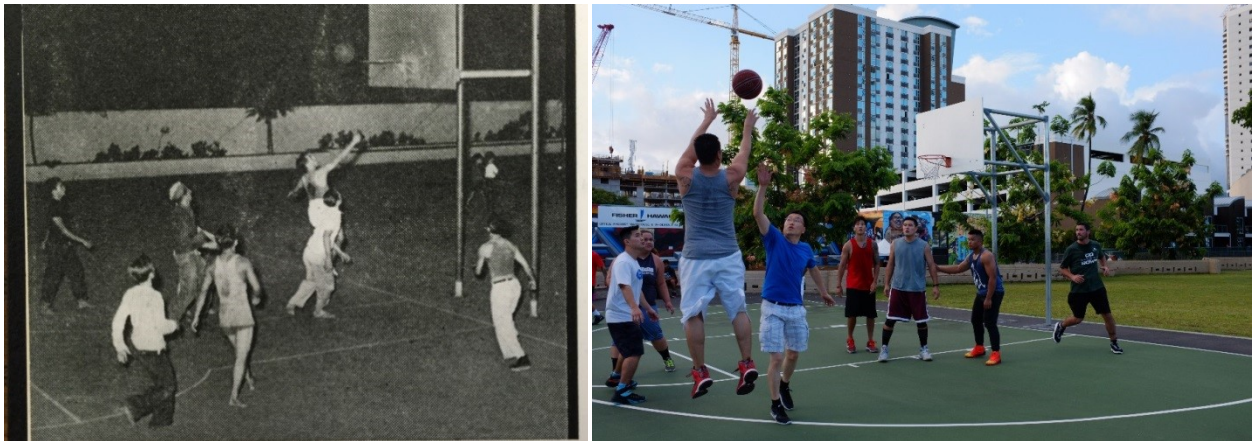
Figure 4.1: Photographs of basketball being played on the senior playground in 1938 (left) and 2016 (right).

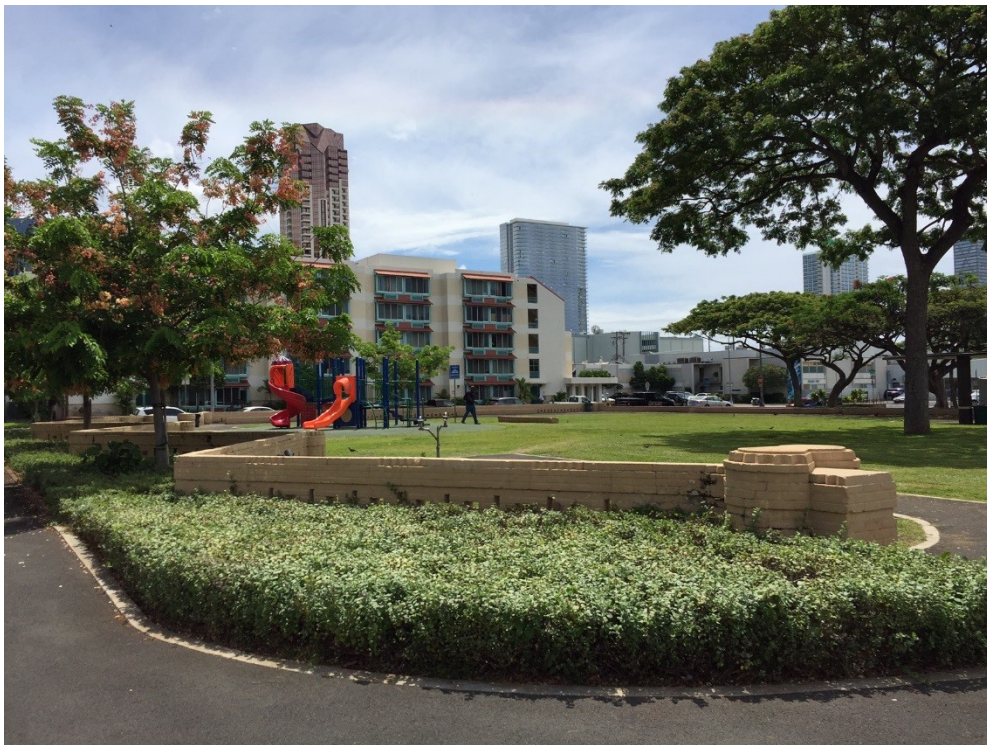
Figure 4.3: Comparative views looking east across the junior playground from the main entry along the Coral Street right-of-way; ca. 1938 (top) and 2016 (bottom).

New asphalt walkways with flush concrete curbs and the expanded flagstone pavement in front of the comfort station are non-contributing additions that negatively impact the original design and spatial character of the central lawn. (Figure 4.3). The historic expanse of asphalt pavement in the two playgrounds has been considerably reduced. About half of the senior playground and the majority of what remains of the junior playground are now grassed. Although the asphalt on the edge of the junior playground remains from the earlier playground, it no longer retains integrity as a pedestrian surface for active recreation. In contrast, the asphalt basketball courts of the senior playground do retain some integrity.

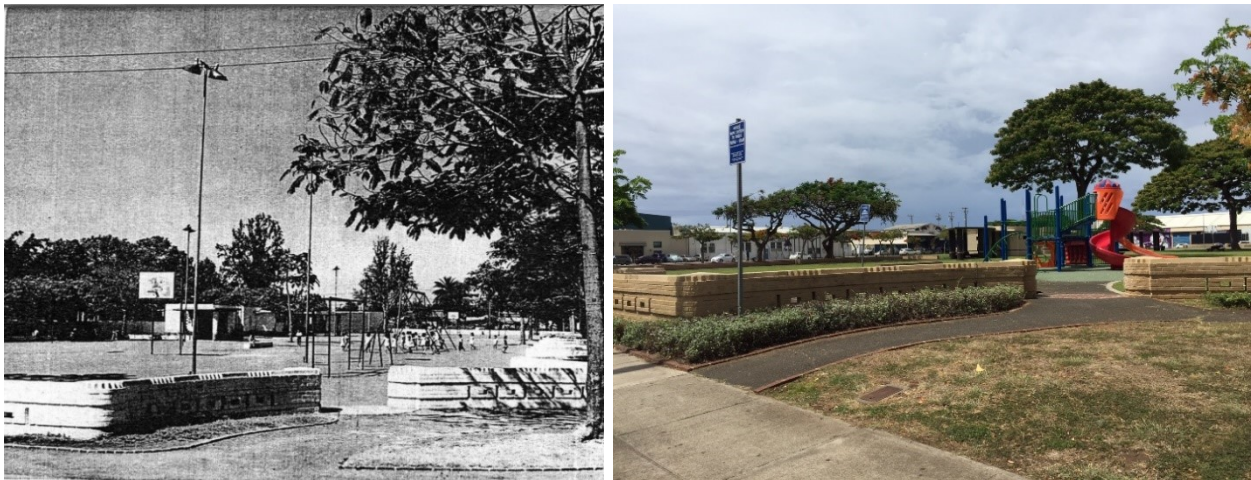
Figure 4.4: Comparative views of the pedestrian entry and the junior playground beyond from Halekauwila Street looking south near Coral Street. Note the grassy planting spaces ca. 1960-70s (post period of significance, at left) and the present-day lawn and akia plantings (right).

Bent's designed pattern of canopy street trees planted within the alcoves of the perimeter playground walls has been retained along the Coral, Halekauwila, and Pohukaina Street edges of the playground. The tree species was changed from the original royal poinciana to rainbow shower trees in 2014. No other trees from the period of significance exist, either species type or location, which compromises the symmetry and functionality that Bent intended the tree plantings to provide. Many of the brick-edged planting spaces from Bent's design generally retain their location, size and shape, including the wall alcoves, corner entries, and behind the pergolas. The specific historic vegetation within the planting spaces is unknown but photos indicate many contained grass. Today, most of the spaces are planted with grass or akia groundcover. (Figure 4.4).

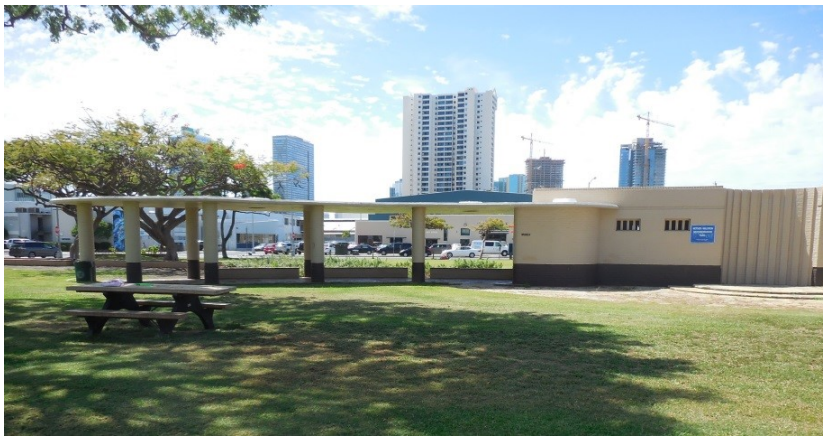
Figure 4.5: Comparative views of the comfort station and *mauka* pergola in 1937 (top) and 2016 (bottom). Note the modified block openings in the restroom wall and the two-color paint scheme.

The Mother Waldron Playground comfort station and attached pergolas retain their integrity in terms of external architectural elements, patterns, and materials that visually and spatially contribute to the cultural landscape. (The 2013 draft NRHP form provides information on both the internal and external architectural character-defining features). The current two-color paint scheme differs from the original solid white color, but is a reversible condition. The replacement of the original screen block openings in the two restrooms (ca. 1969) is the primary external modification. (Figures 4.5 and 4.6).

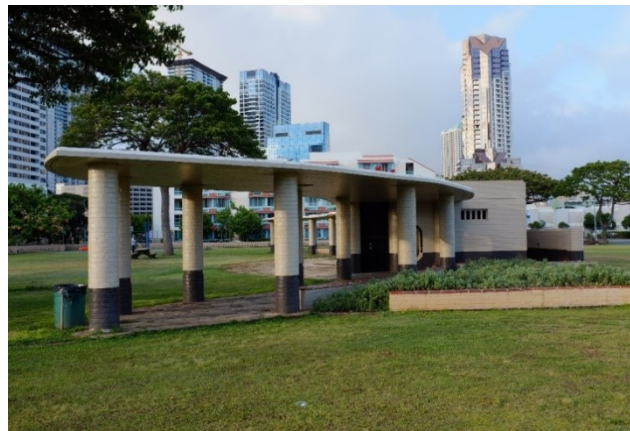
Figure 4.6: Comparative views of the *makai* pergola, looking *mauka*, ca 1980 (above) and 2016 (below). The comfort station, pergola, benches, wall behind storage room (far right) and low walls (front right) have changed very little. However, note the loss of mountain views in the distance, and note the lawn in the foreground where the asphalt senior playground used to be. (Source: “Final EIS for the Kakaako Community Development District Plan,” State of Hawai‘i HCDA & US Dept. of Housing and Urban Development, June 1983; Plate 15⁹⁰)
